FINAL REPORT

EVALUATION AND ASSESSMENT
TOWN OF SALEM DISTRICT COURTHOUSE
35 GEREMONTY DRIVE
SALEM, NEW HAMPSHIRE

FEBRUARY 10, 2017

Facility Assessment Report

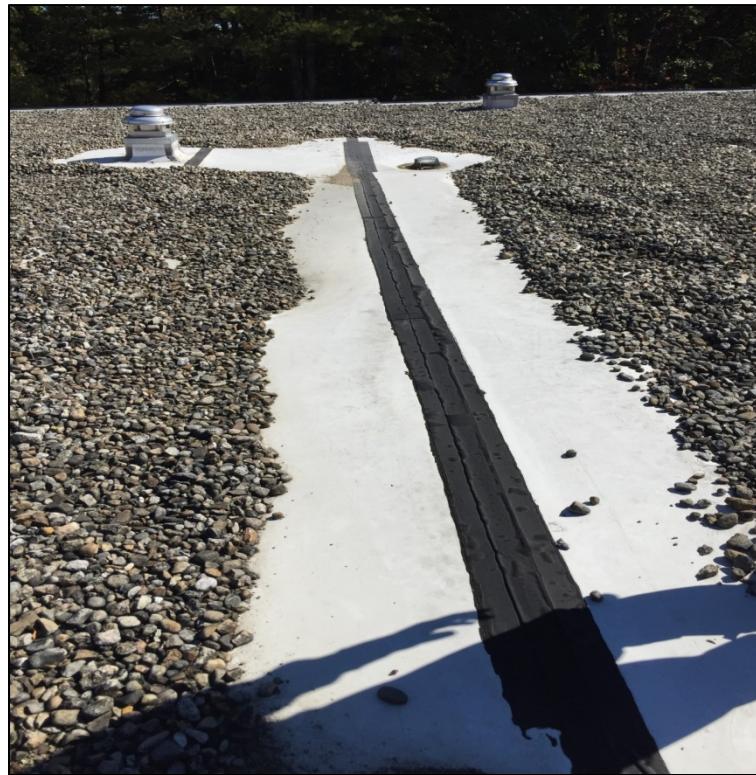
The roof is a loose laid membrane-type roof overlaying rigid insulation. The membrane is held in place by a 1 to 2-inch layer of small diameter river stones or rounded stones. We observed some of the stone ballast had been pulled back from some of the seams and it was reported that these particular seams had been replaced with new seam strips. The roof edges, including the gravel stops/fascia appear to be in fair condition. The brick-faced elevator penthouse which extends about 6 feet above the roof has been a source in the past for water leakage into the building. The reglet flashing around the perimeter, where the brick façade of the enclosure meets the EPDM, has recently been caulked with silicone. This has temporarily stopped the water intrusion. There are two raised roof areas directly over the courtroom ceiling coffers. We noticed standing water in the ballast at both locations. There is a single scupper at each raised roof section, designed to collect the water and direct it toward a downspout and eventually to a roof drain. We suspect debris is preventing the water from properly draining from these raised roof sections or the insulation is not properly sloped to the scupper.

Stone ballasted EPDM or TPO roof membrane. Seams have been re-striped.

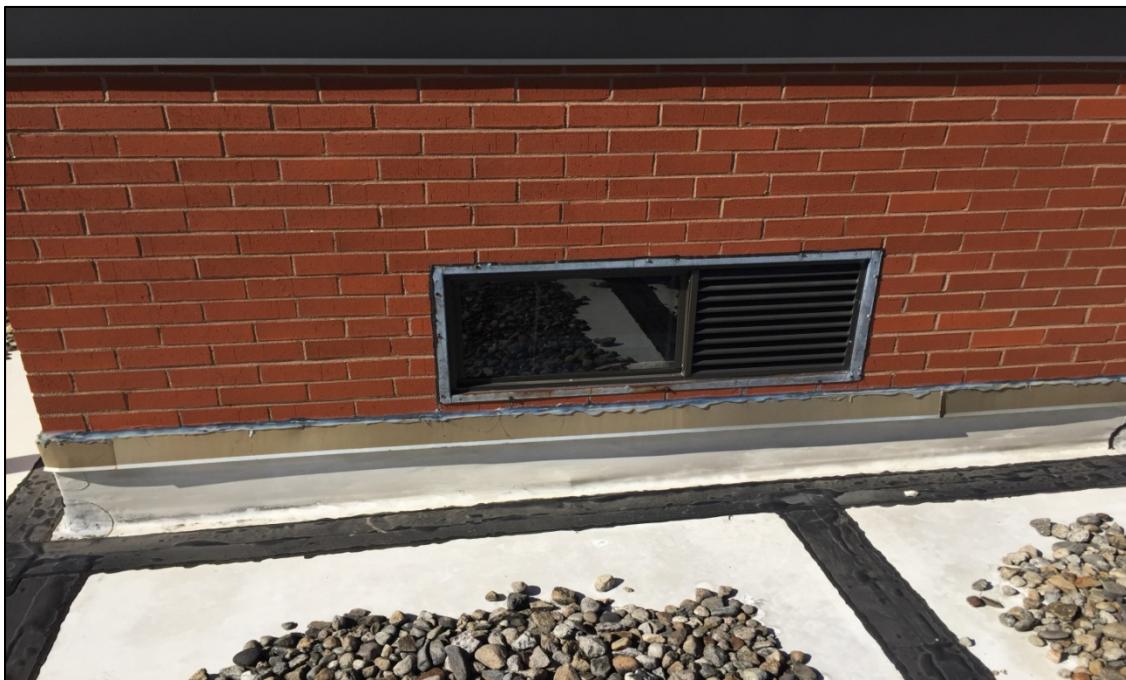
Silicone caulking applied at reglet flashing around base of elevator room to stop leakage.

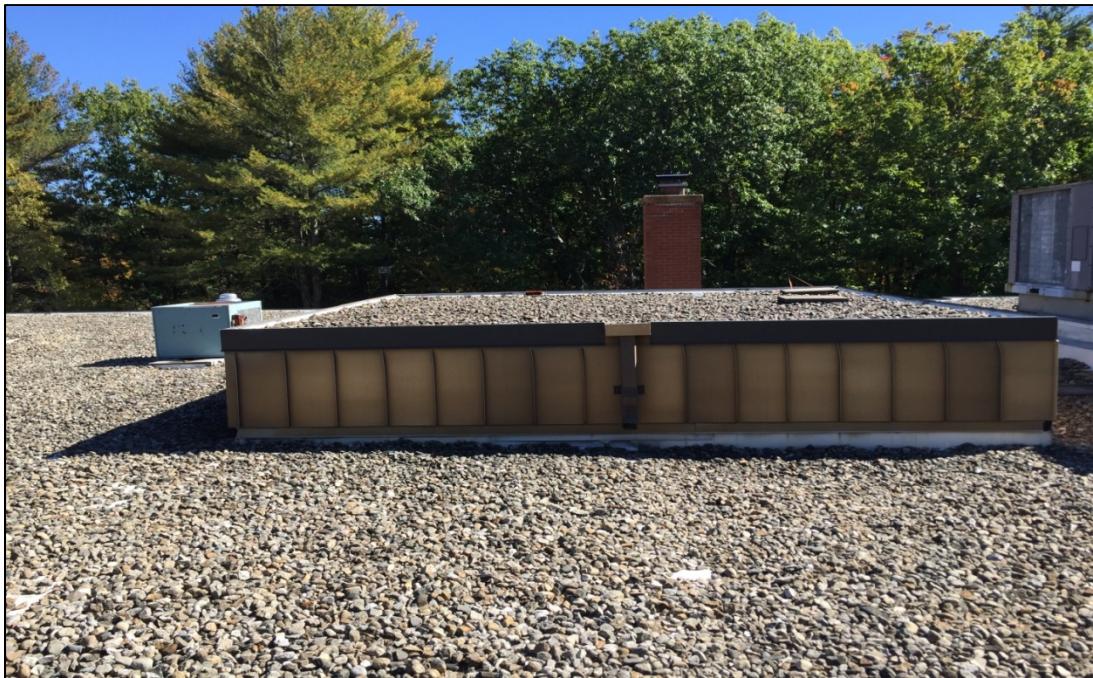
Raised roof section over courtroom ceiling coffers. Note single drain scupper in foreground.

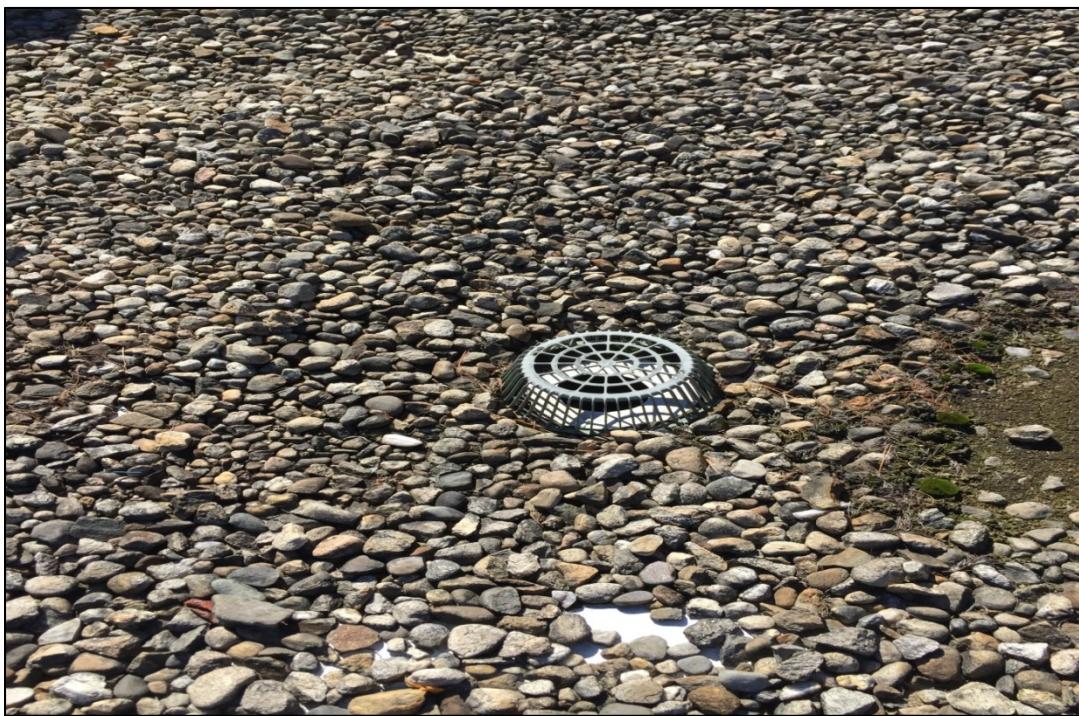
The roof has six interior roof drains. In at least two locations the basket strainers were damaged and many of the drains are surrounded by debris, preventing proper water flow to the drains. The current roof drains have no provision for overflow should the primary drain become blocked. There are two dome-shaped, acrylic skylights over two interior light wells. We noted that the exterior glazing layer is broken on both skylights and moisture/condensation is visible between glazing layers. One skylight has a sizable crack extending from the corner to just beyond the center of the dome. There is a brick-faced chimney that extends about 8 to 10 feet above the surface of the roof. The brick at the top of the chimney just under the precast cap shows signs of moisture intrusion and it should be re-flashed and re-pointed.

Typical roof drain with a build-up of debris around strainer.

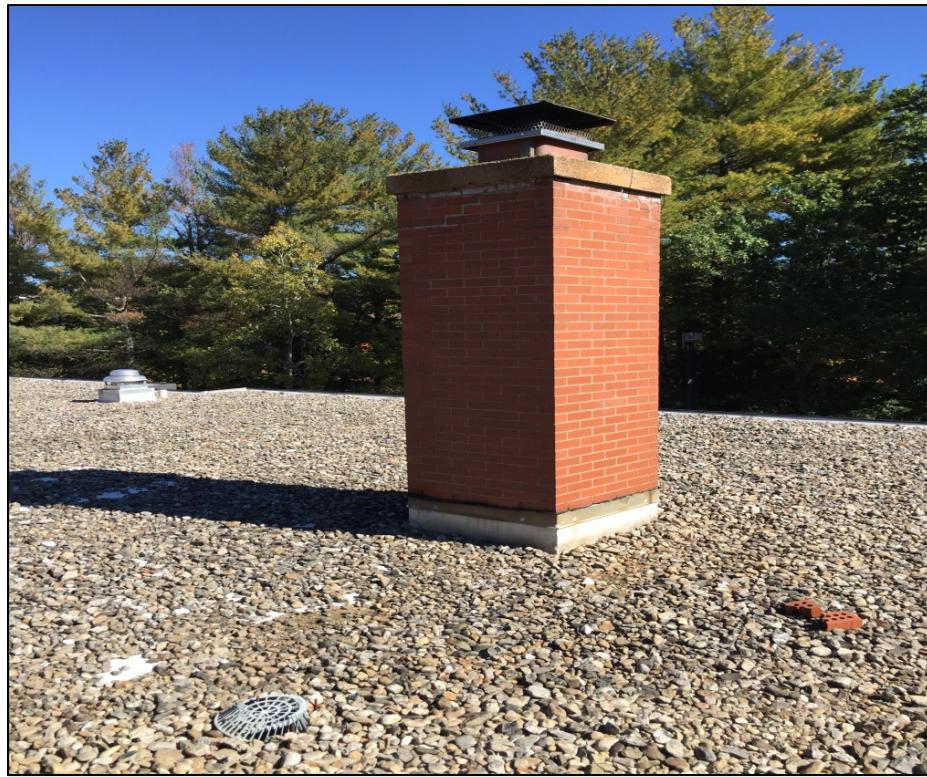
Top of chimney needs repointing and repairs to concrete cap.

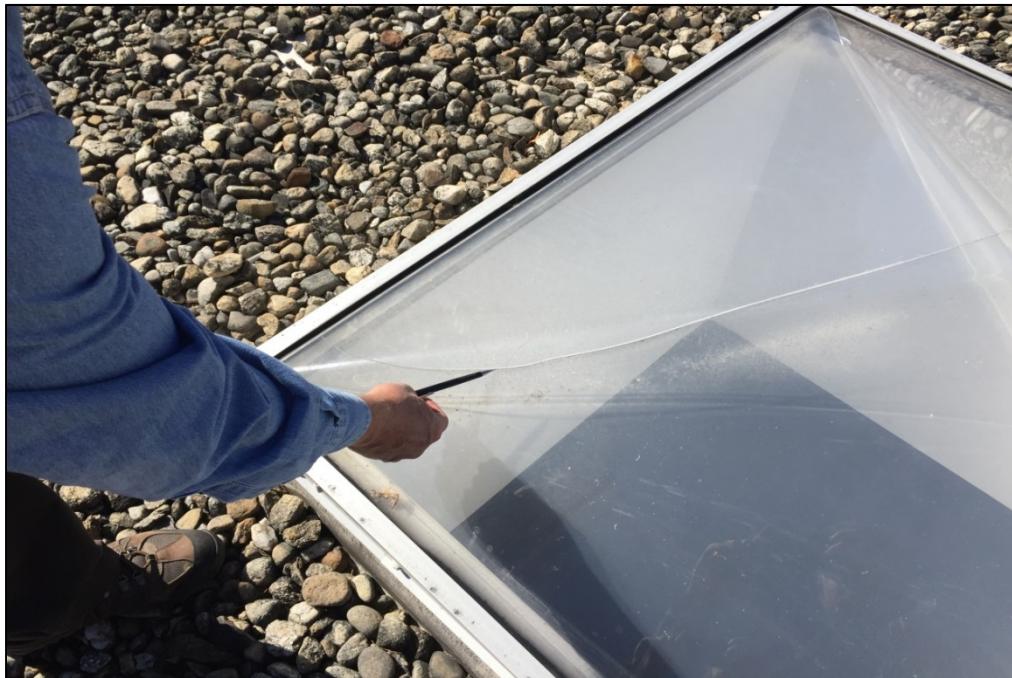
Cracked skylight over main lobby.

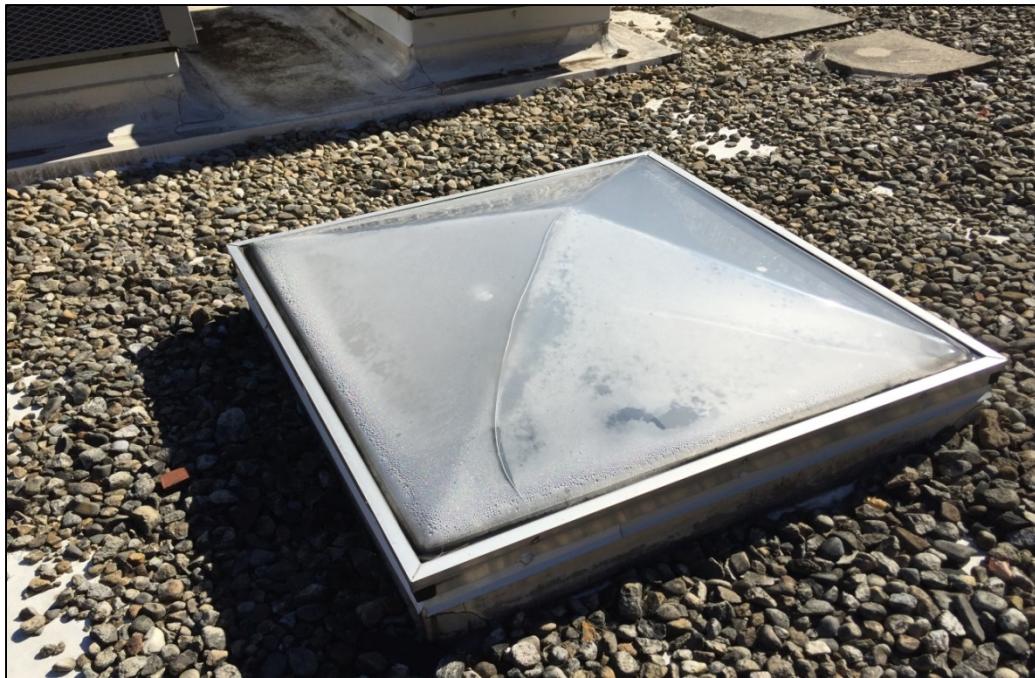
Note build-up of condensation in skylight.

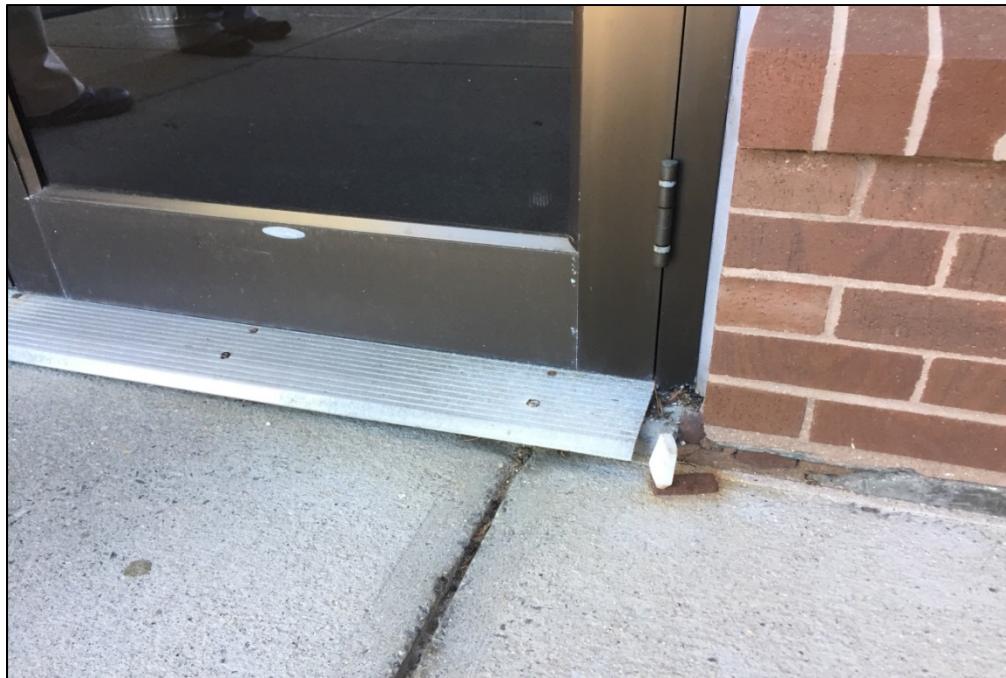
Slab has settled resulting in a raised sill at main entry.

At the main entrance to the facility the concrete slab in front of the vestibule doors appears to have settled, because the door threshold no longer sits flush to the surface and is elevated $\frac{1}{2}$ -inch to 1-inch above the concrete. This condition creates a tripping hazard and provides an opening for stormwater and snowmelt to enter, potentially leading to problems relative to freeze-thaw cycles. The entire slab between the stairs and the doors will need to be removed and replaced to correct the condition.

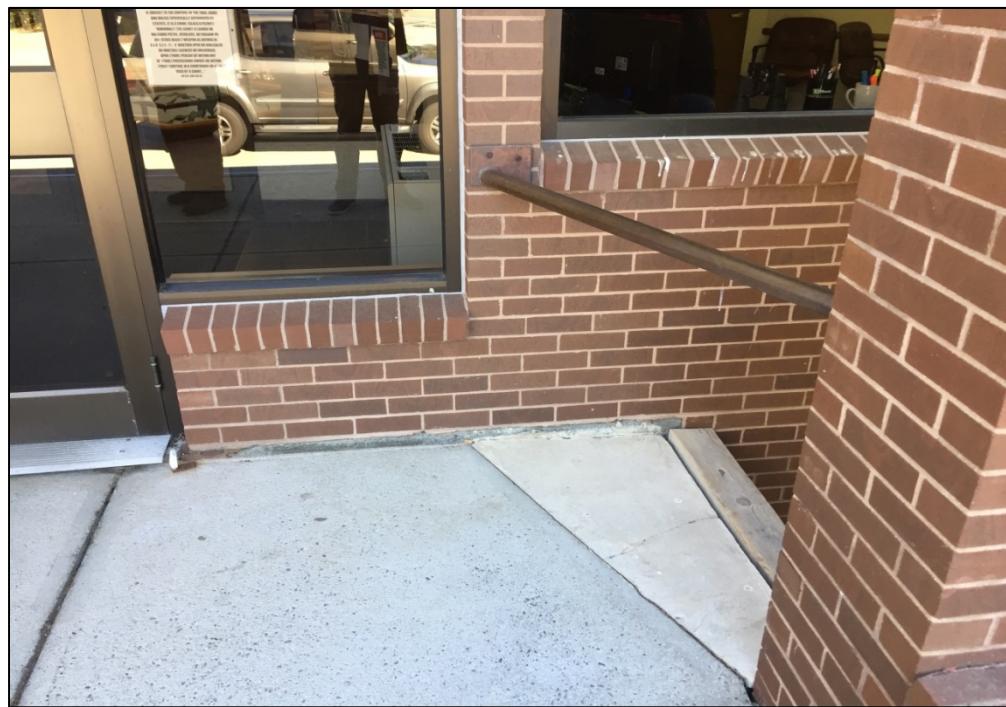
Slab at main entry is settling as material is washed out from under slab. Note settlement crack.

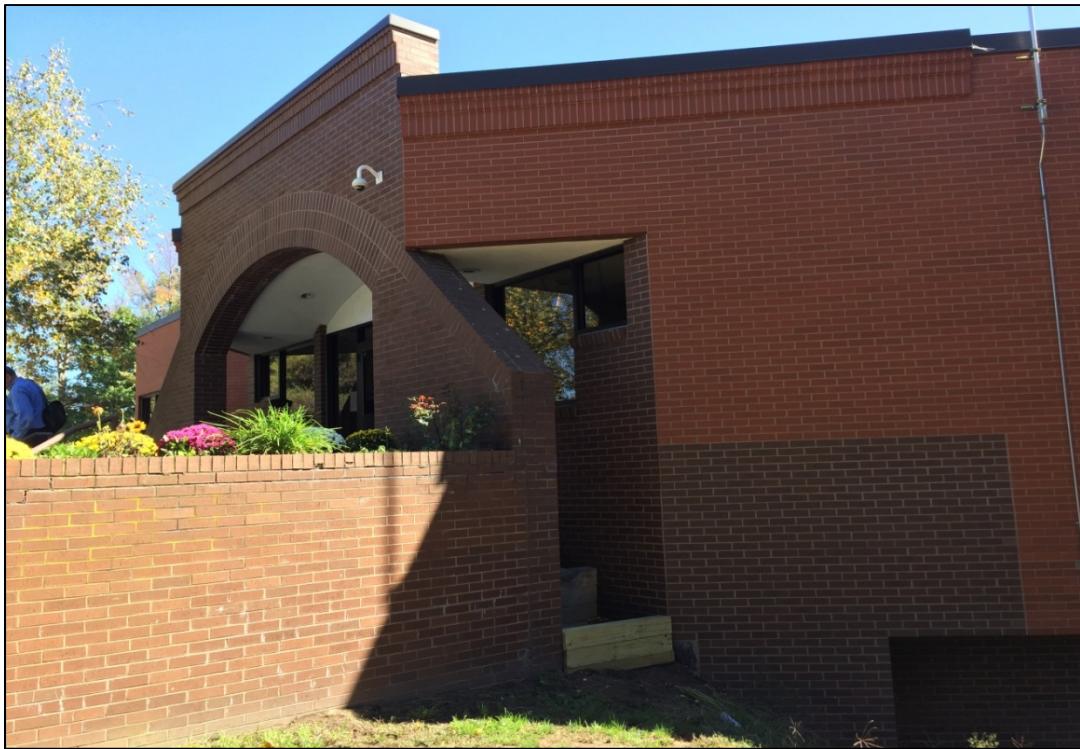
The brick caps on the entry walls are in need of repair. The mortar is deteriorating and receding from the brick edges at the joints. The brick masonry wing walls/planter walls are showing signs of moisture intrusion causing deterioration of the mortar. The mortar is cracking and falling out of the joints. In particular, the planter walls at the main entry exhibit badly deteriorated joints, and joints that are completely open in some locations. A considerable re-pointing effort is needed on this brickwork. The sidewalk is also in poor condition and this is addressed in the Civil/Site section. At the main entry we did observe settlement to the right of the front door. It appears that runoff has penetrated between some of the concrete slab sections adjacent to the building causing soil to washout from underneath the concrete resulting in settlement of the slab sections.

Missing mortar between bricks along planter.
Wood timbers placed to retain soil and keep it from washing out adjacent to main entry.

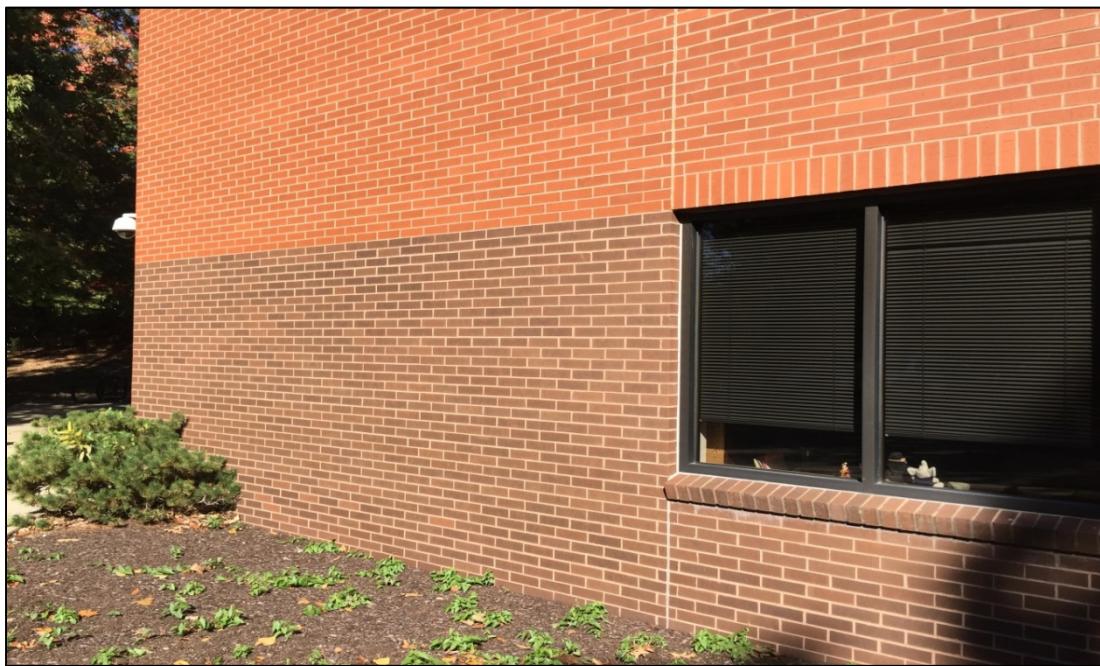
Typical brick façade; caulking in expansion joint in good condition; mulch blocking weeps.

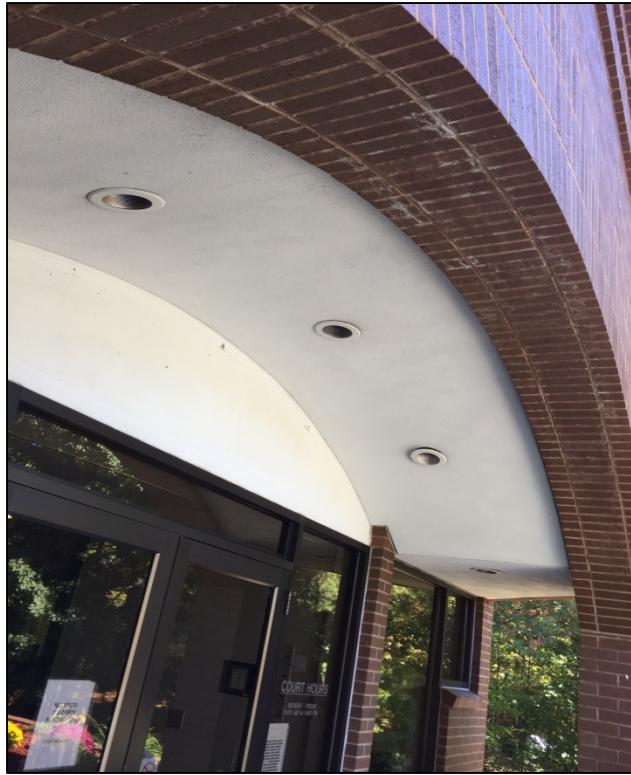
The brick arch at the main entry exhibits efflorescence at the soffit. Efflorescence is crystalline salt deposits that form on the surface of porous masonry. The salts are dissolved by a source of water or moisture and are transported to the surface of the brick as the water moves through the brick toward the outside. Once at the surface, the water evaporates leaving the salts behind. The salt source could be attributed to the type of

Efflorescence on brickwork under archway at main entry.

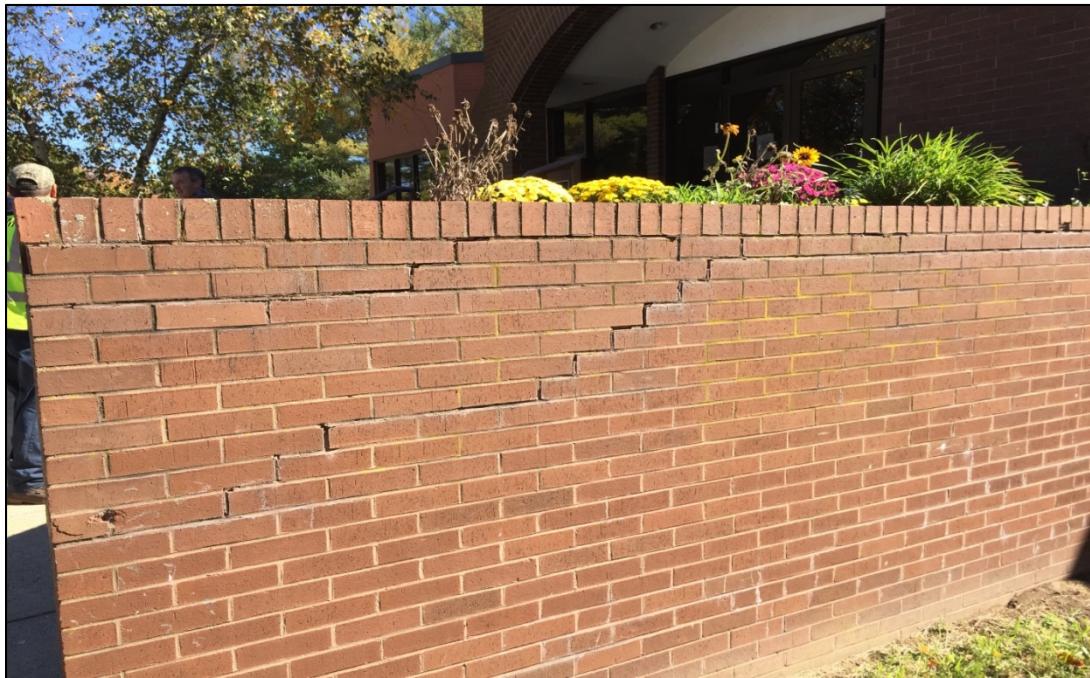
Planters at main entry require re-pointing repairs.

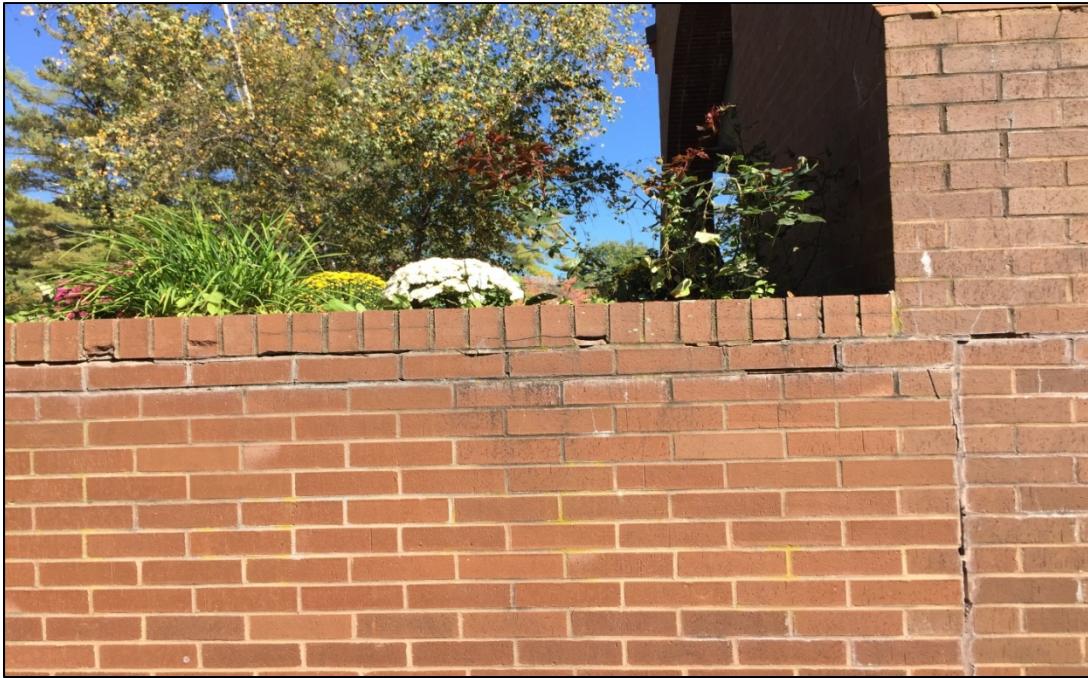
Poor condition of planters at main entry. Note caulking in expansion joint is failing.

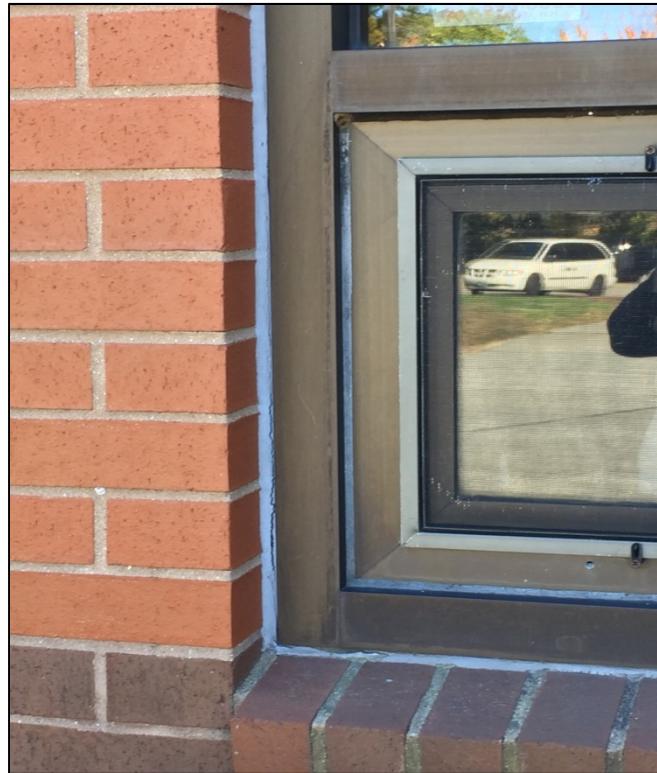
The windows throughout the building are generally in good condition. Some of the sealant around the exterior of the window frames is starting to fail. In our opinion, the sealants are quickly reaching the end of their useful life and should be replaced within the next five years.

Caulking around window units is starting to fail.

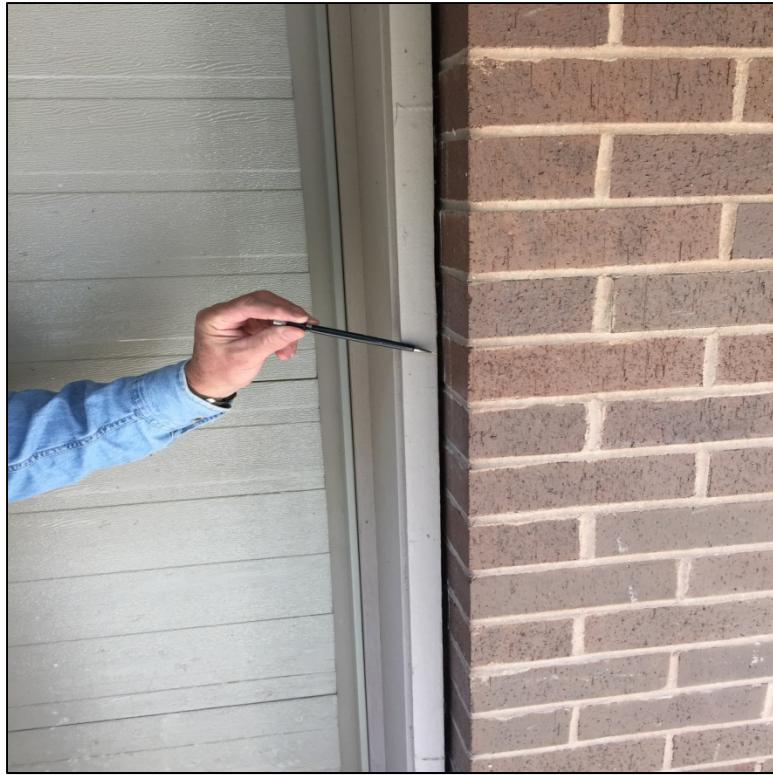
Missing caulking around door at judge's parking garage.

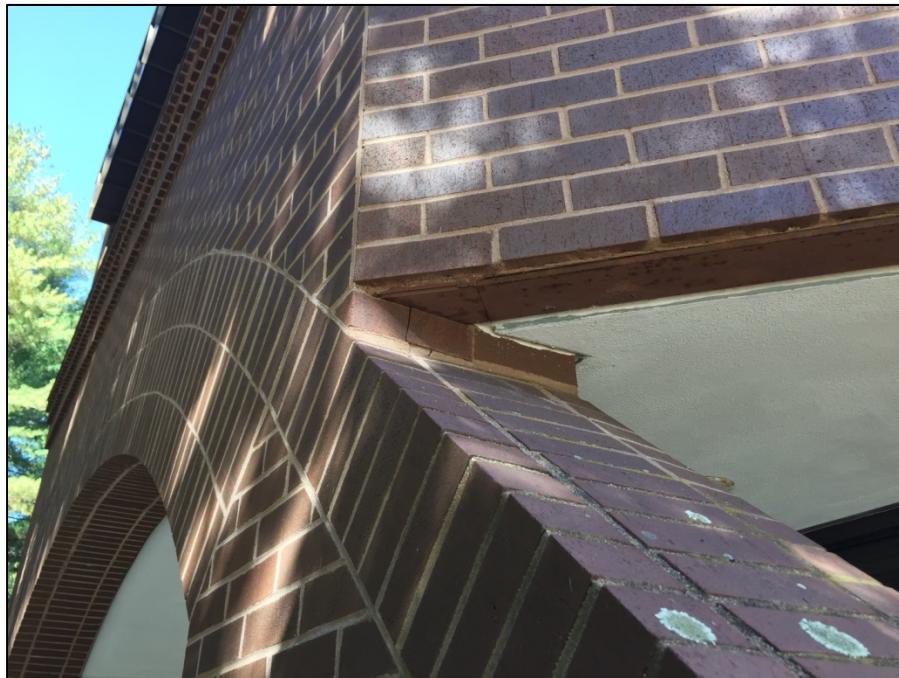
At the lower level entrance, we observed cracked bricks at several of the locations where the steel angle iron lintels bear on the brick. These are the long lintels at the overhanging portion of the building and it appears that there may be insufficient bearing length for the steel on the brick.

Steel lintel bearing on cracked brick.

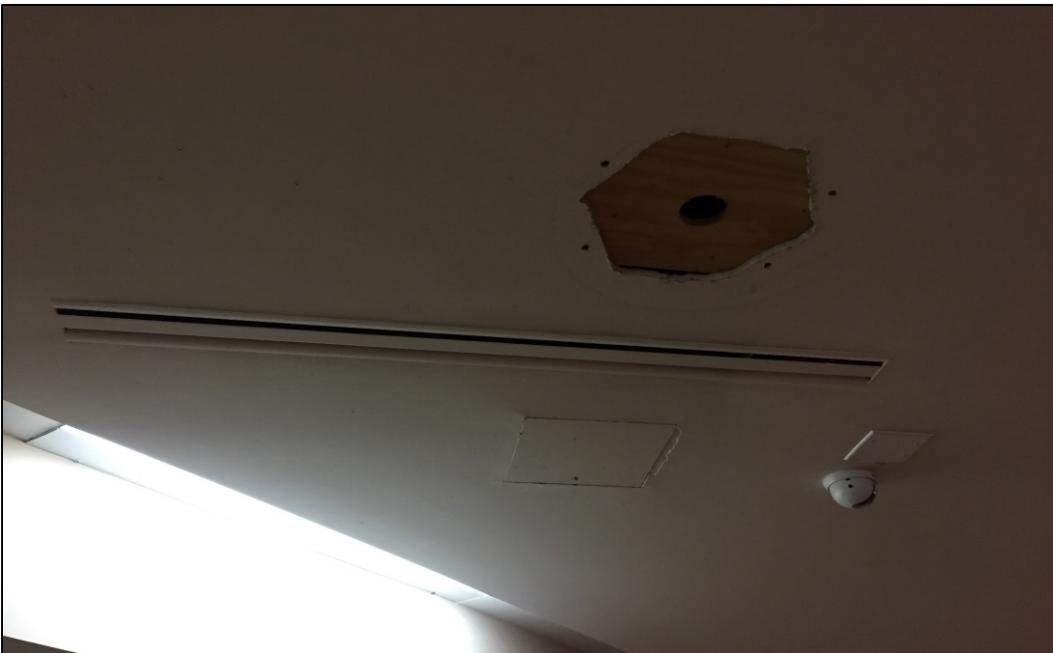
Ceiling in courtroom requires patching.

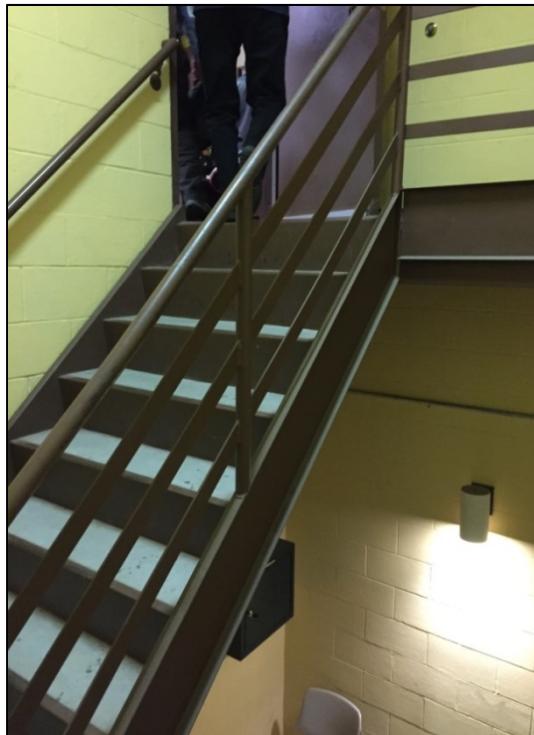
The stairways from the holding cell area to the courtrooms and from the lower level corridor to the back corridor behind the courtrooms, do not meet code in terms of the stair rise to run. The tread to riser ratio is too steep. In addition, the upper and intermediate landings are not wide enough in the direction of travel. The handrails on the stairs throughout the building do not meet certain aspects of the code. The horizontal slats on the stairs to the holding cells are spaced such that a 4-inch sphere is allowed to pass through the slats. The same can be said of the main stair set at the lobby area. The horizontal pipes on the guardrail are positioned such that the clear space between pipes exceeds the 4-inch maximum. The building code states that a 4-inch sphere shall not be allowed to pass through a handrail system. Other violations include no hand rail extensions, both top and bottom, and there are handrails missing on the guardrail side of the stair. The code requires a separate handrail in addition to the top rail of a guardrail system.

Stairs from holding cell to courtroom.

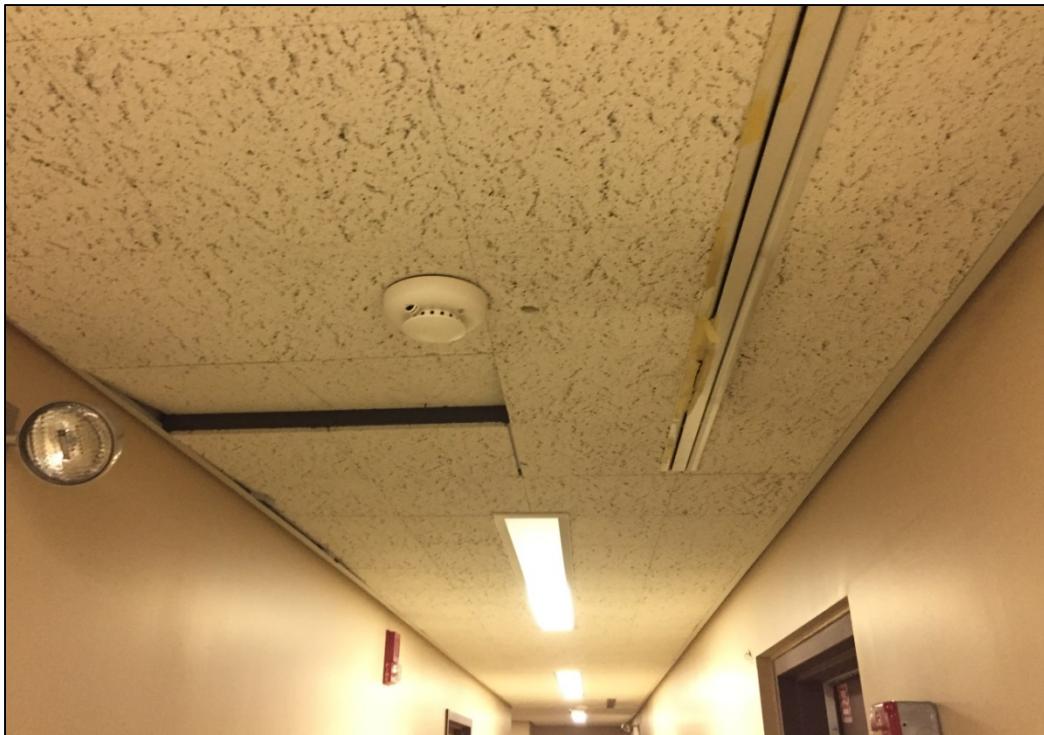
Spline-type acoustical ceiling. Unable to get tile back into place after maintenance.

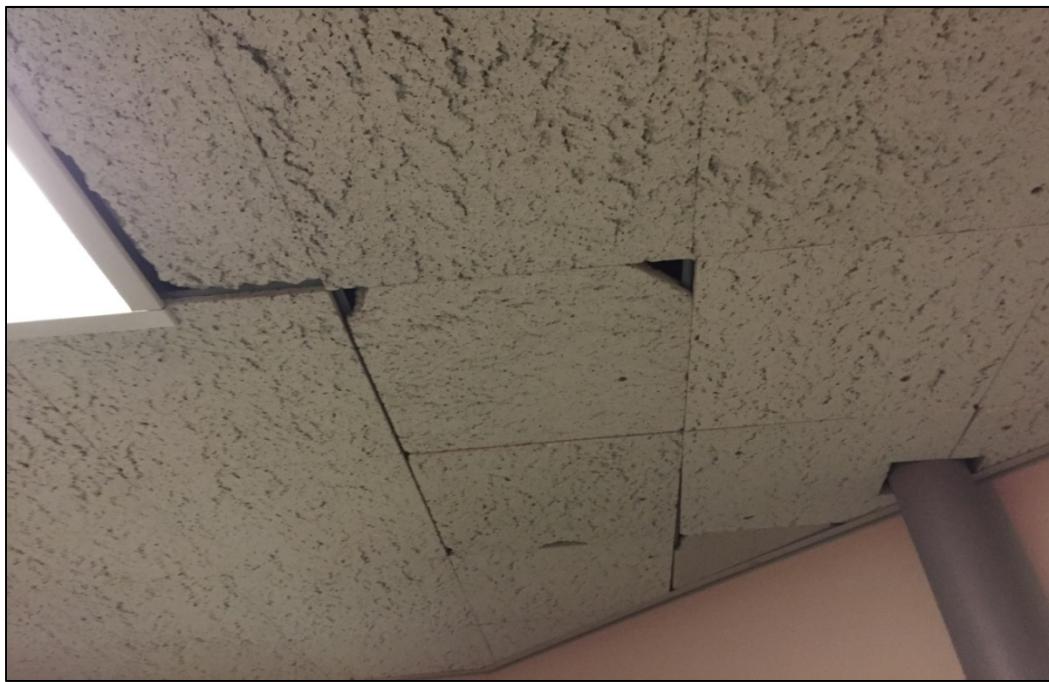
Broken corners/edges and misaligned tiles on spline-type acoustical ceiling.

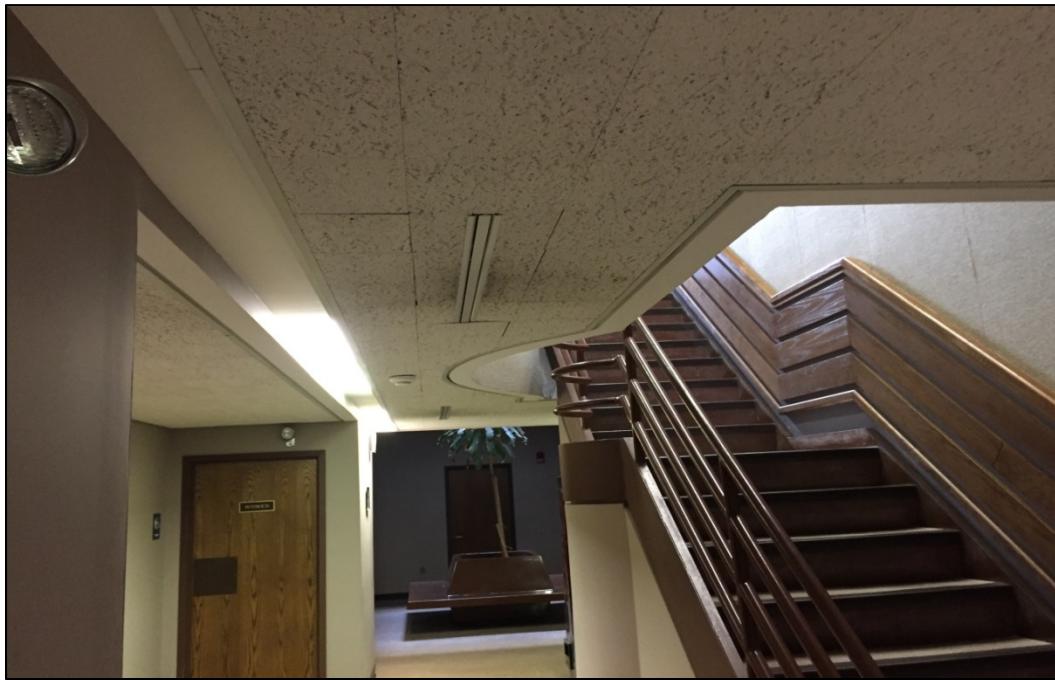
Staining on tiles around air vents.

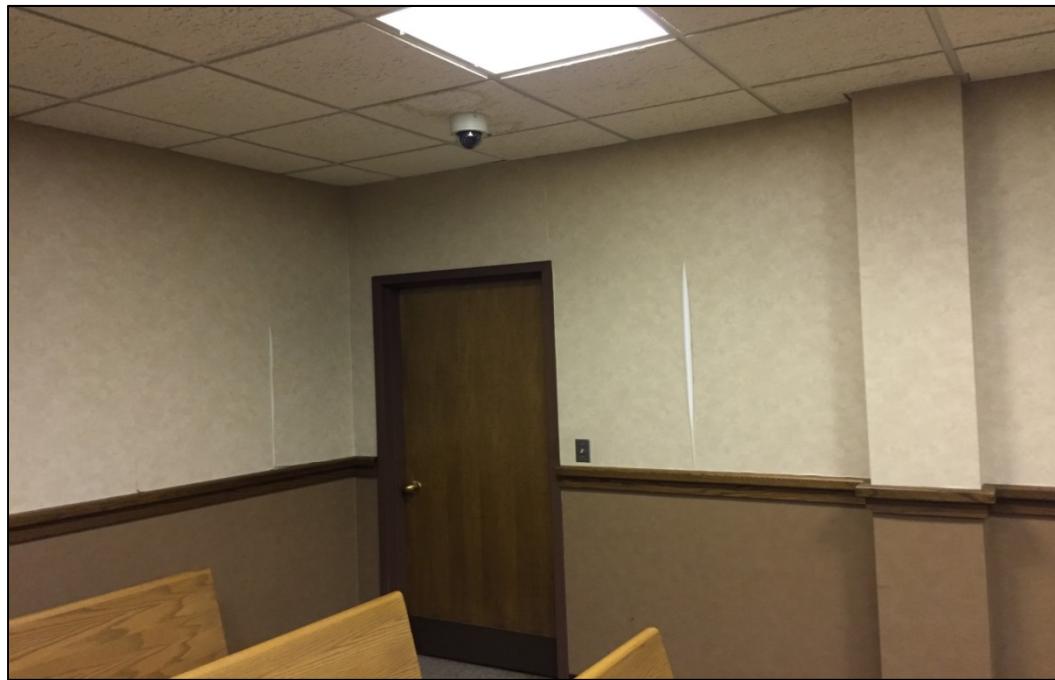
Peeling wallpaper and grid-type acoustical ceiling in juvenile hearing room.

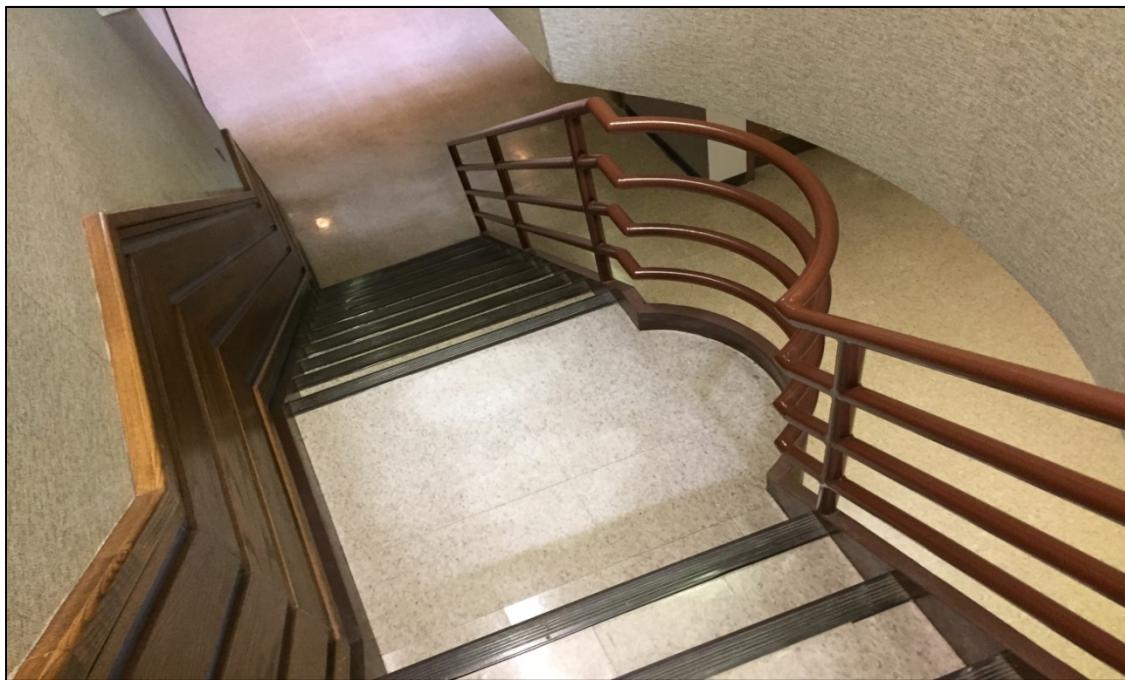
Main stairway from lobby.

Note lack of proper handrail on either side and oversized openings in guardrail.

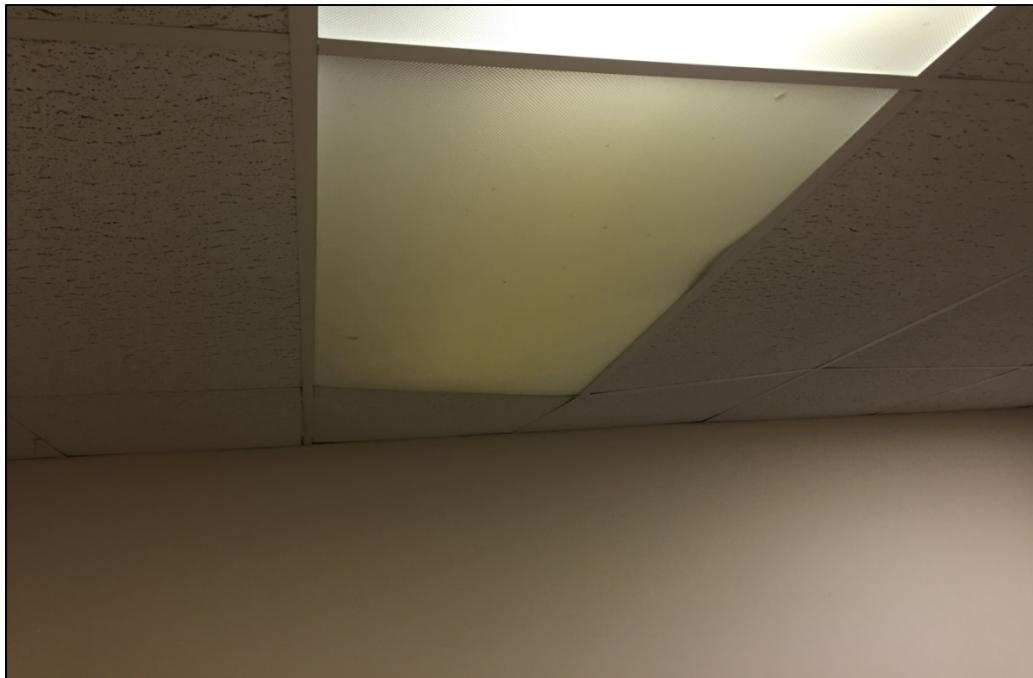
Damaged ceiling in Room G11 on lower level.

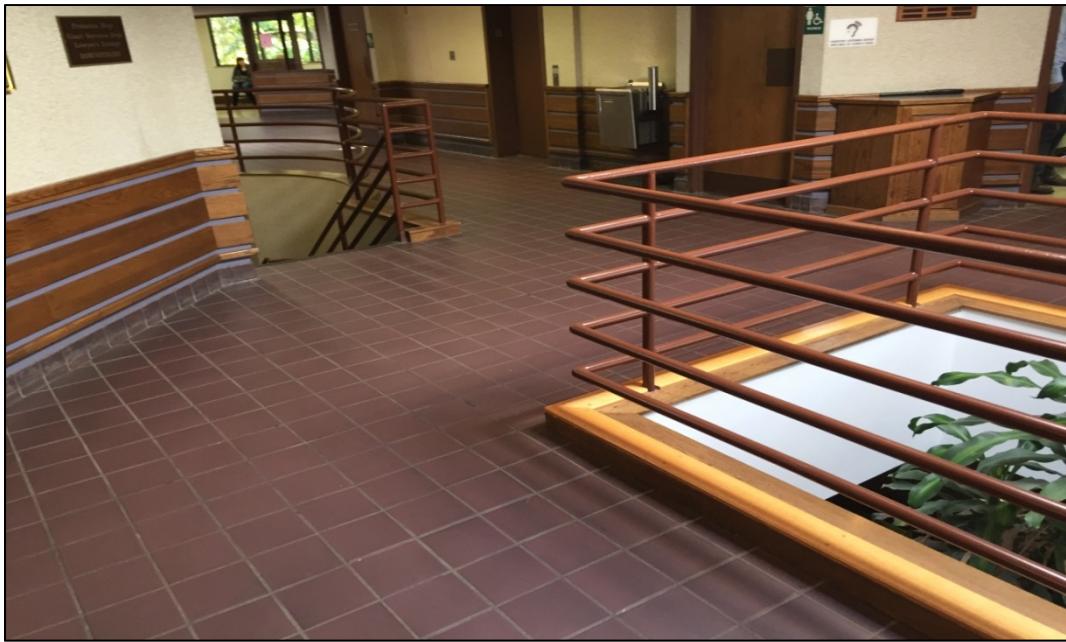
Guardrail around floor opening. Note excessive opening between horizontal rails.

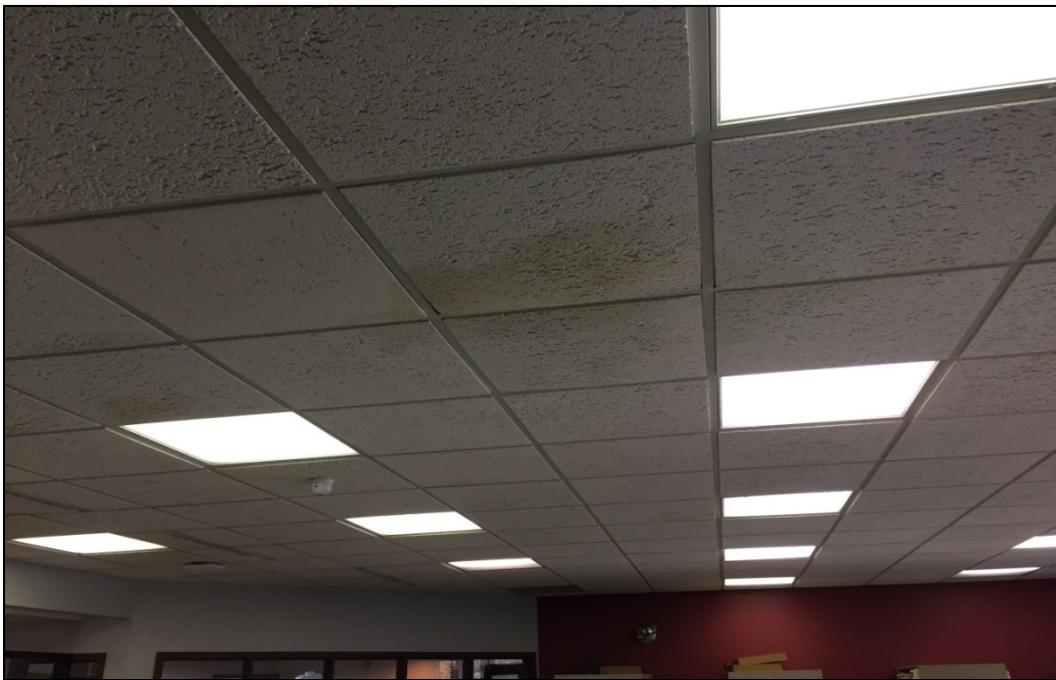
Stained ceiling tiles in clerk's department.

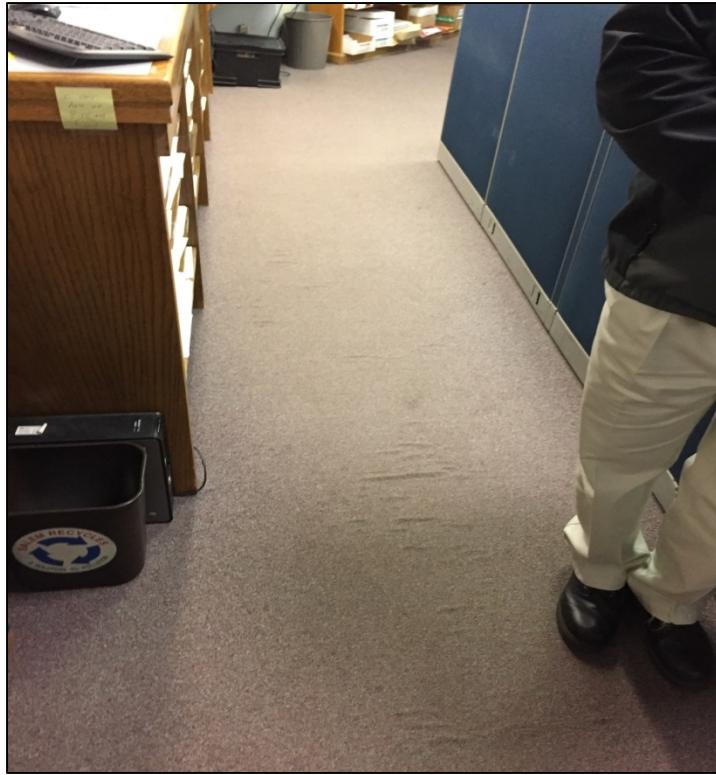
Worn out carpeting in the clerk's department.

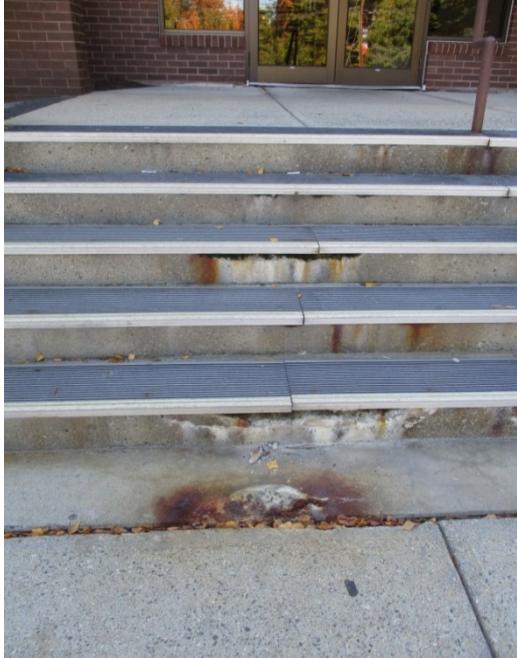
The concrete stairs leading from the concrete sidewalk to the main entrance show deterioration of the risers and of the concrete landings at the top and bottom of the stairs. Metal treads and nosings have been installed to provide a secure walking surface, but the deteriorated areas should be cleaned out and repaired. Additionally, where the stairs meet the brick retaining walls flanking either side, there is evidence of weather-related damage due to water flowing off the stairs and into the joint between the walls and the stairs.

Concrete deterioration at main entrance stairs.

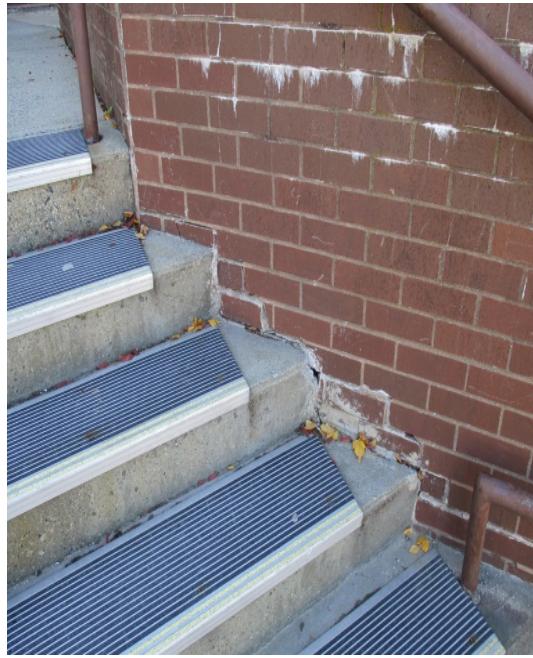
Concrete and brick deterioration at main entrance.

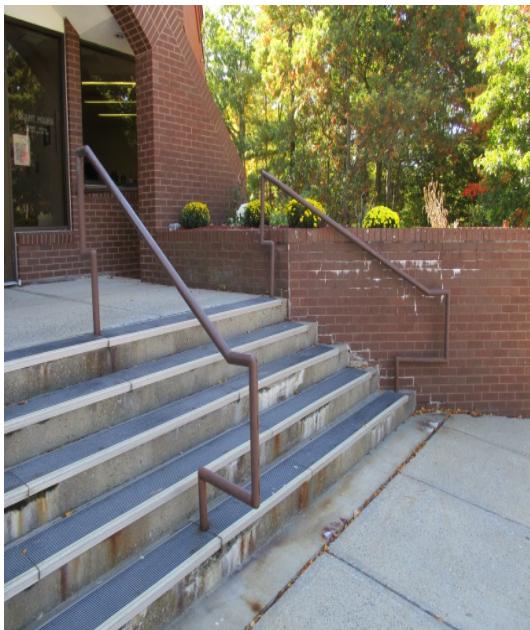
The handrails provided at the stairs to the main entrance do not comply with current regulations and should be replaced.

Railings at main entrance.

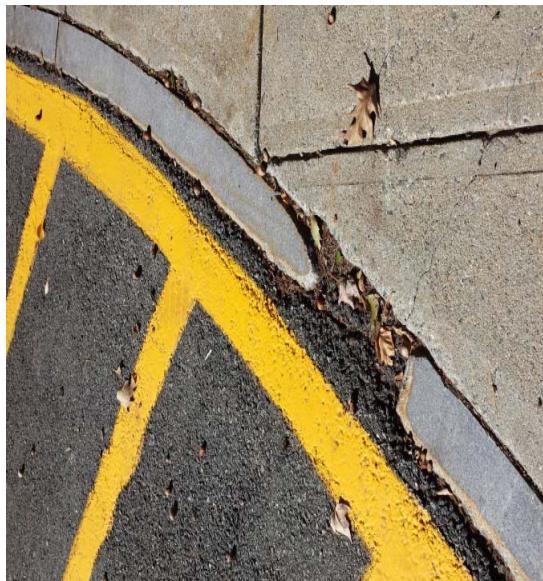
Missing curbing at accessible parking.

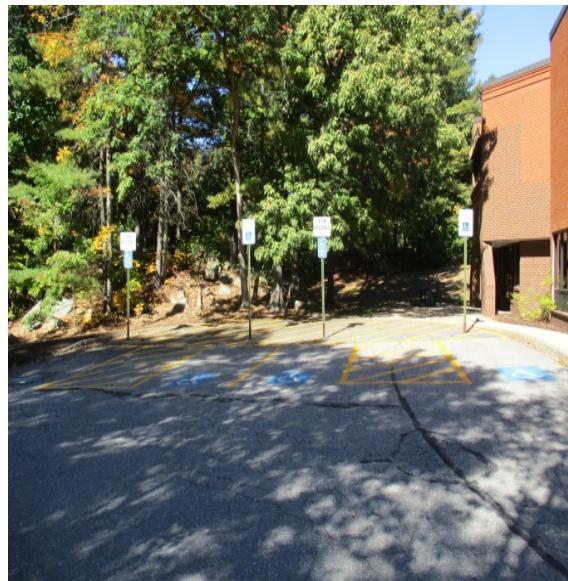
Accessible spaces.
Note sign posts and sign height.
