FINAL REPORT

EVALUATION AND ASSESSMENT
TOWN OF SALEM DISTRICT COURTHOUSE
35 GEREMONTY DRIVE
SALEM, NEW HAMPSHIRE

FEBRUARY 10, 2017

Facility Assessment Report

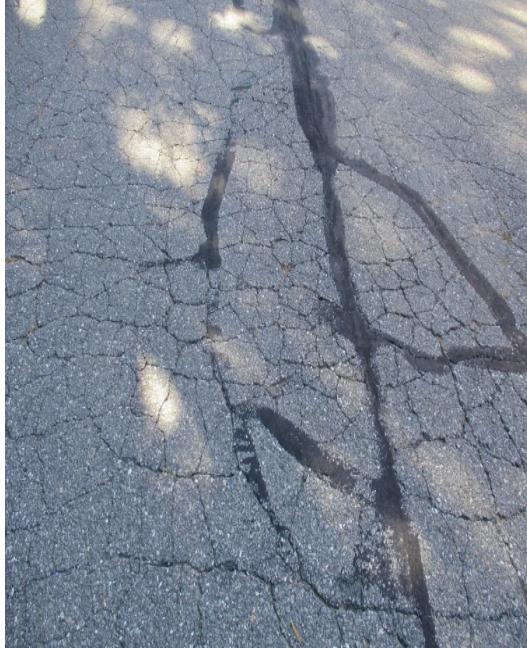
The parking lot pavement is in poor condition. Despite some attempted repairs at sealing cracks, there is evidence the base gravels are also in poor condition (extensive cracking, uneven settlement, raveling) and do not provide the structural stability required to support traffic. The Town should consider reclaiming the pavement and base gravels, regrading and compacting, and placing new pavement to a minimum depth of 4 inches across the site. The contractor should ensure the site continues to drain properly, in accordance with the original design.

Failing pavement.

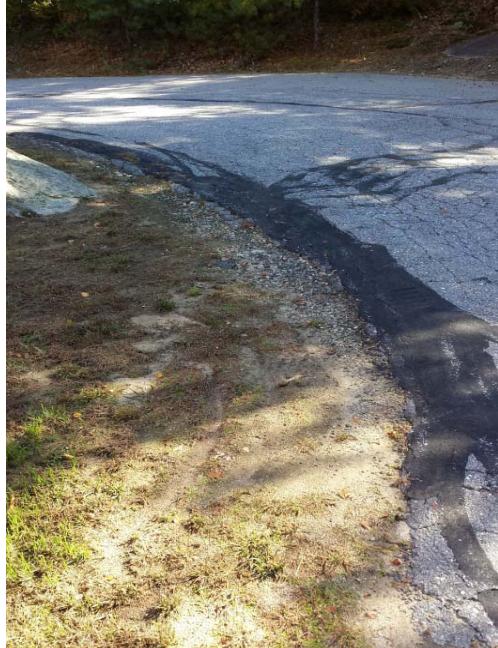
Failing pavement.

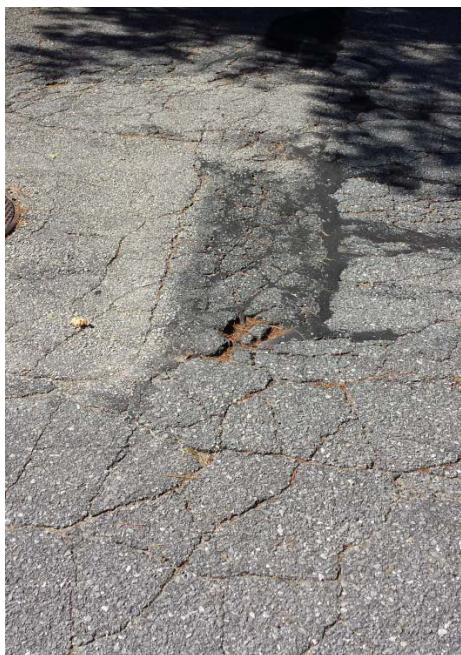
Failing pavement.

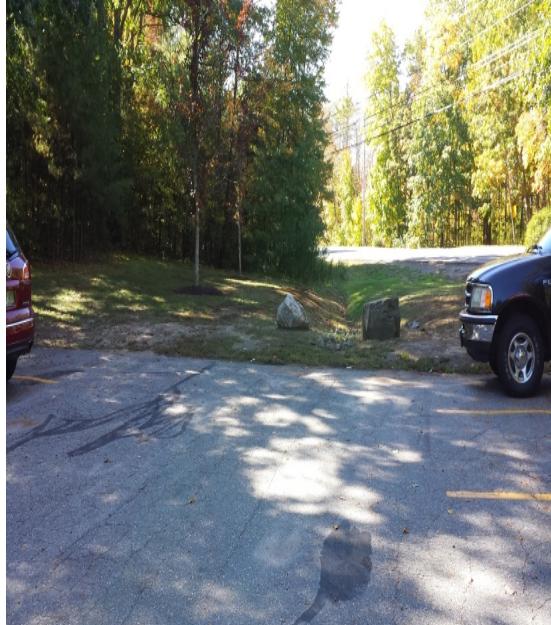
Extend driveway to provide turnaround.

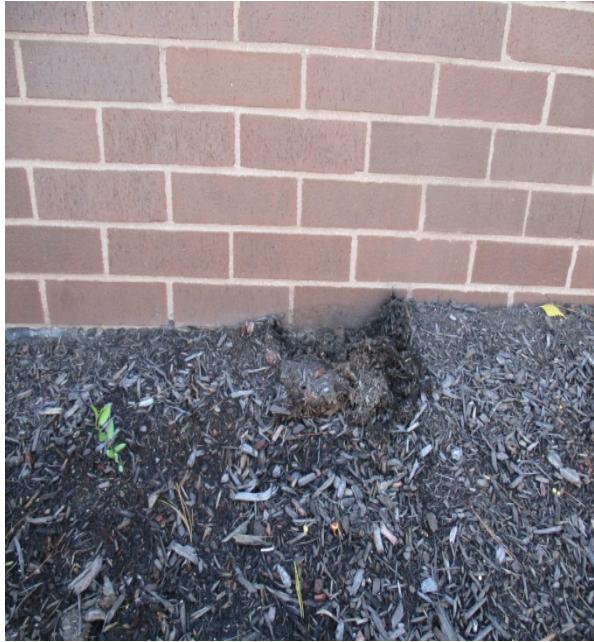
In those areas where mulched landscaping beds directly abut the exterior walls of the building, the mulch is mounded above the lower courses of brick, obstructing the weep holes, which can either prevent moisture from escaping from the wall assembly or allow moisture in the soil to wick up into the wall. Rake the mulch away from the lowest brick courses and redistribute throughout the beds.

Mulch piled over masonry weeps.

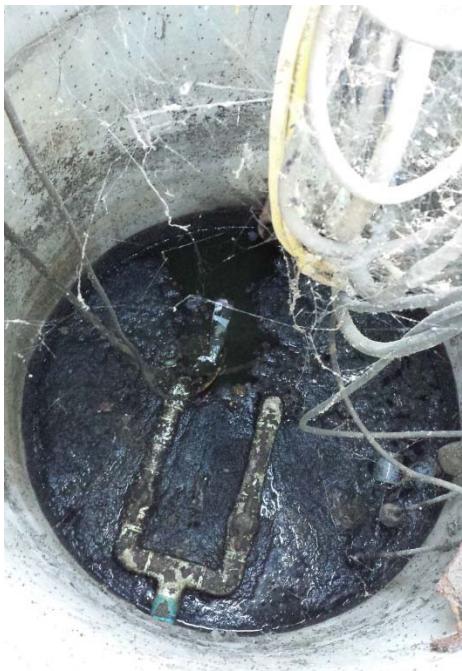
Pump station interior - general condition.

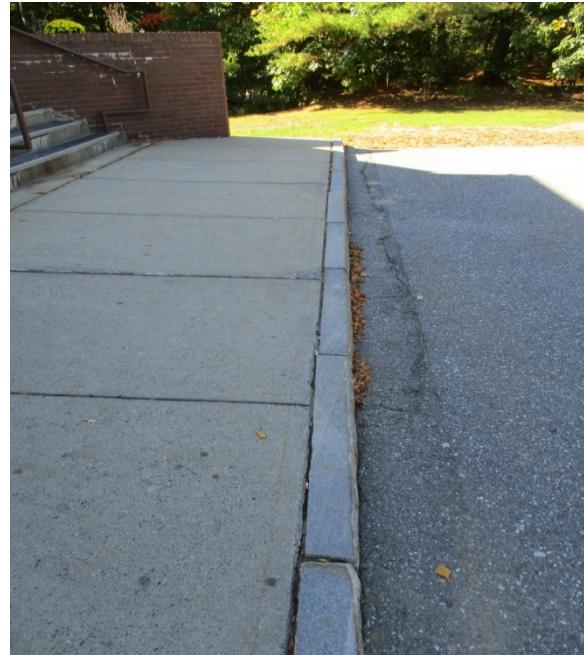
Displaced curbing.
