**HAZARDOUS MATERIALS SURVEY  
COMMERCIAL BUILDING  
1 NORTH BROADWAY  
SALEM, NEW HAMPSHIRE**

**January 2020**

**Project 19039**

## **HAZARDOUS MATERIALS SURVEY**

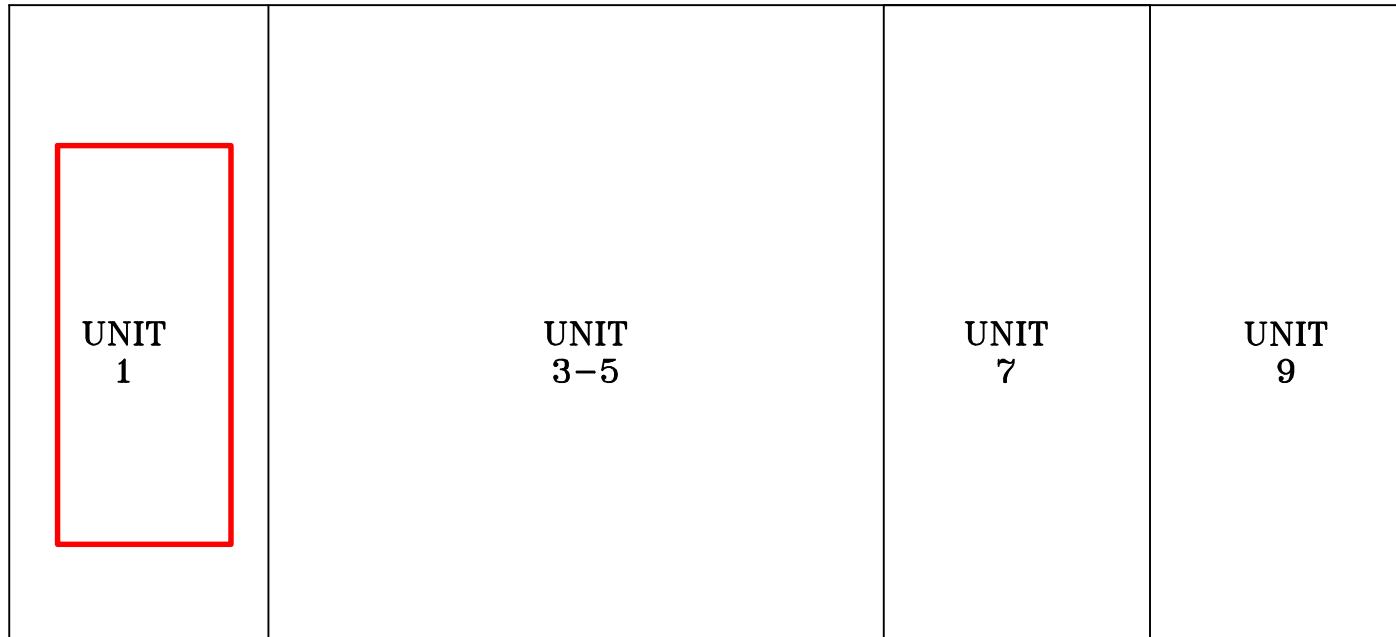
FIGURE: 1  
PROJECT NO.: 19039  
DATE: JANUARY 2020

APPROXIMATE LOCATION OF  
ASBESTOS CONTAINING 12"  
PINK FLOOR TILE

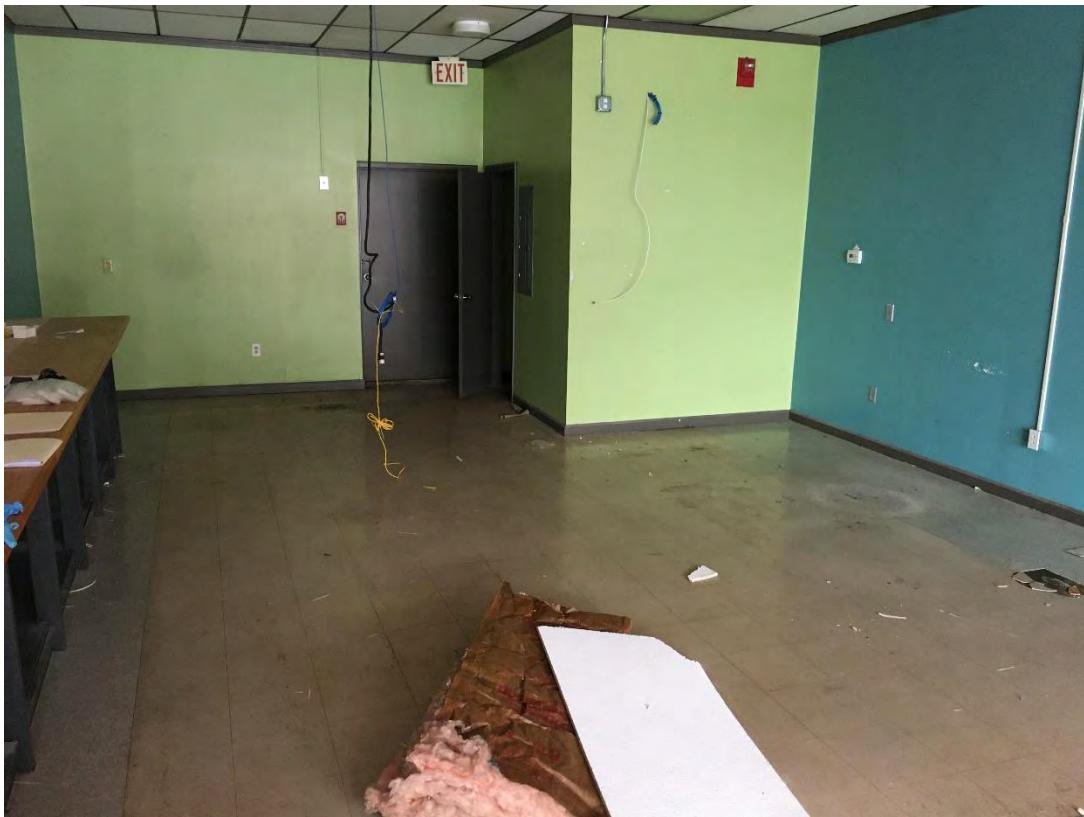
A view of the interior of Unit 1

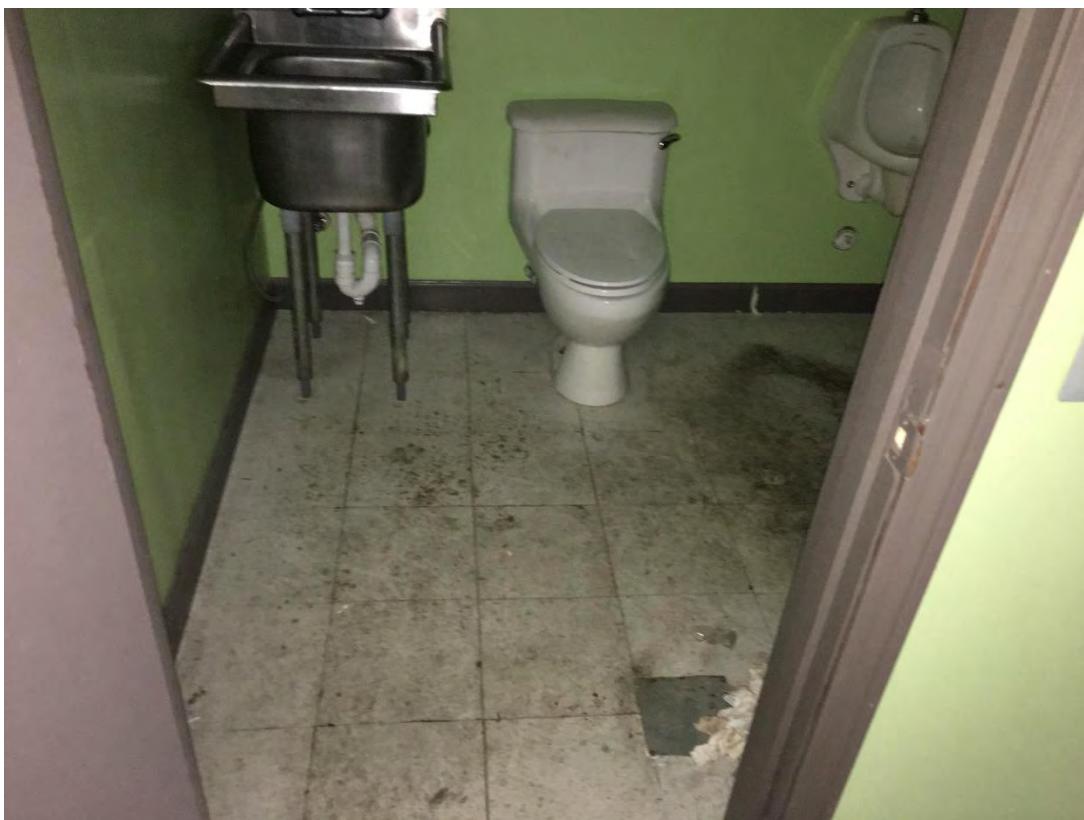
A view of the interior of Unit 1
