**HAZARDOUS MATERIALS SURVEY
COMMERCIAL BUILDING
10 SOUTH BROADWAY
SALEM, NEW HAMPSHIRE**

January 2020

Project 19039

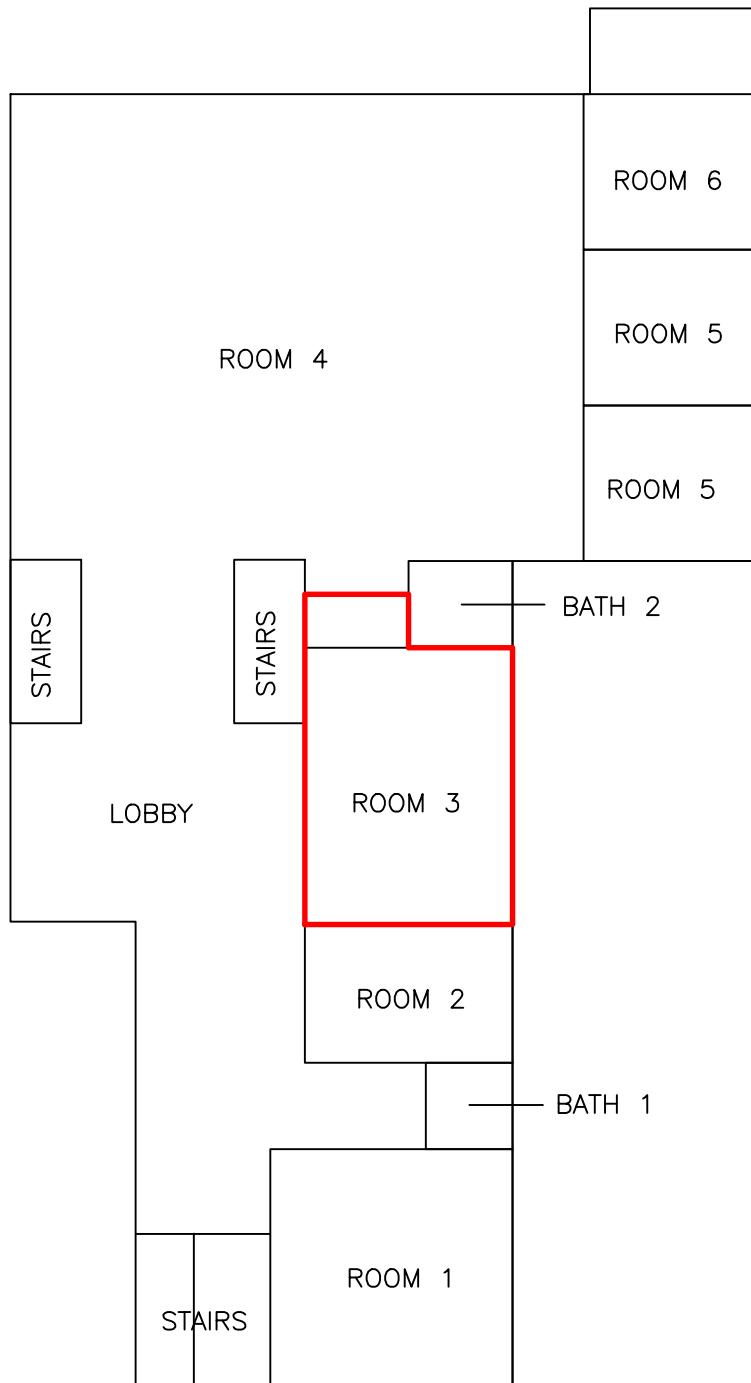
FIGURE: 1
PROJECT NO.: 19039
DATE: JANUARY 2020

APPROXIMATE LOCATION OF
ASBESTOS CONTAINING BEIGE
SHEET FLOOR

Asbestos was positively identified at the 10 South Broadway building, as summarized in **Section 2** and **Appendix E**. In accordance with NESHPAP and NHDES regulations, all friable ACM, or materials made friable by demolition or renovation activities, must be removed from the building by a licensed asbestos abatement contractor, prior to demolition or renovation. Removal of ACM is regulated by NHDES. GREEN recommends the identified ACMs be removed from the buildings in accordance with applicable asbestos abatement regulations prior to the start of planned demolition activities. Asbestos abatement must be done by a New Hampshire licensed Asbestos Abatement Contractor and be properly disposed of offsite at an appropriate receiving facility in compliance with all applicable state and federal regulations. The New Hampshire asbestos regulations require visual inspection and clearance air monitoring at the completion of an asbestos abatement project. Additionally, full-time monitoring of asbestos abatement procedures in compliance with design specifications and regulations is recommended during major asbestos abatement projects.

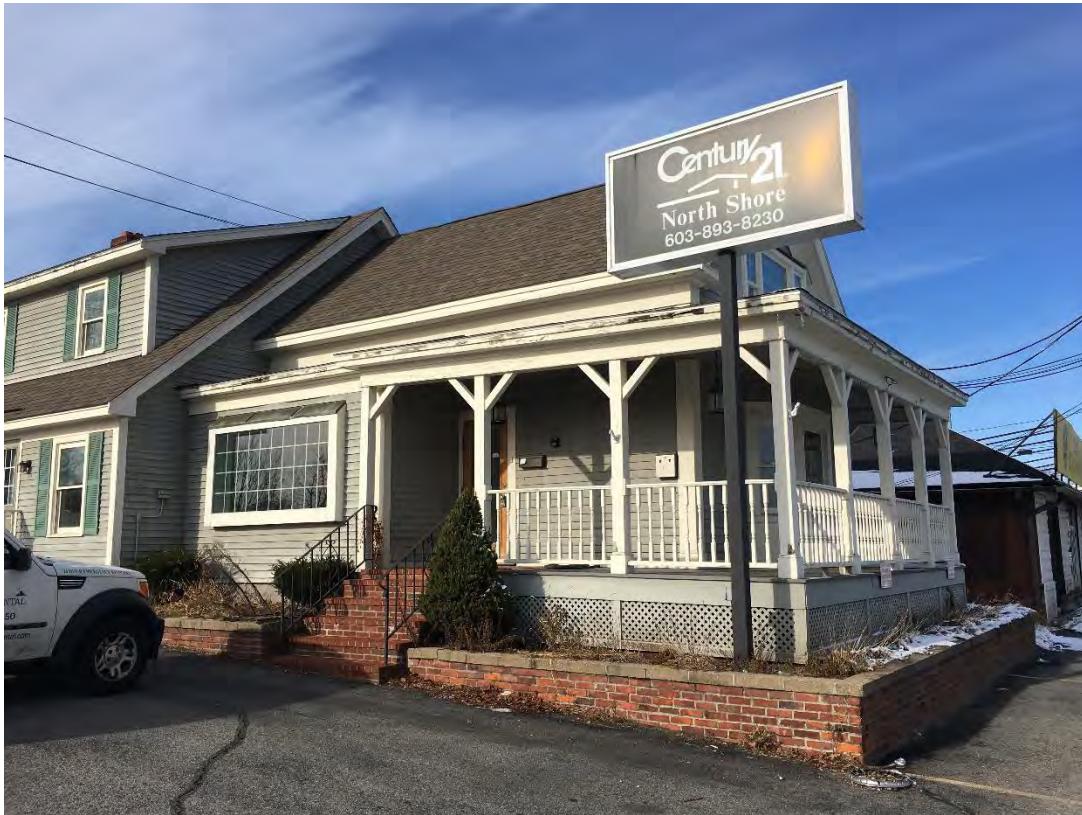
A view of the south side of the building facing northwest

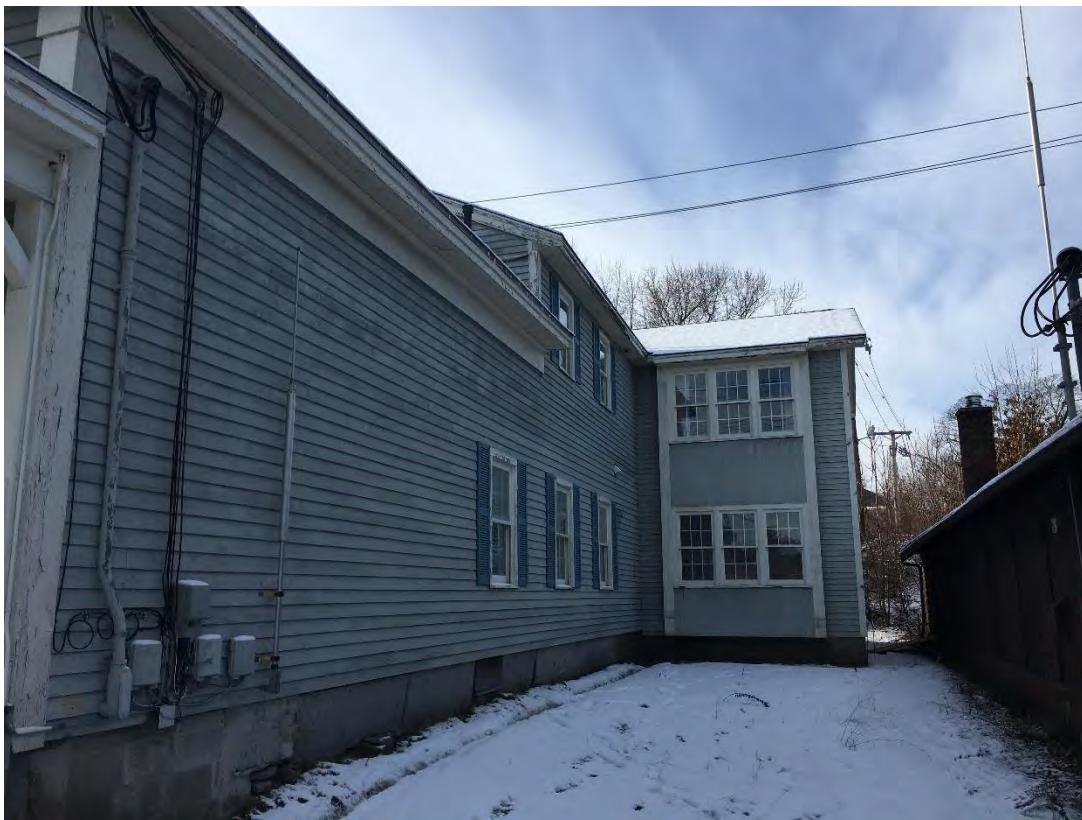
A view of the north side of the building, facing west

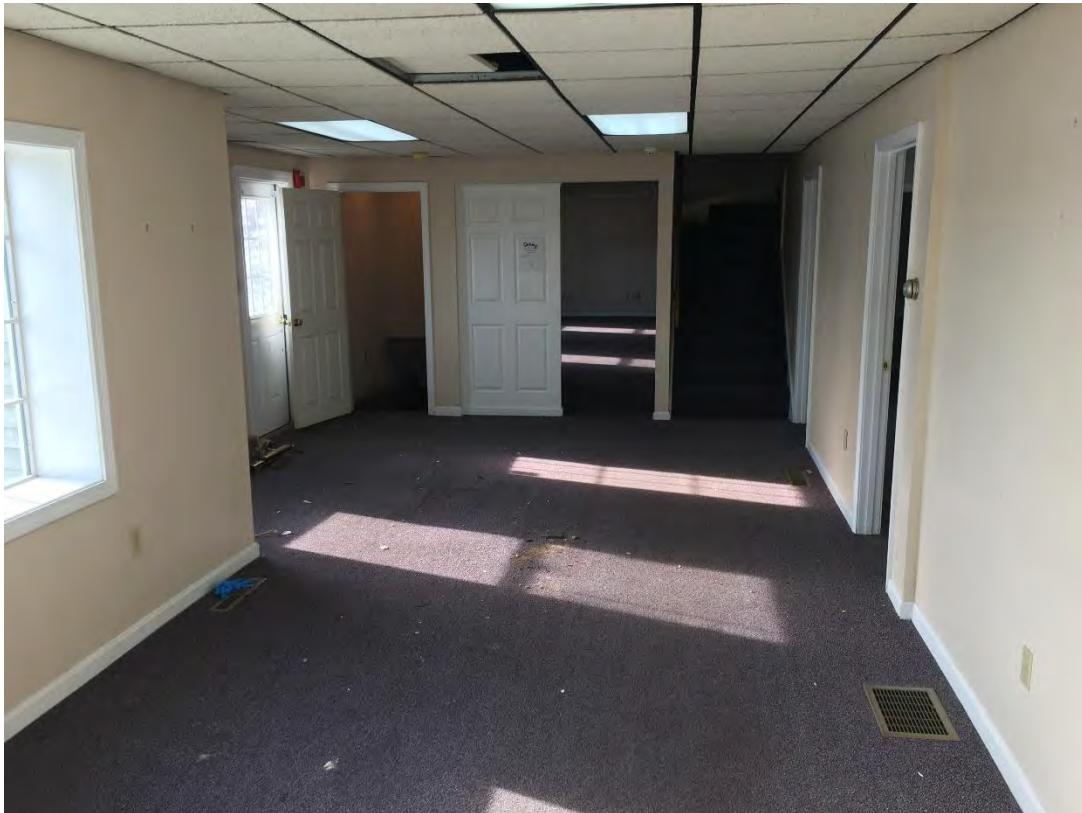
A view of the 1st floor of the 10 South Broadway building

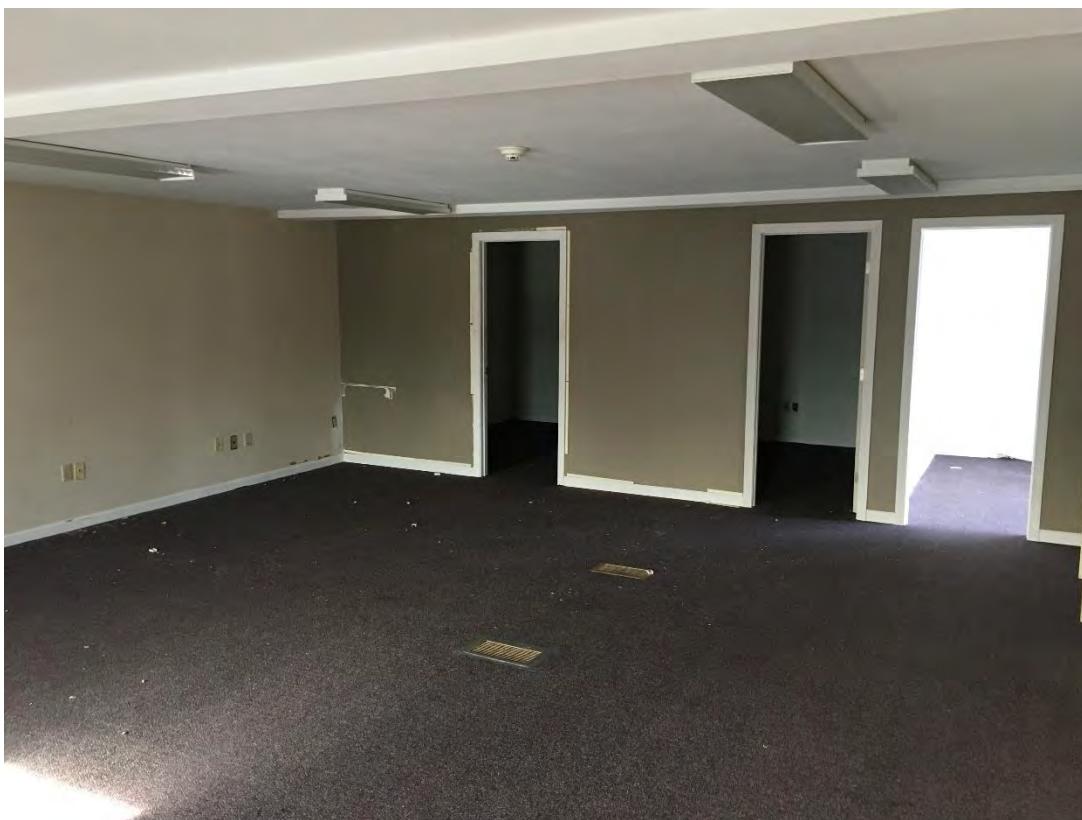
A view of the 1st floor of the 10 South Broadway building

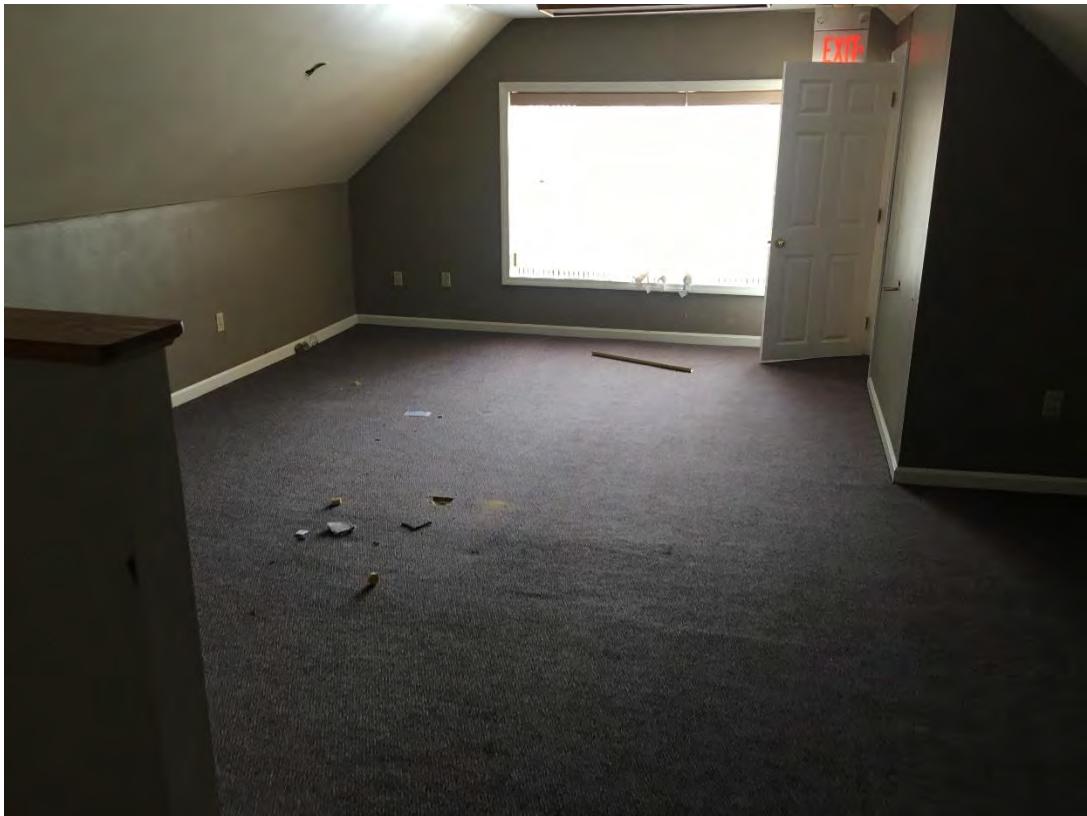
A view of the 2nd floor of the 10 South Broadway building

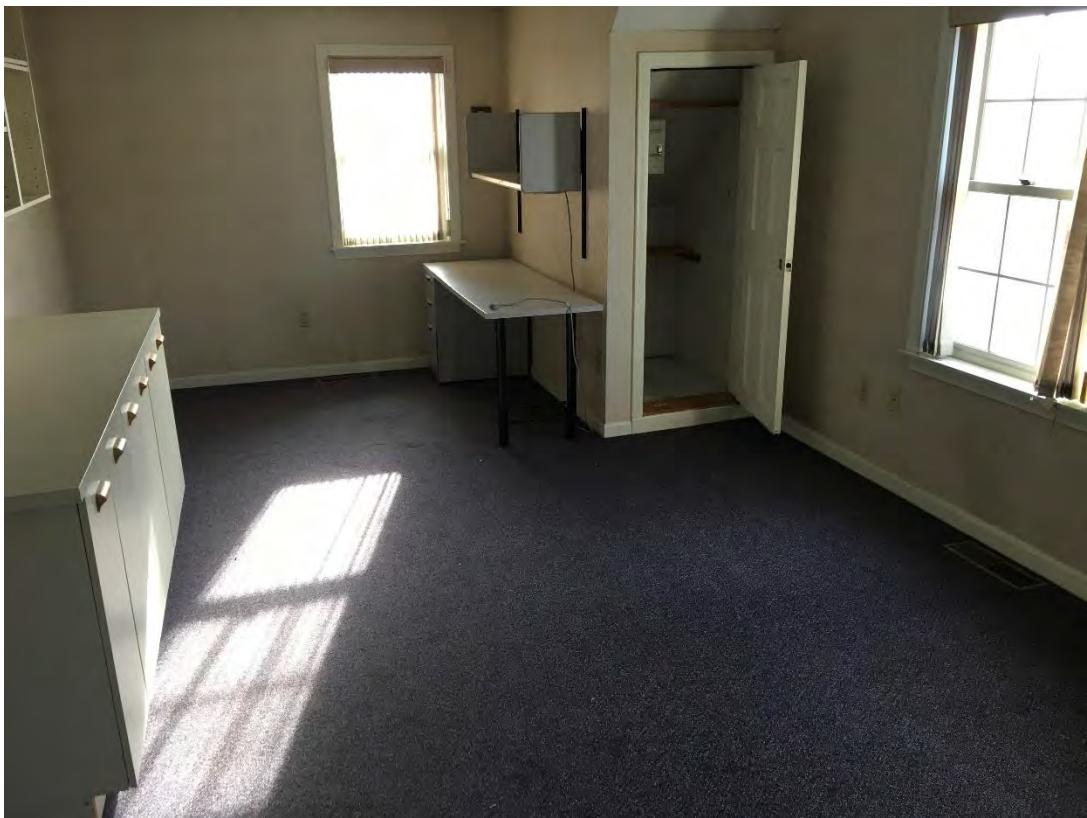
A view of the 2nd floor of the 10 South Broadway building
