**HAZARDOUS MATERIALS SURVEY  
COMMERCIAL BUILDING  
22 SOUTH BROADWAY  
SALEM, NEW HAMPSHIRE**

**January 2020**

**Project 19039**

## **HAZARDOUS MATERIALS SURVEY**

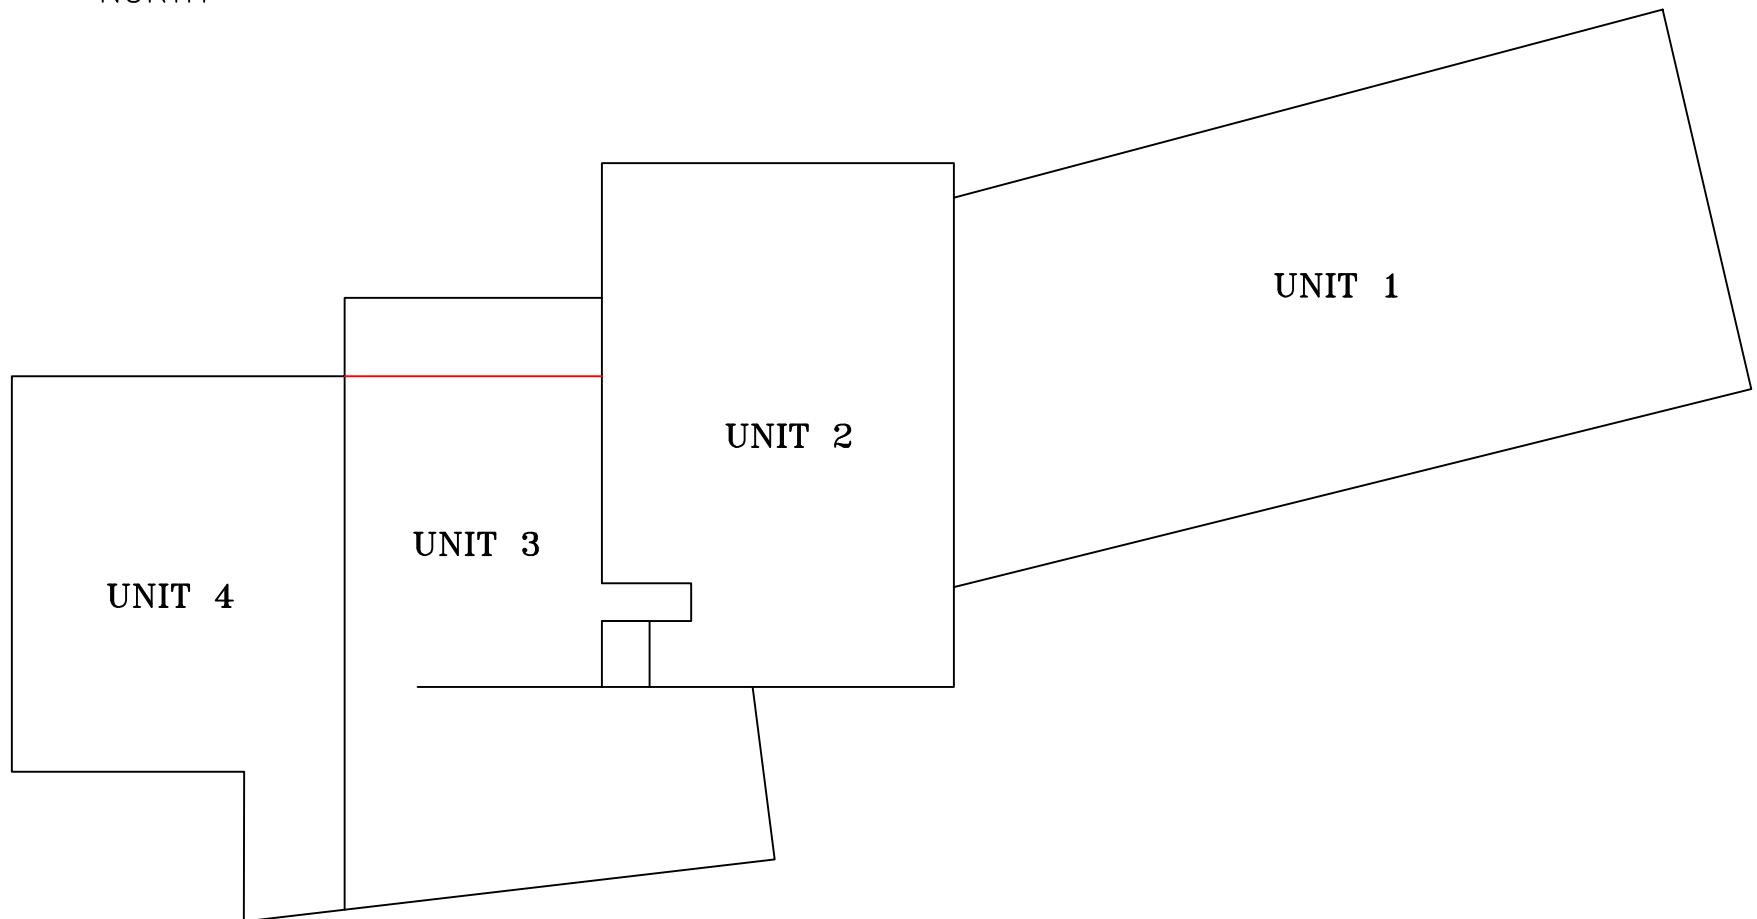
FIGURE: 1  
PROJECT NO.: 19039  
DATE: JANUARY 2020

1ST FLOOR SITE PLAN  
22 SOUTH BROADWAY  
SALEM, NH

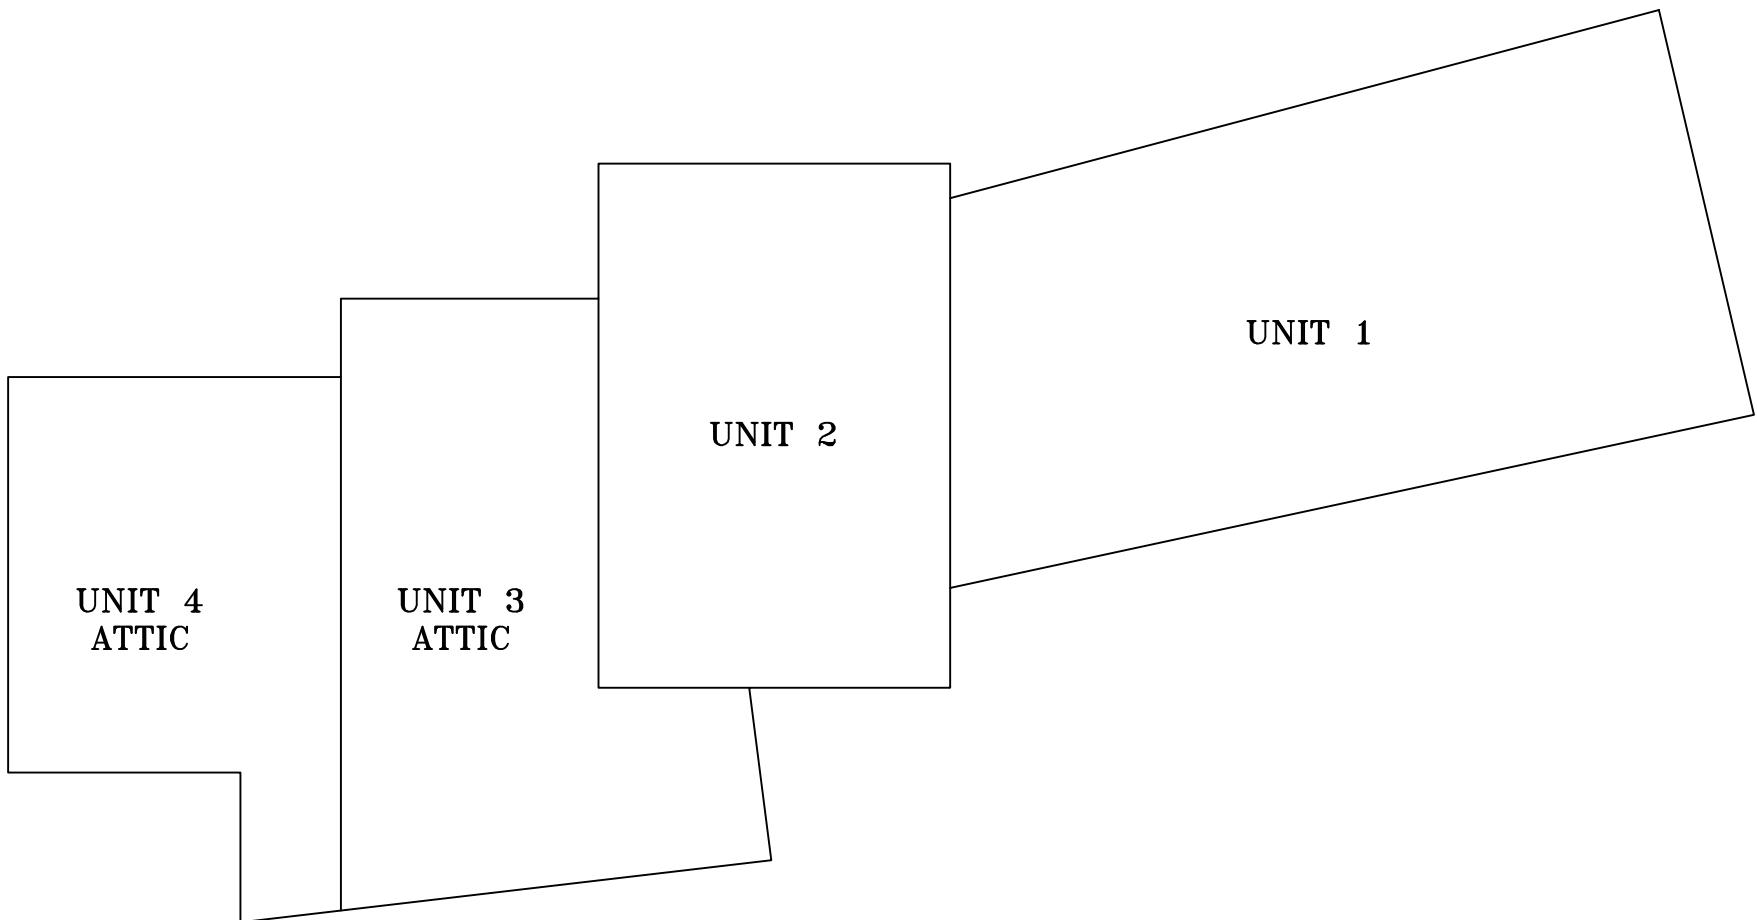
FIGURE: 2  
PROJECT NO.: 19039  
DATE: JANUARY 2020

2ND FLOOR SITE PLAN  
22 SOUTH BROADWAY  
SALEM, NH
