**HAZARDOUS MATERIALS SURVEY
COMMERCIAL BUILDING
28 SOUTH BROADWAY
SALEM, NEW HAMPSHIRE**

January 2020

Project 19039

January 24, 2020

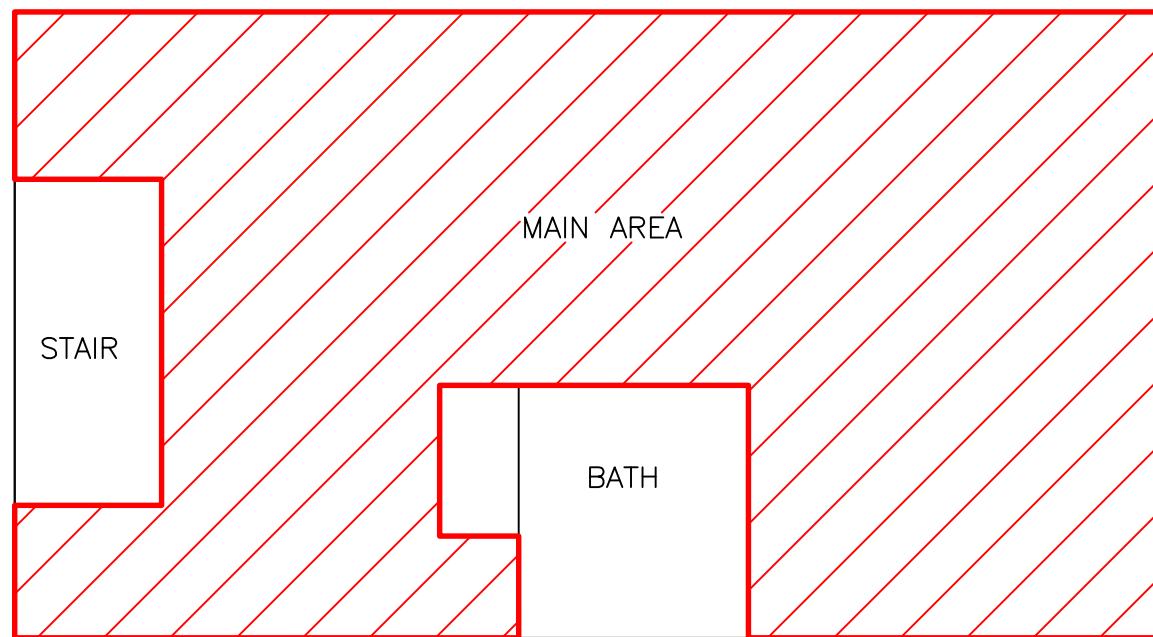
1ST FLOOR SITE PLAN
28 SOUTH BROADWAY
SALEM, NH

APPROXIMATE LOCATION OF ASBESTOS
CONTAINING GRAY FLOOR TILE

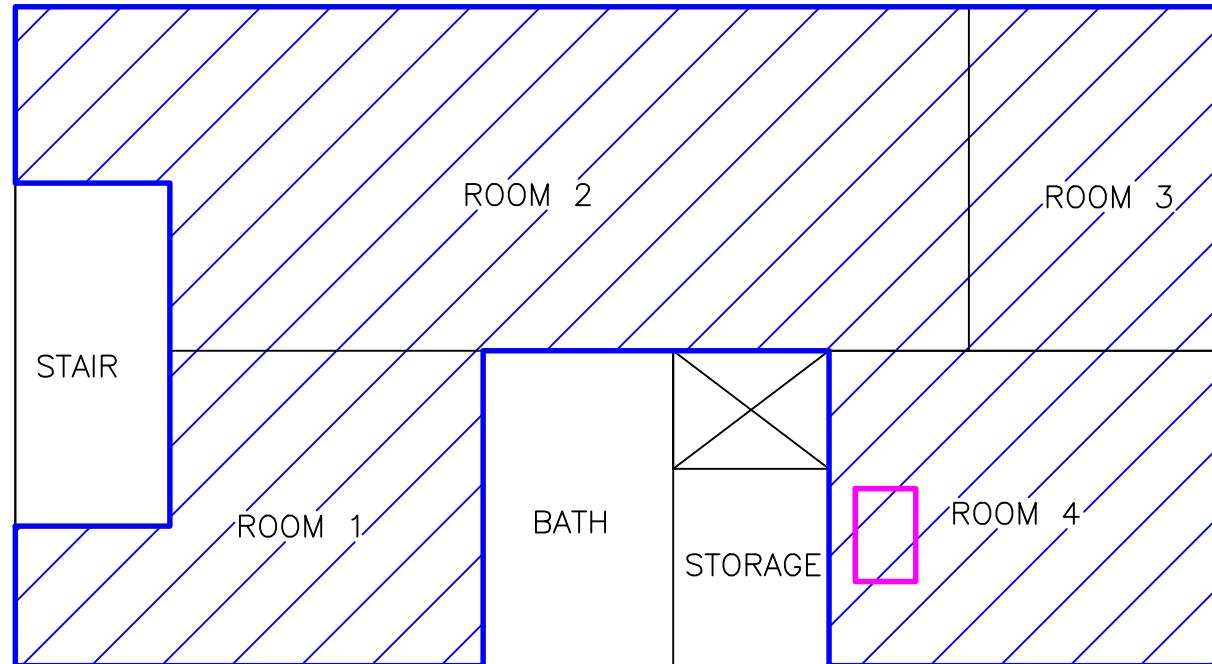
2ND FLOOR SITE PLAN
28 SOUTH BROADWAY
SALEM, NH

APPROXIMATE LOCATION OF
ASBESTOS CONTAINING
9" BROWN/BLACK FLOOR TILE

APPROXIMATE LOCATION OF
ASBESTOS CONTAINING
BLACK SINK COATING

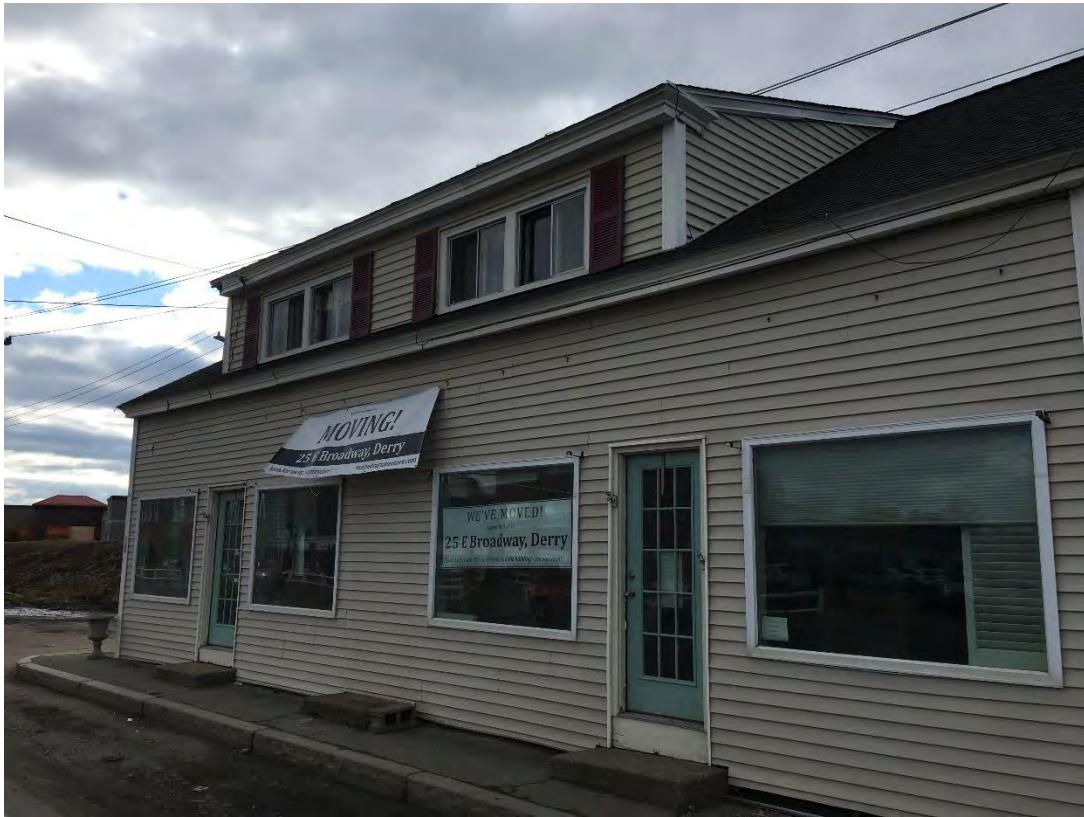
A view of the east side of the building, facing southwest

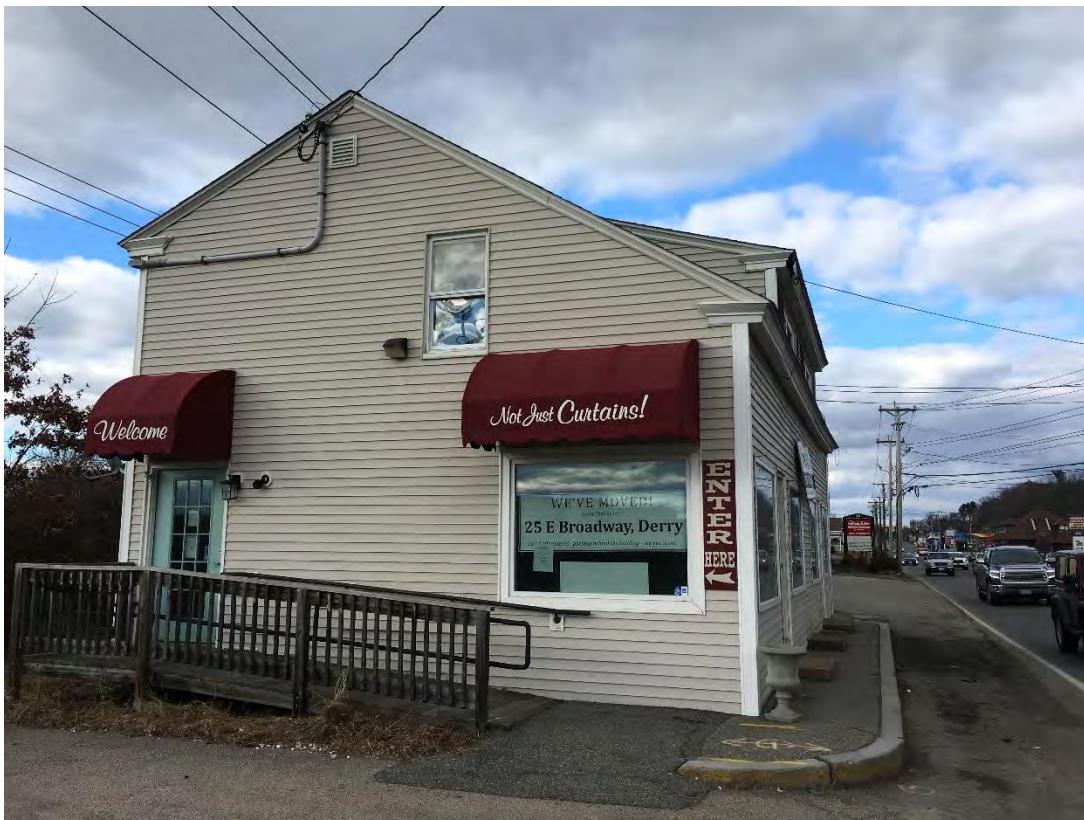
A view of the south side of the building, facing north

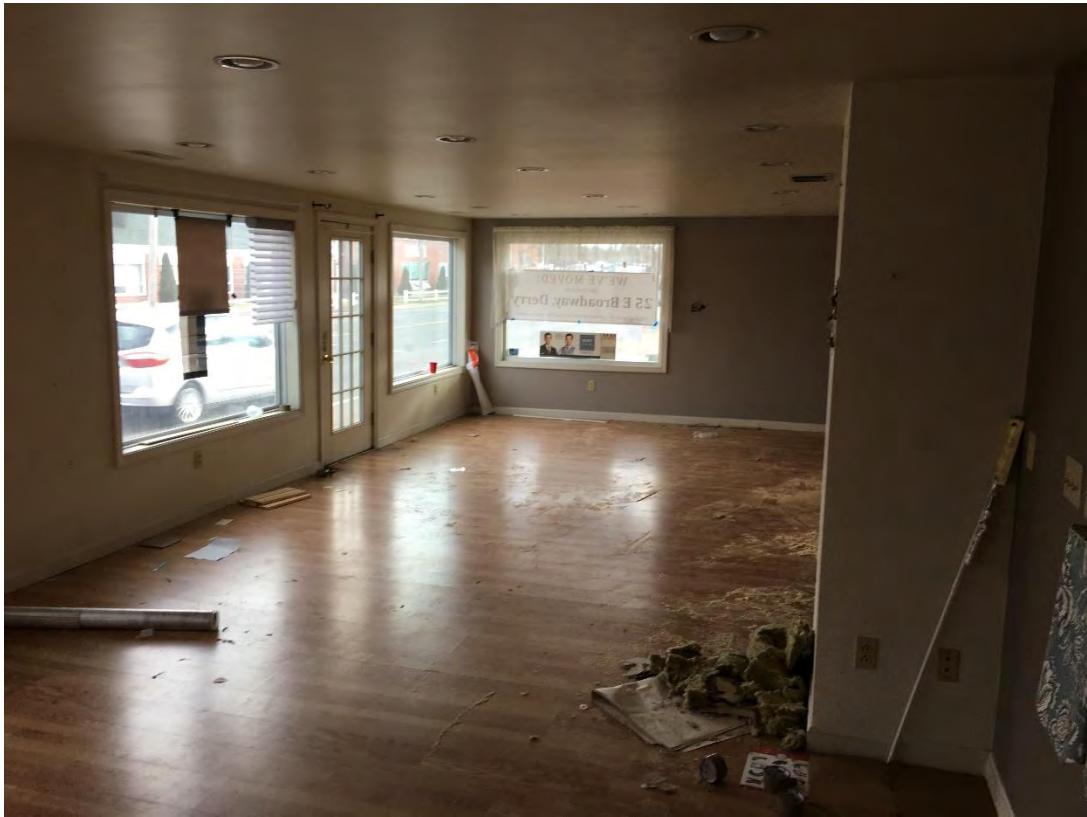
A view of the 1st floor interior

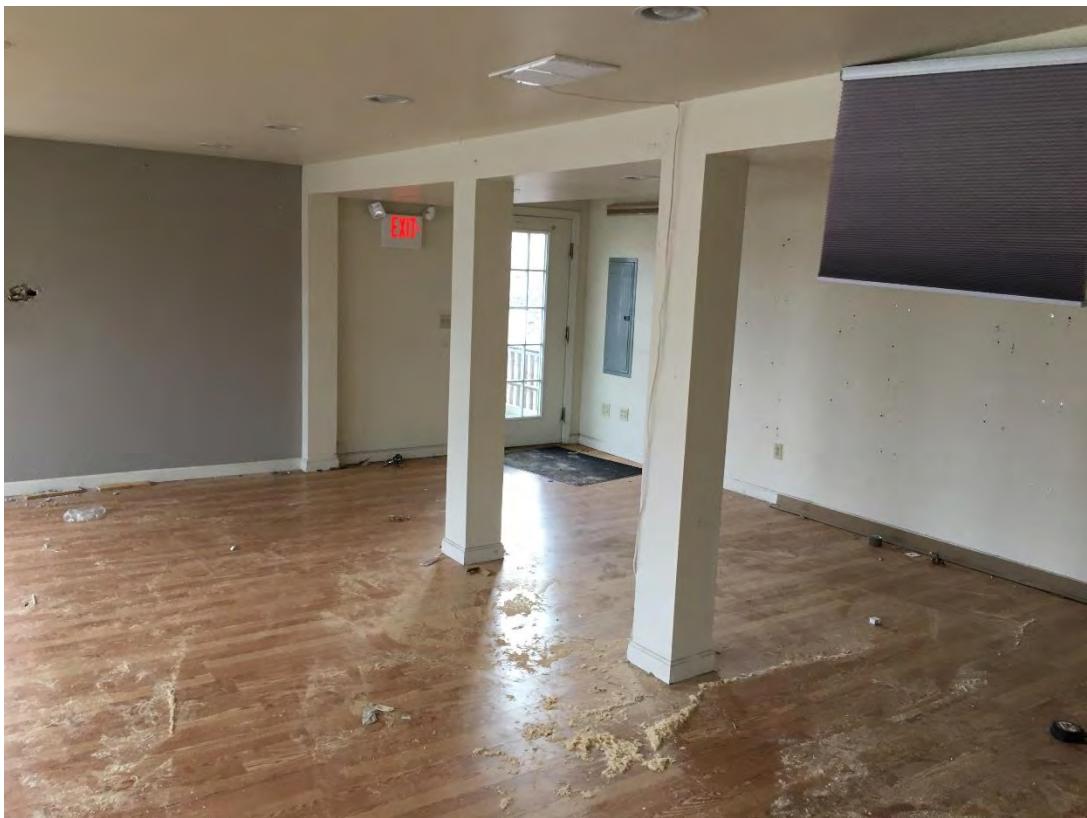
A view of the 1st floor interior

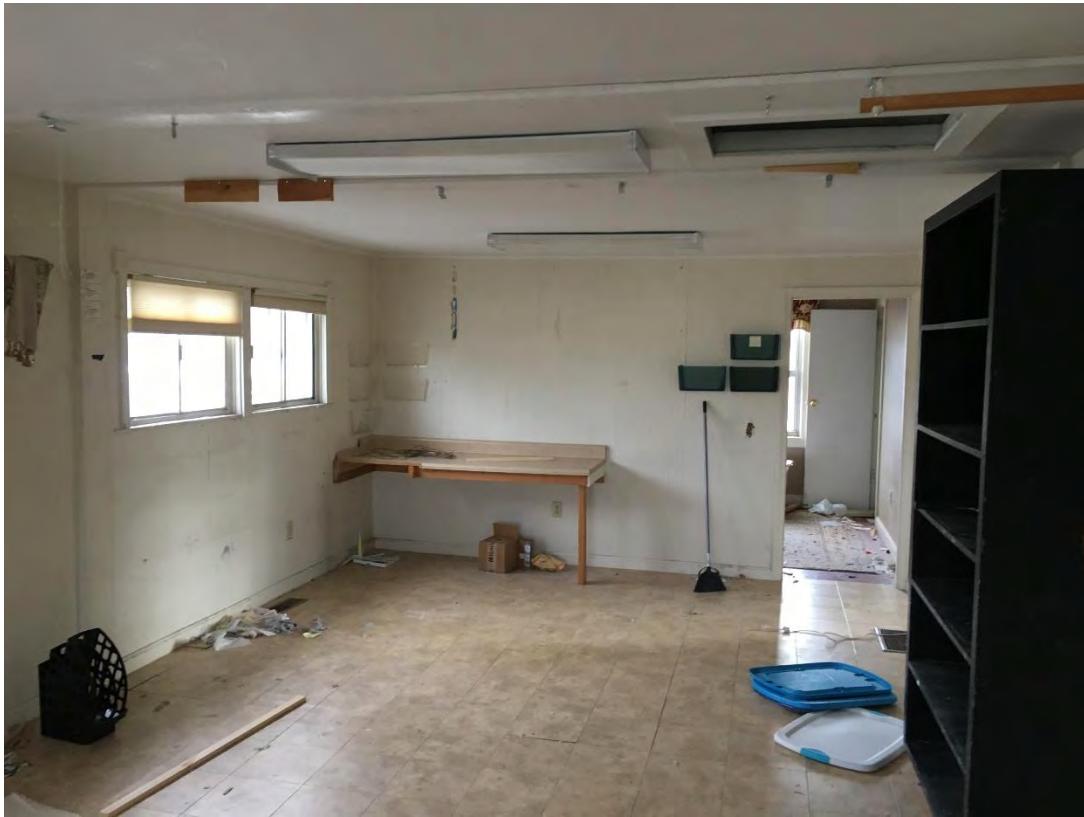
A view of the 2nd floor interior

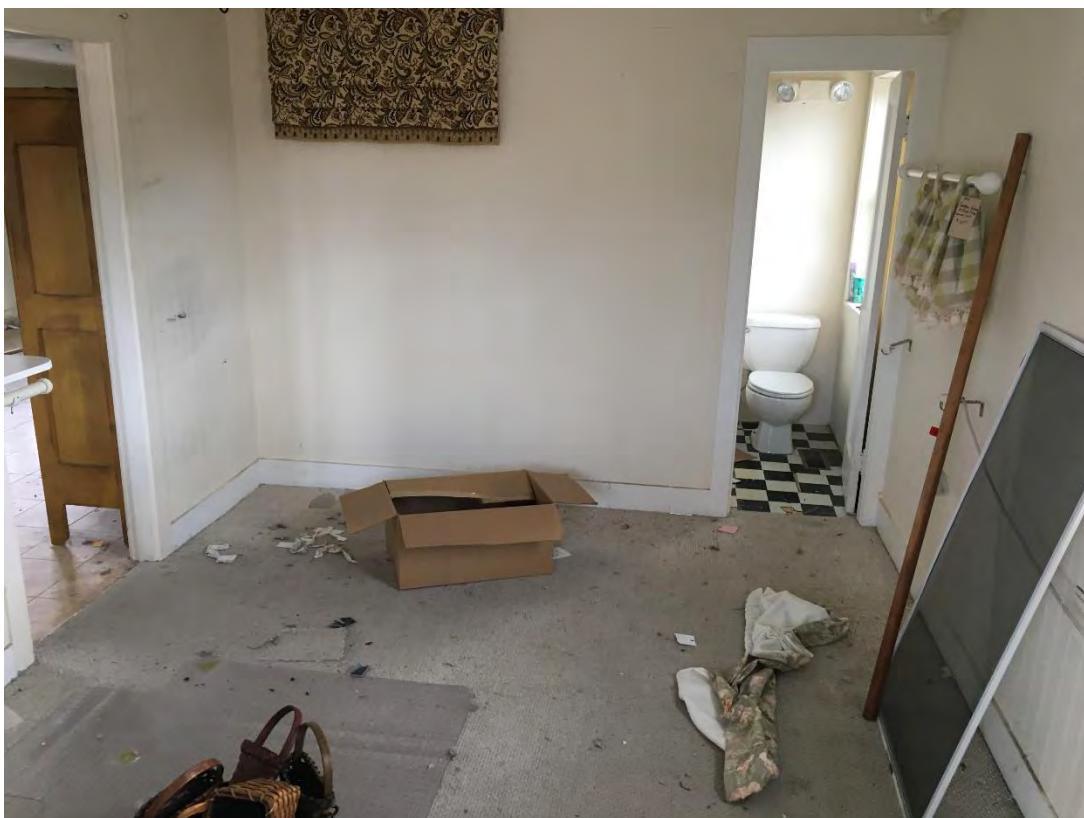
A view of the 2nd floor interior
