TECHNICAL | MEMORANDUM

TO: Roy Sorenson, Director of Municipal Services, Town of Salem
FROM: Lauren Bizzari, FB Environmental
SUBJECT: [Task 2: Hotspot Catchment Investigation](#)
DATE: September 15, 2016
CC: Forrest Bell, Laura Diemer, & Carly Ellis, FB Environmental

This memo provides a review of Task 2: Hotspot Catchment Investigation results for select stormwater outfalls at Captain and Millville Ponds.

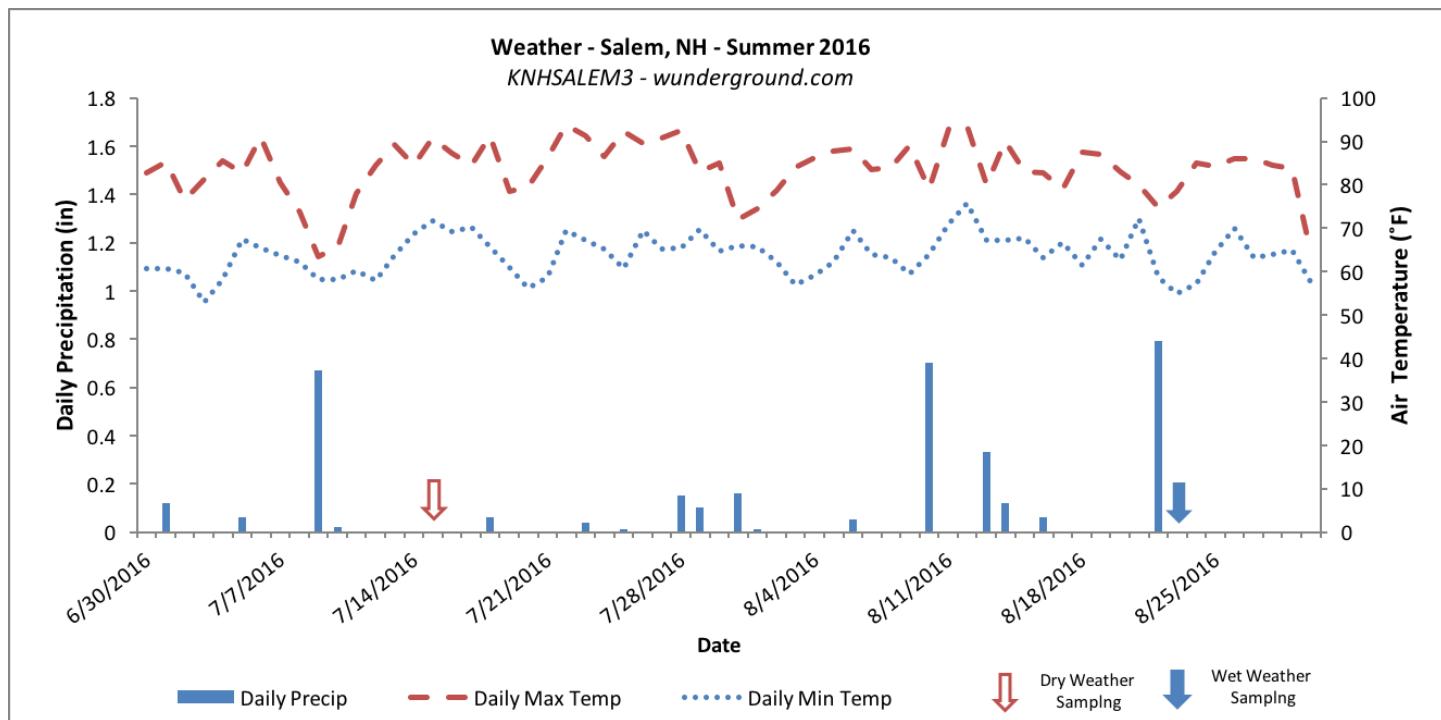
FIGURE 1. Summer sample dates with daily minimum and maximum temperatures and daily cumulative precipitation from weather station KNHSALEM3 ([Weather Underground](#)), located east of Millville Pond.

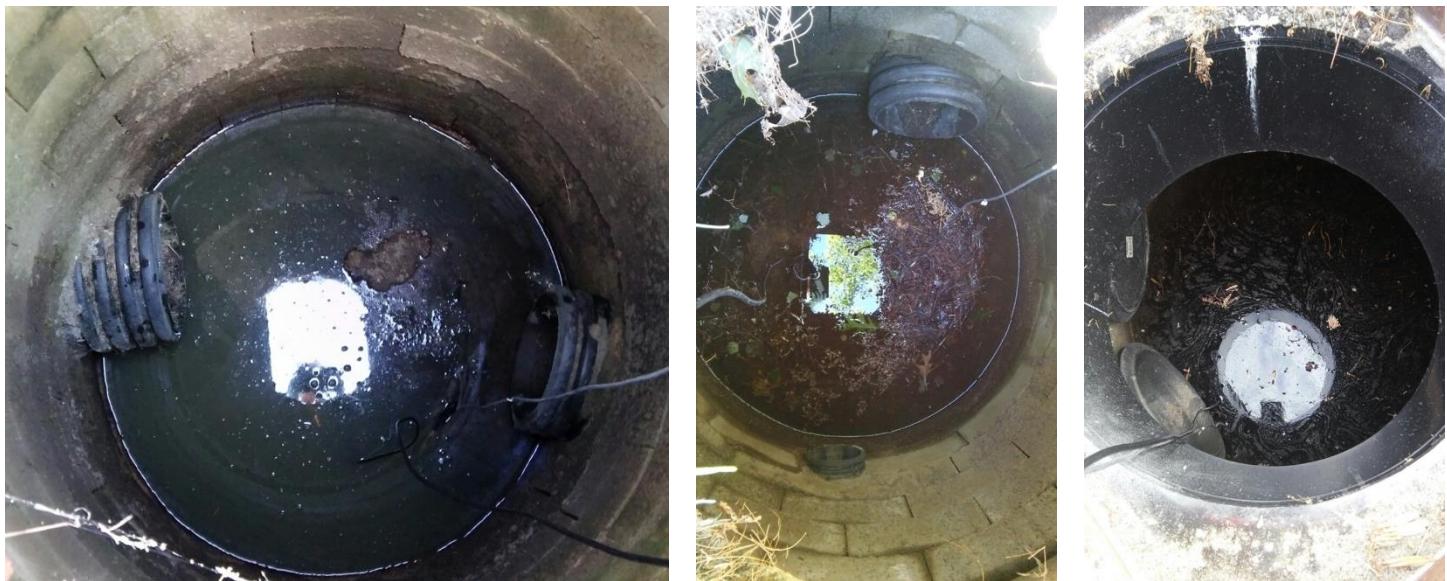
FIGURE 2. CB-3000 (left) during dry weather sampling showed evidence of dumping of some sort, perhaps dog feces, which would account for the *E. coli* concentration >2420 col/100 mL. CB-3001 (center) with minimal stormwater present, even after a 0.8" precipitation event the day prior. CB-3375 (right) during dry weather conditions.

Three of the four sites in exceedance were part of the investigation for hotspot OF-0517, draining to Captain Pond (Figure 4). During the dry weather sampling, the highest *E. coli* values were at the upstream-most catch basin that had water, CB-3000. Extremely high levels of bacteria found at CB-3000 confirmed FBE staff's concern about evidence of dumping in this basin found during the site visit (Figure 2). During the wet weather sampling, the highest *E. coli* values were, again, at the upstream-most catch basin that had water, CB-3001 (Figure 2). Concentrations of *E. coli* decreased stepwise at each downstream catch basin towards the outfall (Table 1, Figure 4).

The last of the four sites in exceedance, CB-3375 of the OF-0611 investigation (Figure 5) was well within compliance of these limits during the dry weather investigation, but spiked above the state's threshold after a ~0.8" precipitation event (Table 1, Figure 2). It should be noted that CB-3375 was part of the OF-0611 investigation, but was found to have no direct connection to that outfall. Further catchment sampling in the area of hotspot OF-0611 would help determine which particular basins are contributing to the high *E. coli* concentrations seen in previous monitoring.

Surfactants were measured at or above the MS4 criteria value (0.25 ppm) at several catchments during dry weather sampling, while only one field test (at CB-3001) from wet weather sampling tested above that level (Table 3). Finally, specific conductivity exceeded the NHDES¹ acute or chronic exposure criteria estimates on both sampling occasions at one site (CB-3000). This is the basin at which FBE staff is concerned may contain some sort of animal feces or other dumped pollutants (Figure 2).

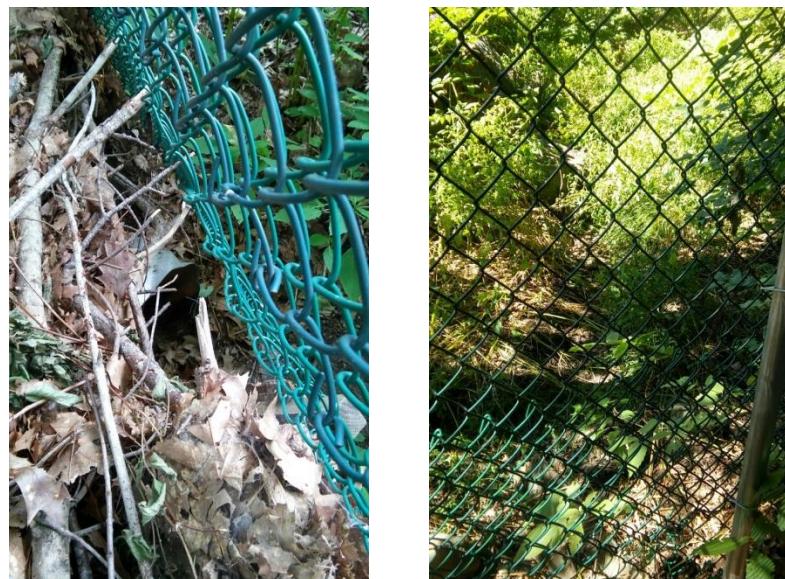
FIGURE 3. DS-1061 during dry weather sampling (left) and wet weather sampling (right). There was no flow at this site during either sampling occasion.

Finally, conditions remained too dry throughout the summer sampling season for any wet-up around the Millville Pond hotspot, OF-0701 (Figure 6). An investigation of this catchment, despite the dry conditions, did provide a better understanding of the stormwater flows to OF-0701. DS-0187 was not present at the surface (Figure 6), and it is likely that this is an underground joint, rather than an above ground structure. Further upstream at DS-1061 (Figure 3), a wetland area surrounded by houses drains into the underground pipe. No other outfall pipes or other stormwater infrastructure were observed in this area.

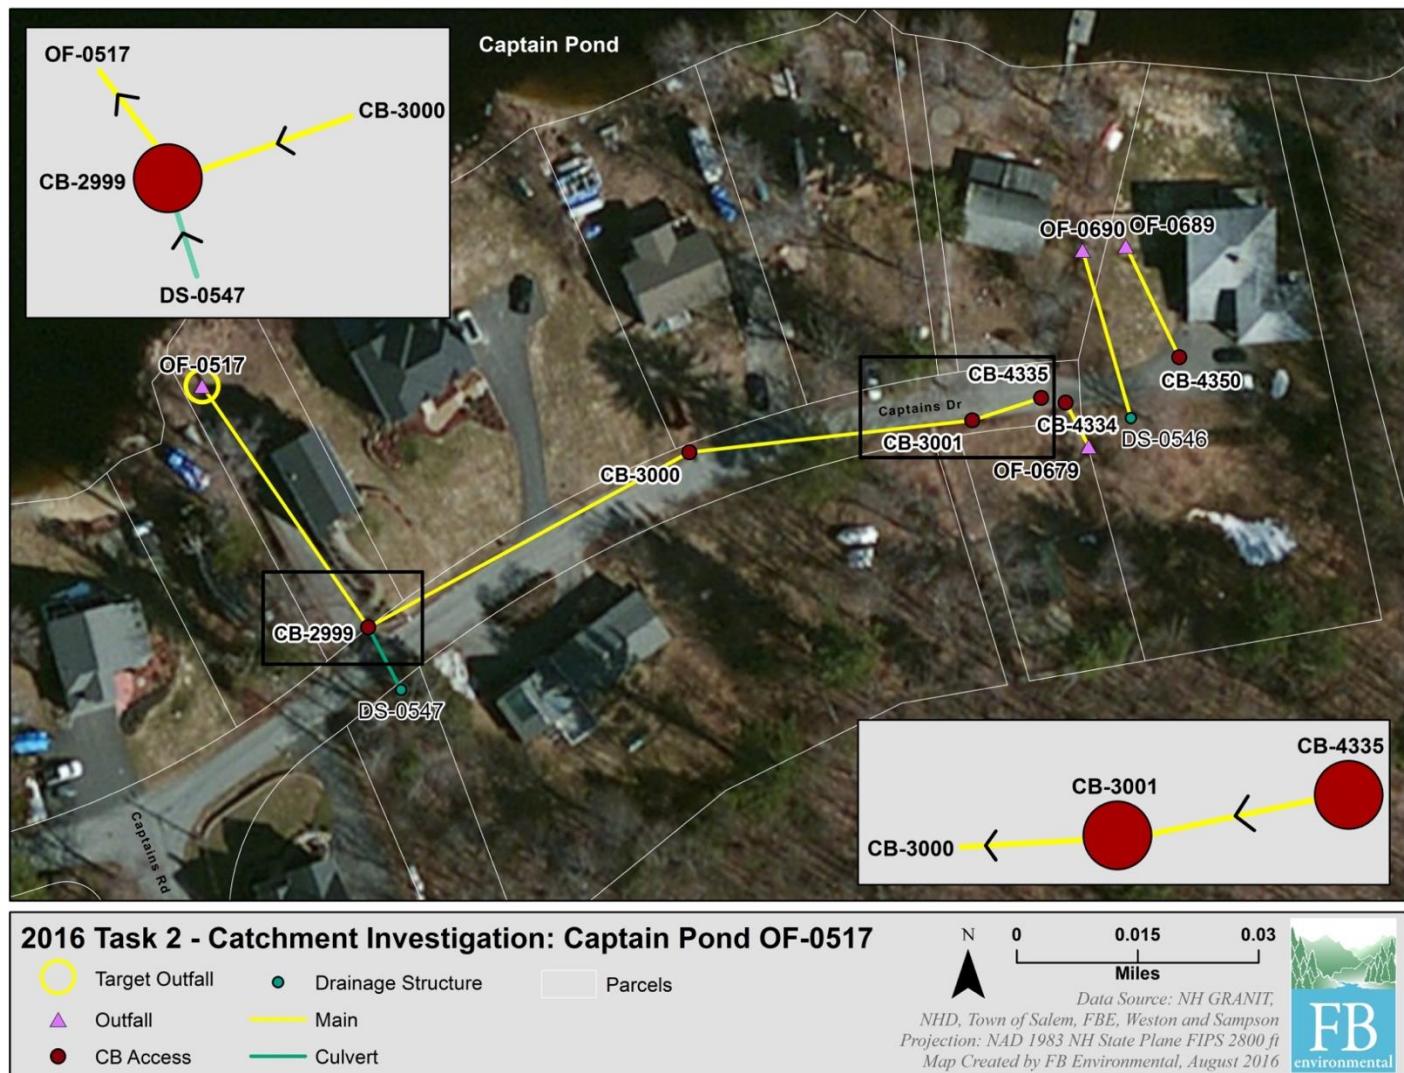
FIGURE 4. Map of stormwater system and flow directions related to hotspot OF-0517 on Captain Pond.

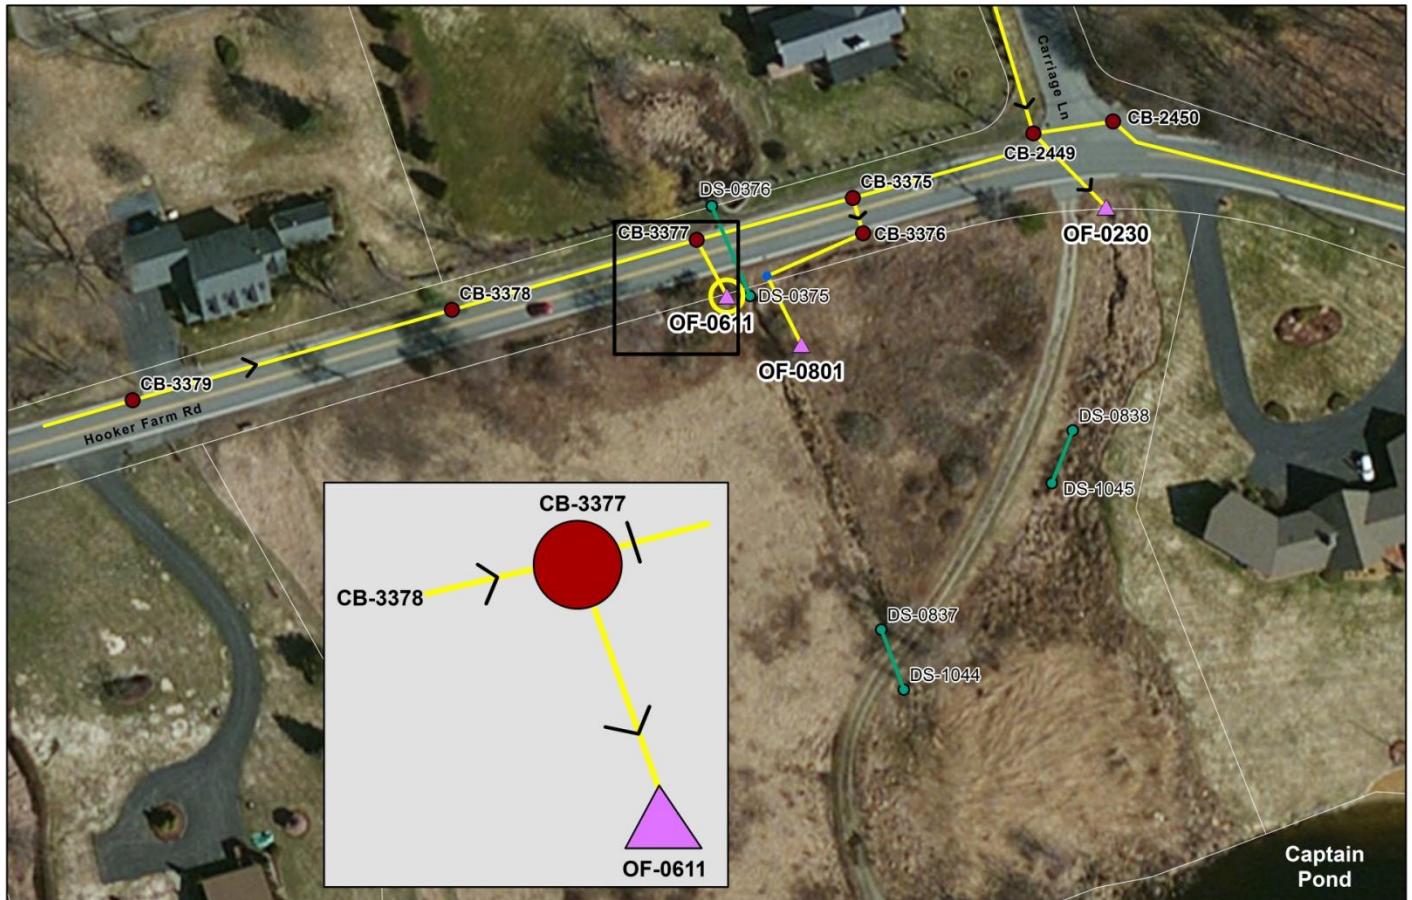
2016 Task 2 - Catchment Investigation: Captain Pond OF-0611

FIGURE 5. Map of stormwater system and flow directions related to hotspot OF-0611 on Captain Pond.

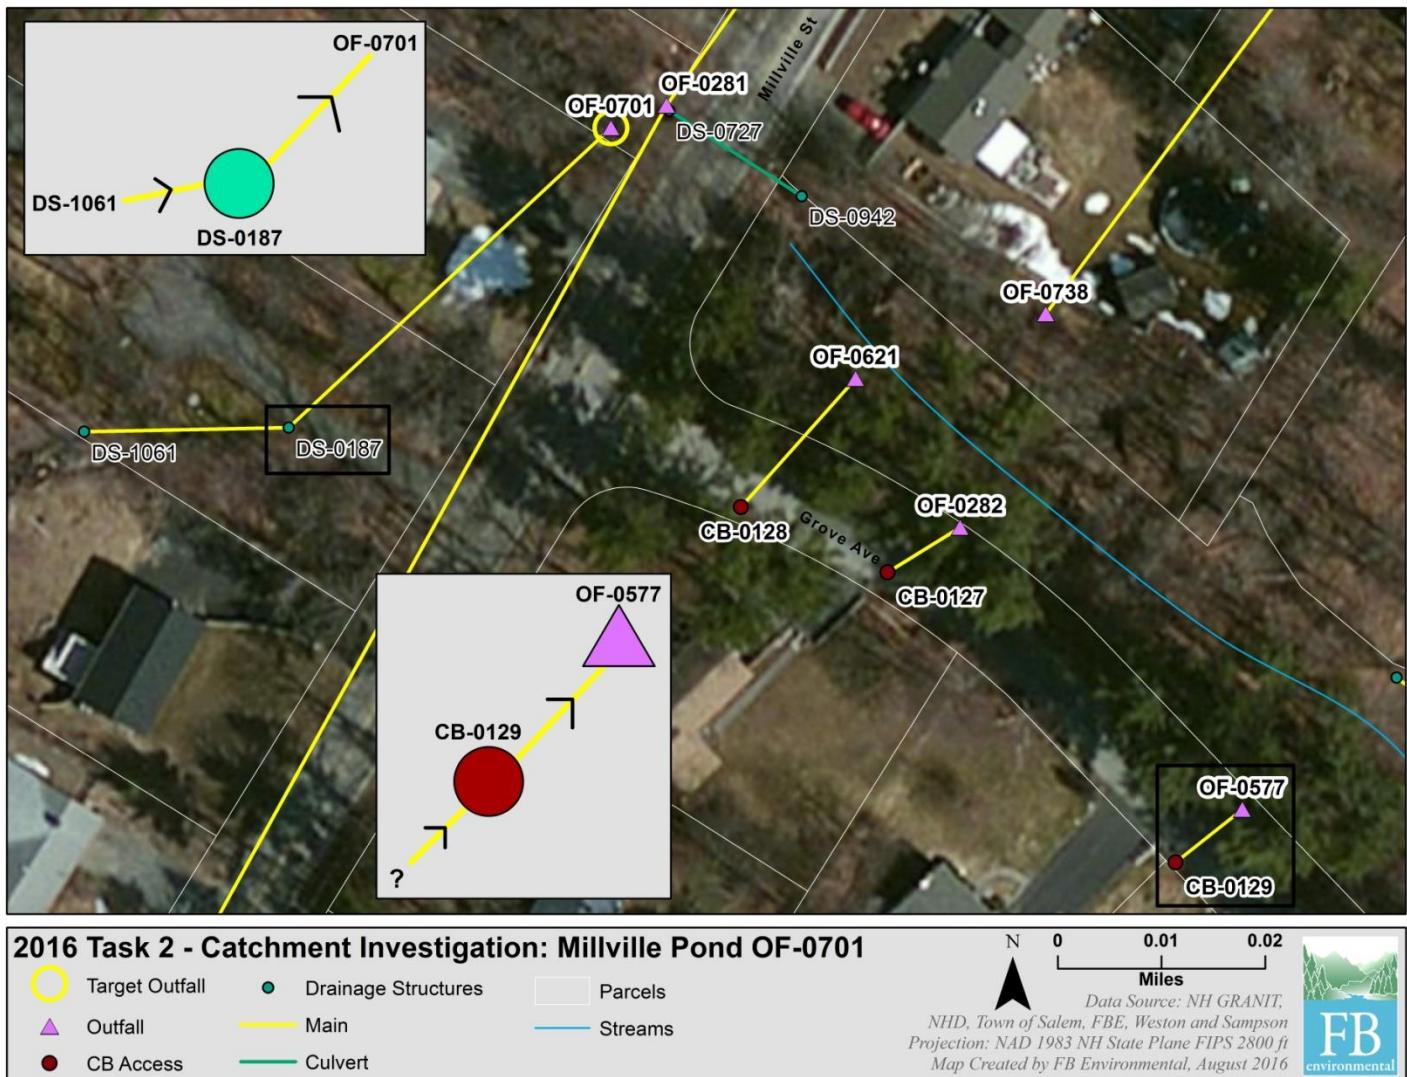
FIGURE 6. Map of stormwater system and flow directions related to hotspot OF-0701 on Captain Pond.
