TO: Robert Puff, Director of Engineering, Town of Salem
FROM: Lauren Bizzari, FB Environmental
SUBJECT: **Task 1: Spring Outfall Investigation and Monitoring**
DATE: July 13, 2016
CC: Forrest Bell, Laura Diemer, & Carly Ellis, FB Environmental

This memo provides a brief review of Task 1: Spring Outfall Investigation and Monitoring results for select stormwater outfalls at Captain and Millville Ponds.

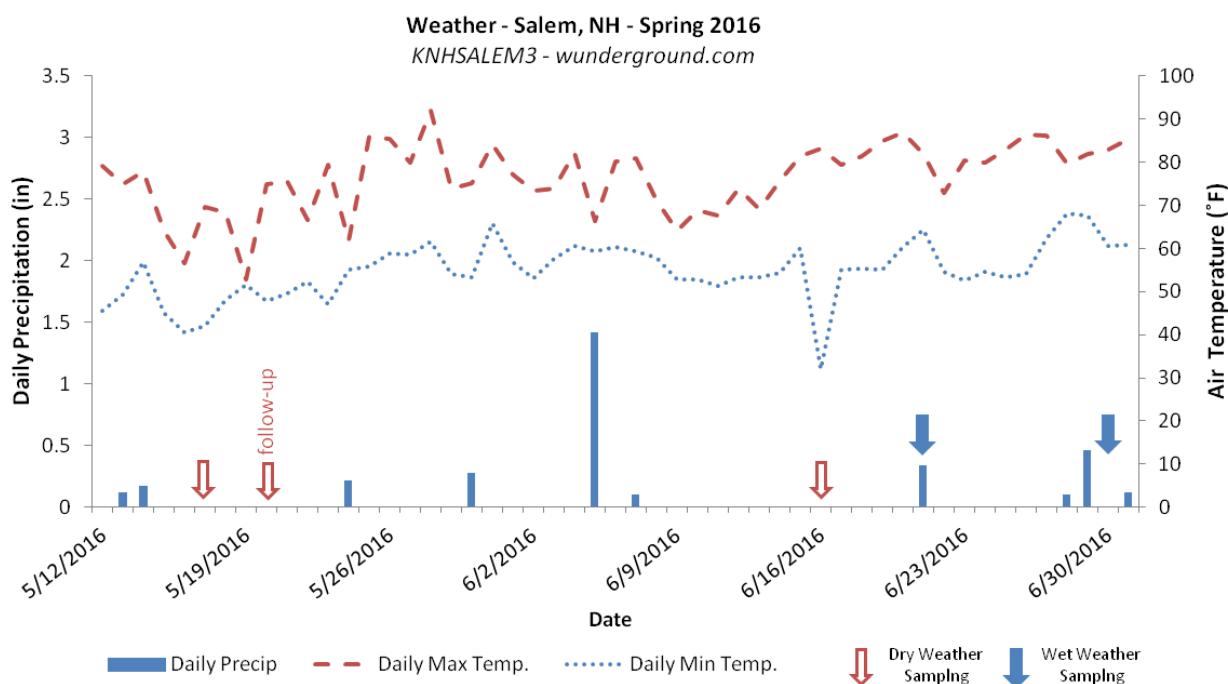
FIGURE 1. Spring sample dates with daily minimum and maximum temperatures and daily cumulative precipitation from weather station KNHSALEM3 ([Weather Underground](#)), located east of Millville Pond.

Outfalls were initially visited during dry weather conditions on 5/17/2016. Those that showed evidence of dry weather flow, but were not flowing during the initial visit, received one additional dry weather follow-up visit on 5/20/2016. Two additional outfalls were also inaccessible during the first visit and were checked during the follow-up. Eight outfalls were selected for continued monitoring during the spring based on the presence of flow during the initial visit: four previously identified as hotspots and four new outfalls. The selected outfalls were visited one additional time during dry weather conditions on 6/16/2016 and twice during wet weather conditions (6/21/2016, 6/30/2016). Wet weather was defined as: >0.1" of precipitation in the 24 hours prior to sampling; or >0.25" in the 48 hours prior to

sampling; or >2.0" in the 96 hours prior to sampling. Weather conditions were considered dry when precipitation was less than those wet weather thresholds (for MS4 Permit requirements: <0.1" of precipitation in the 24 hours prior to sampling). Rainfall was overall very low during the spring sampling season, with only one rain event greater than 0.5" (Figure 1), which occurred over a weekend when the processing laboratory for bacteria samples was not open. As a result, most outfalls were dry during the site visits, even immediately after wet weather events (Table 1).

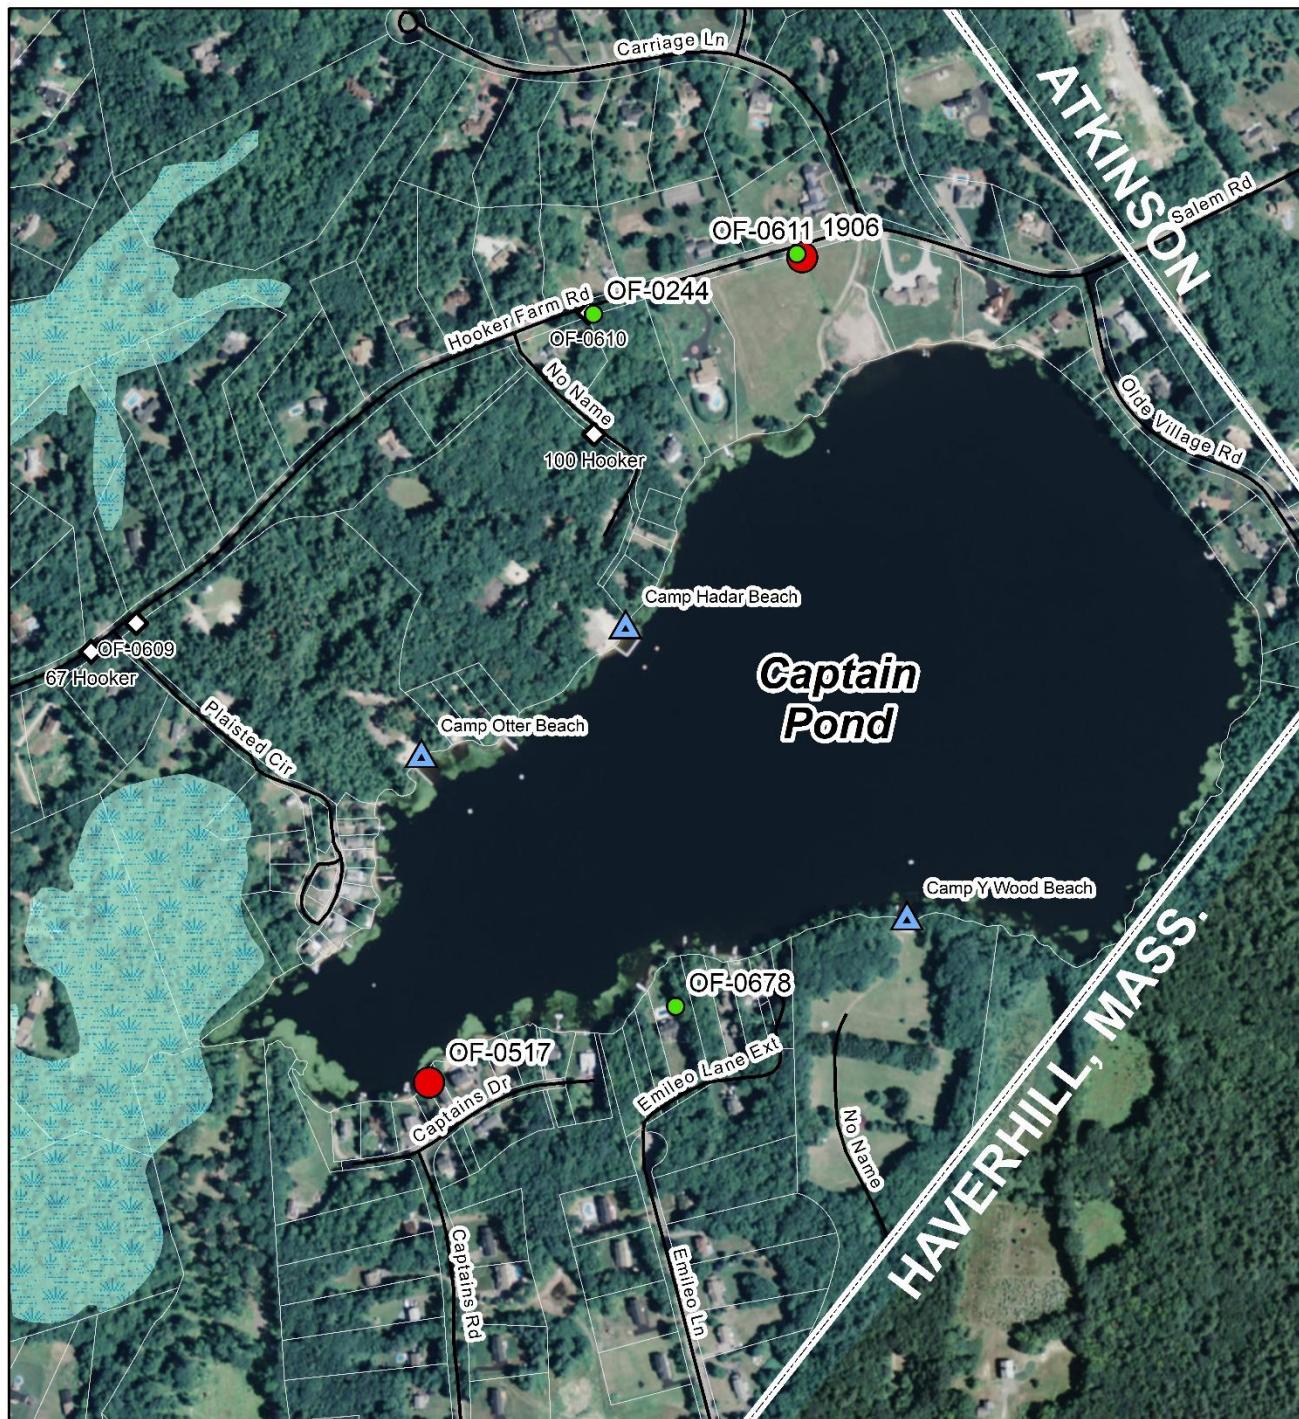
**Captain Pond - Outfall E. coli (Spring 2016)
Geometric Mean, Average, or Single Sample**

FIGURE 2. Summary of stormwater outfall sampling in spring 2016 at Captain Pond.

Additionally, four sites exceeded the instantaneous limit for recreational waters with public beaches (88 col/100mL; 406 col/100mL without beaches; Figures 2 and 3, Attachment 1). Bacteria counts from the outfalls varied with weather conditions. Though fewer sites were sampled during wet weather conditions, all four of the sites exceeding instantaneous limits did so

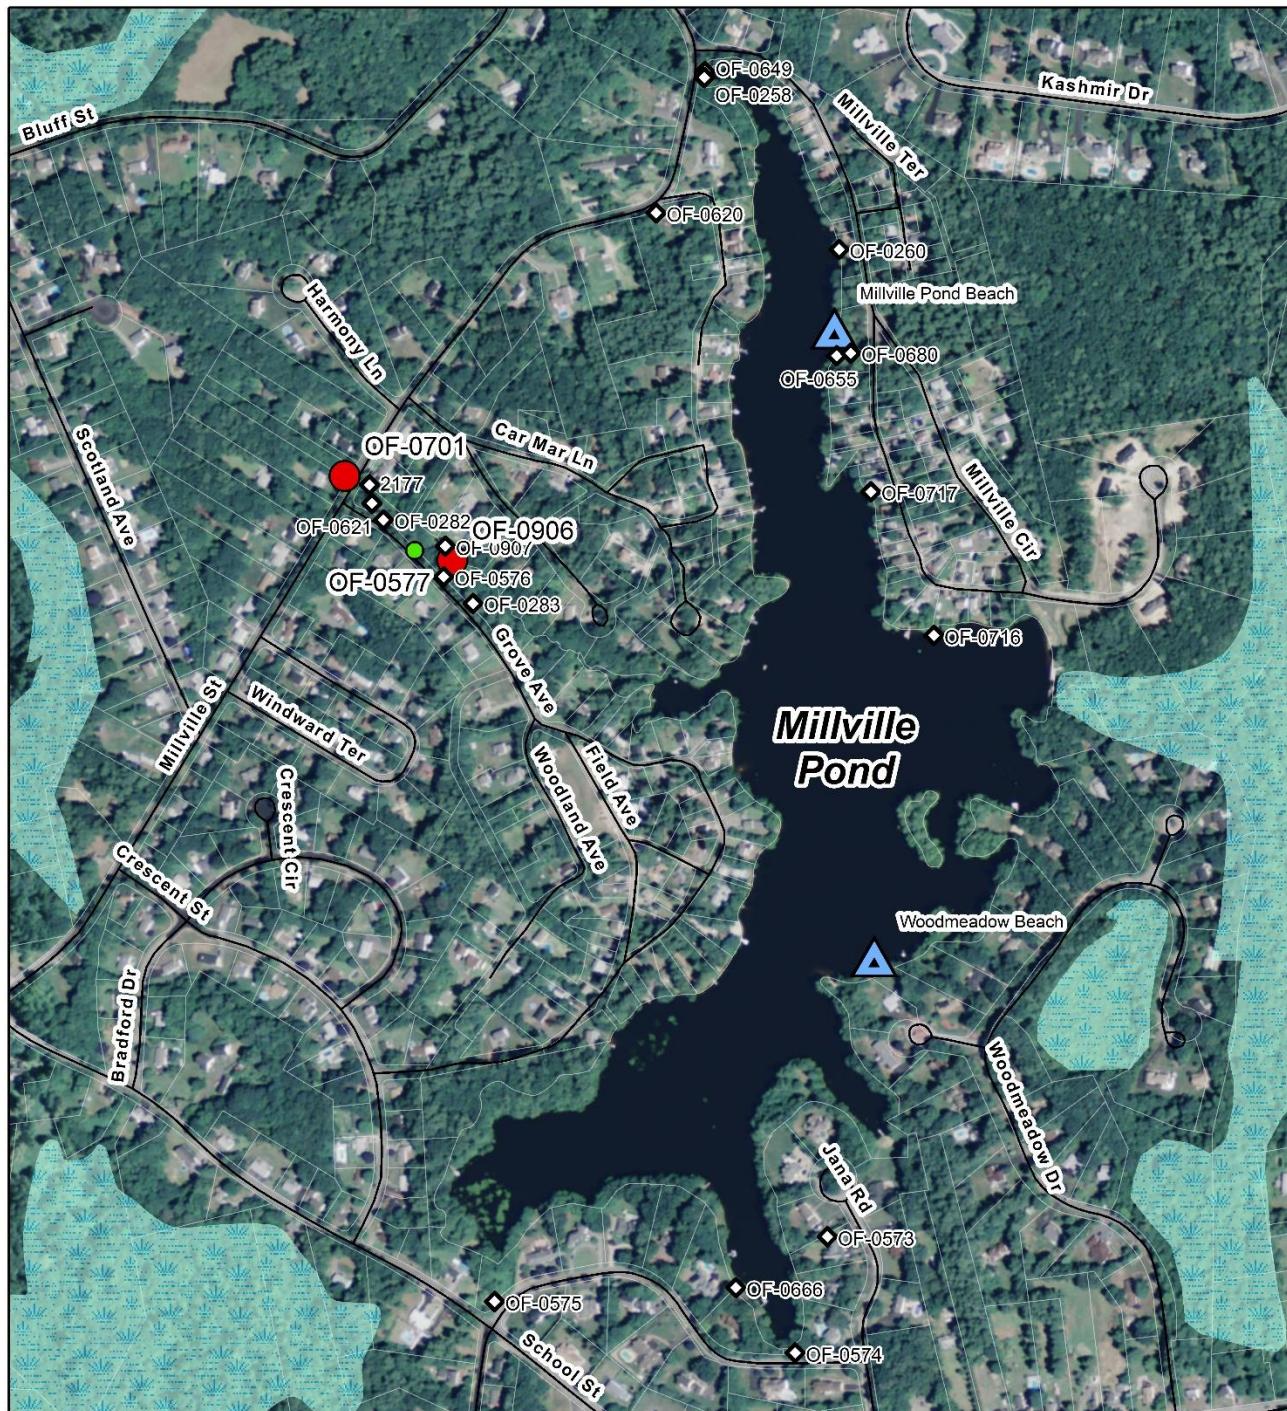
Millville Pond - Outfall E. coli (Spring 2016) Geometric Mean, Average, or Single Sample

FIGURE 3. Summary of stormwater outfall sampling in spring 2016 at Millville Pond.

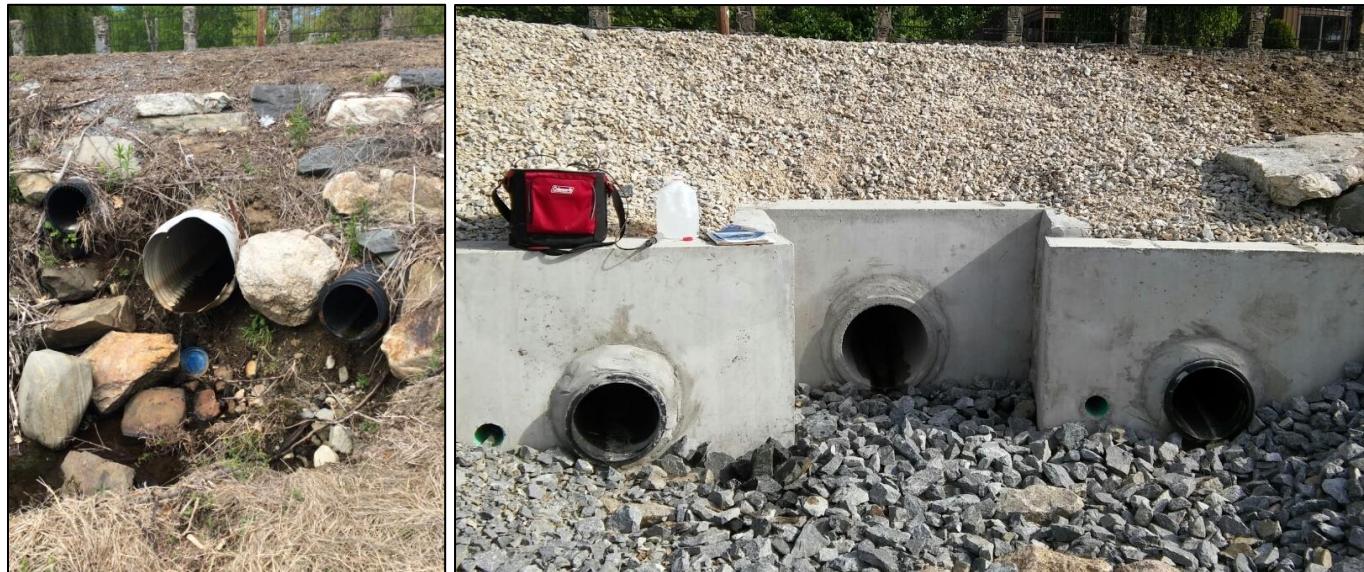
It should also be noted that Hooker Farm Road was resurfaced in the middle of the spring sampling season (between 5/20/2016 and 6/17/2016), which included replacement of pipes and headwalls for 1906, OF-0611, and OF-0244 (Figure 4). Only 1906 continued to have enough flow to sample after construction was completed, and bacteria counts remained high.

FIGURE 4. Before and after photos of culvert and headwall replacements at OF-0611 (left pipe) and 1906 (center pipe).

Based on results from 2014-2016, follow-up catchment investigation is recommended for **OF-0701**, **OF-0611**, and **OF-0517**. These sites had both high bacteria counts and exceeded MS4 criteria across the three sampling years. Additionally, we recommend that the Town further investigate **OF-0577** to determine if illicit discharges are coming from the private pipe into the upstream catch basin.

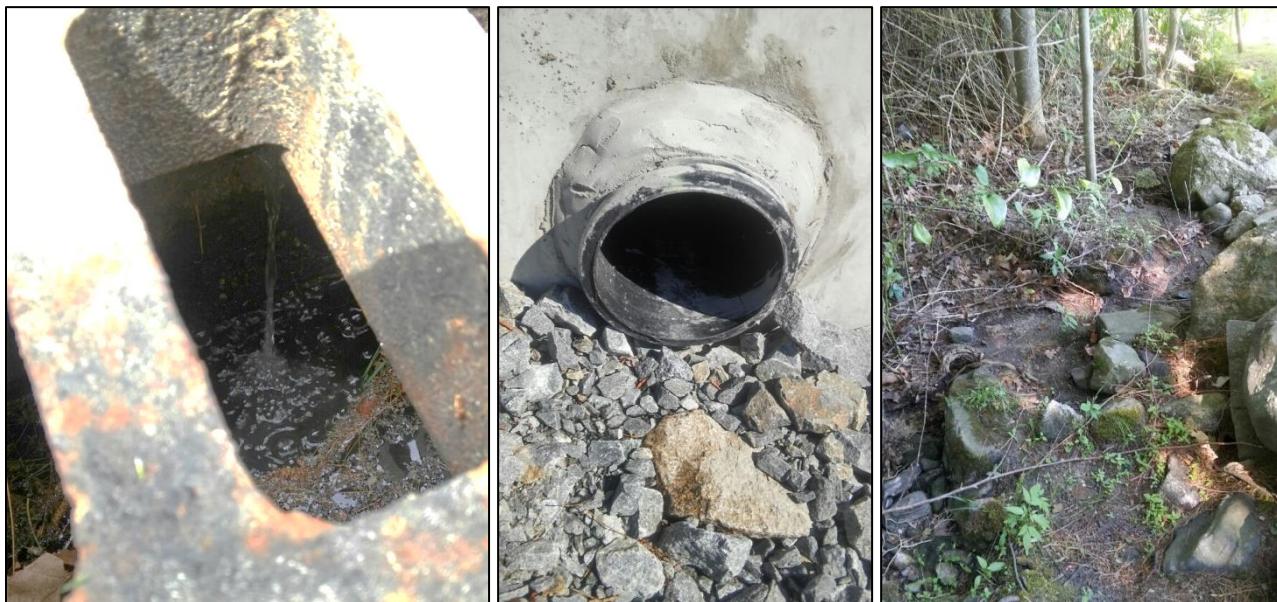
Ammonia levels were elevated above MS4 criteria at outfalls on both ponds, but the issue was more prevalent at Millville Pond (3 outfalls) than at Captain Pond (1 outfall, Table 4). Total chlorine was detectable, and therefore exceeded the MS4 criteria at every outfall sampled. One site, OF-0577 on Grove Avenue near Millville Pond, was particularly elevated for total chlorine during one sample date and should be further investigated for illicit discharges (Figure 5). The actual outfall is buried, but the catch basin immediately upstream was accessible for sampling. Intermittent flow was observed from a private pipe (potentially a basement floor drain) into the catch basin and was sampled when flowing.

Surfactants were measured at the MS4 criteria value (0.25 ppm) at several Millville Pond outfalls, while only one field test from an outfall to Captain Pond tested at that level (OF-0611). Finally, specific conductivity exceeded the NHDES¹ acute or chronic exposure criteria estimates on only one occasion at one site (OF-0611, Figure 5). Several other sites had elevated specific conductivity readings close to the chronic exposure criteria (Attachment 1), including OF-0678 (Figure 5).

FIGURE 5. OF-0577 (left) intermittent flow, OF-0611 (center) dry conditions, and OF-0678 (right) dry conditions.
