# TECHNICAL | MEMORANDUM

**TO:** Dan Hudson, Director of Engineering, Town of Salem  
**FROM:** Laura Diemer & Jacqueline Boudreau, FB Environmental Associates  
**SUBJECT:** **2017 MS4 Outfall Monitoring**  
**DATE:** July 31, 2017  
**CC:** James Danis, Town of Salem; Forrest Bell, FB Environmental Associates

**This memo provides a brief review of 2017 MS4 outfall monitoring results for select stormwater outfalls to Canobie Lake and Arlington Pond.**

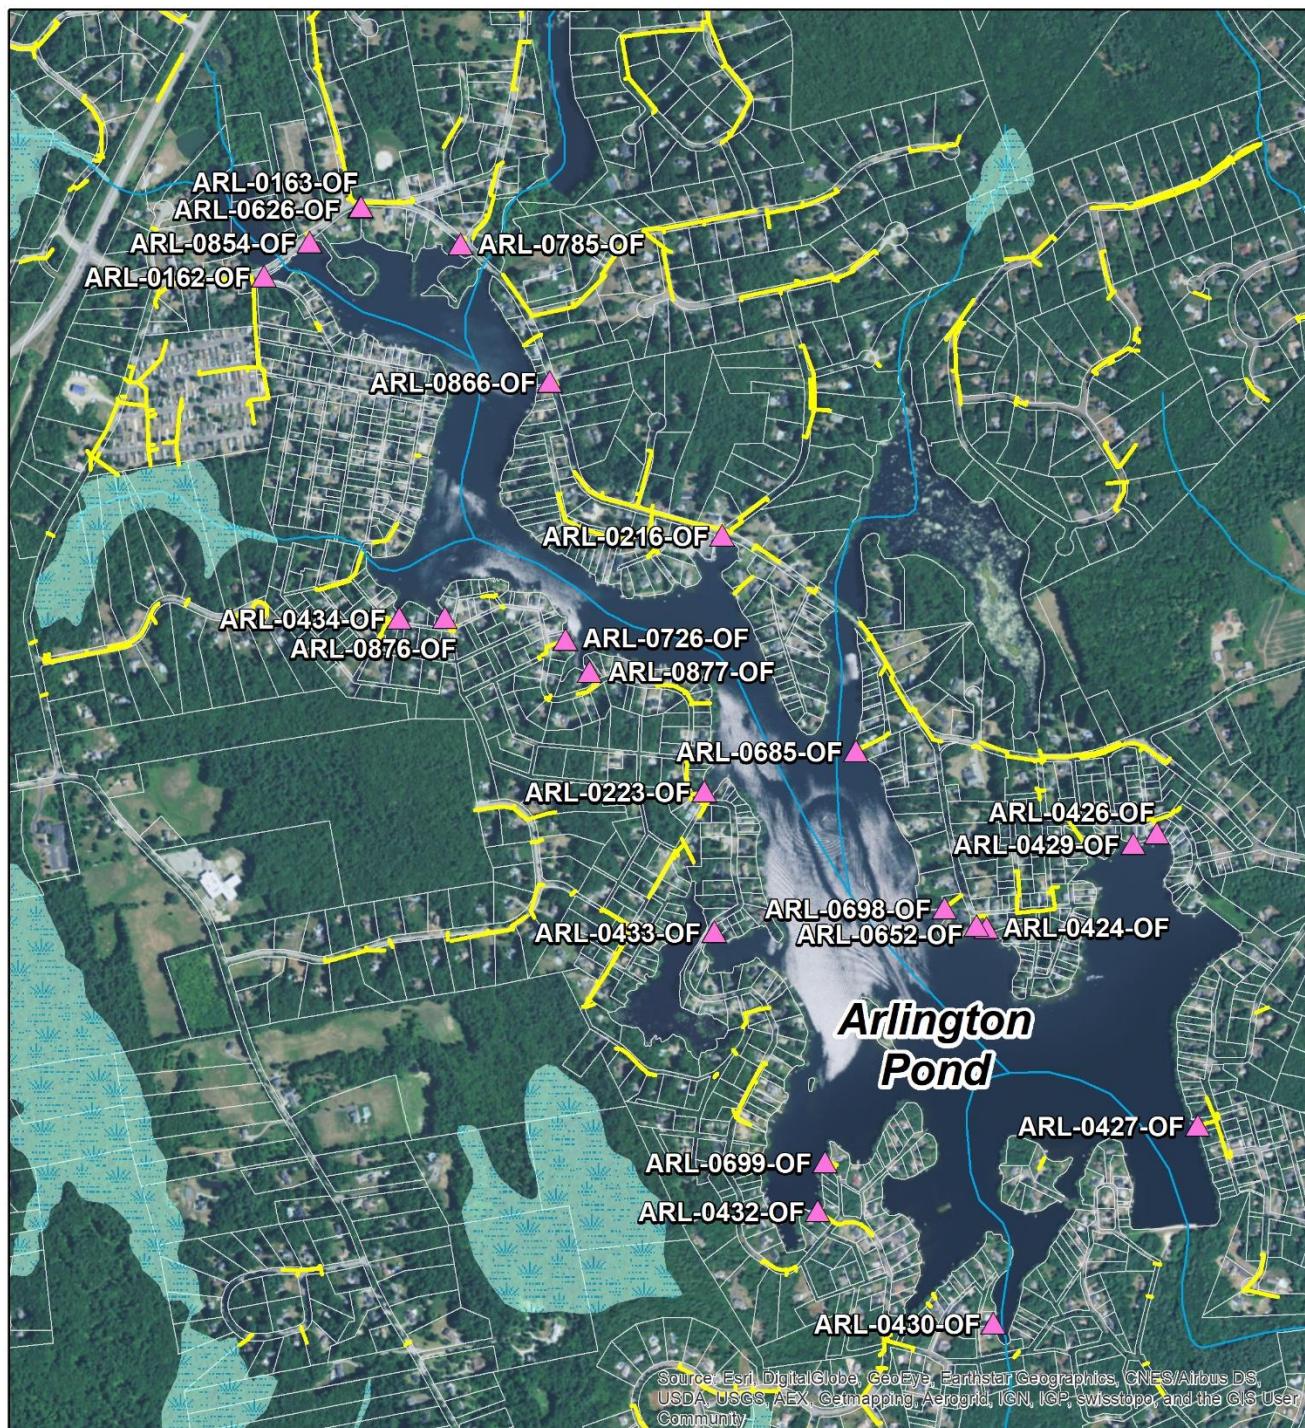
**FIGURE 1.** Stormwater outfall sampling locations for 2017 MS4 screening at Arlington Pond.

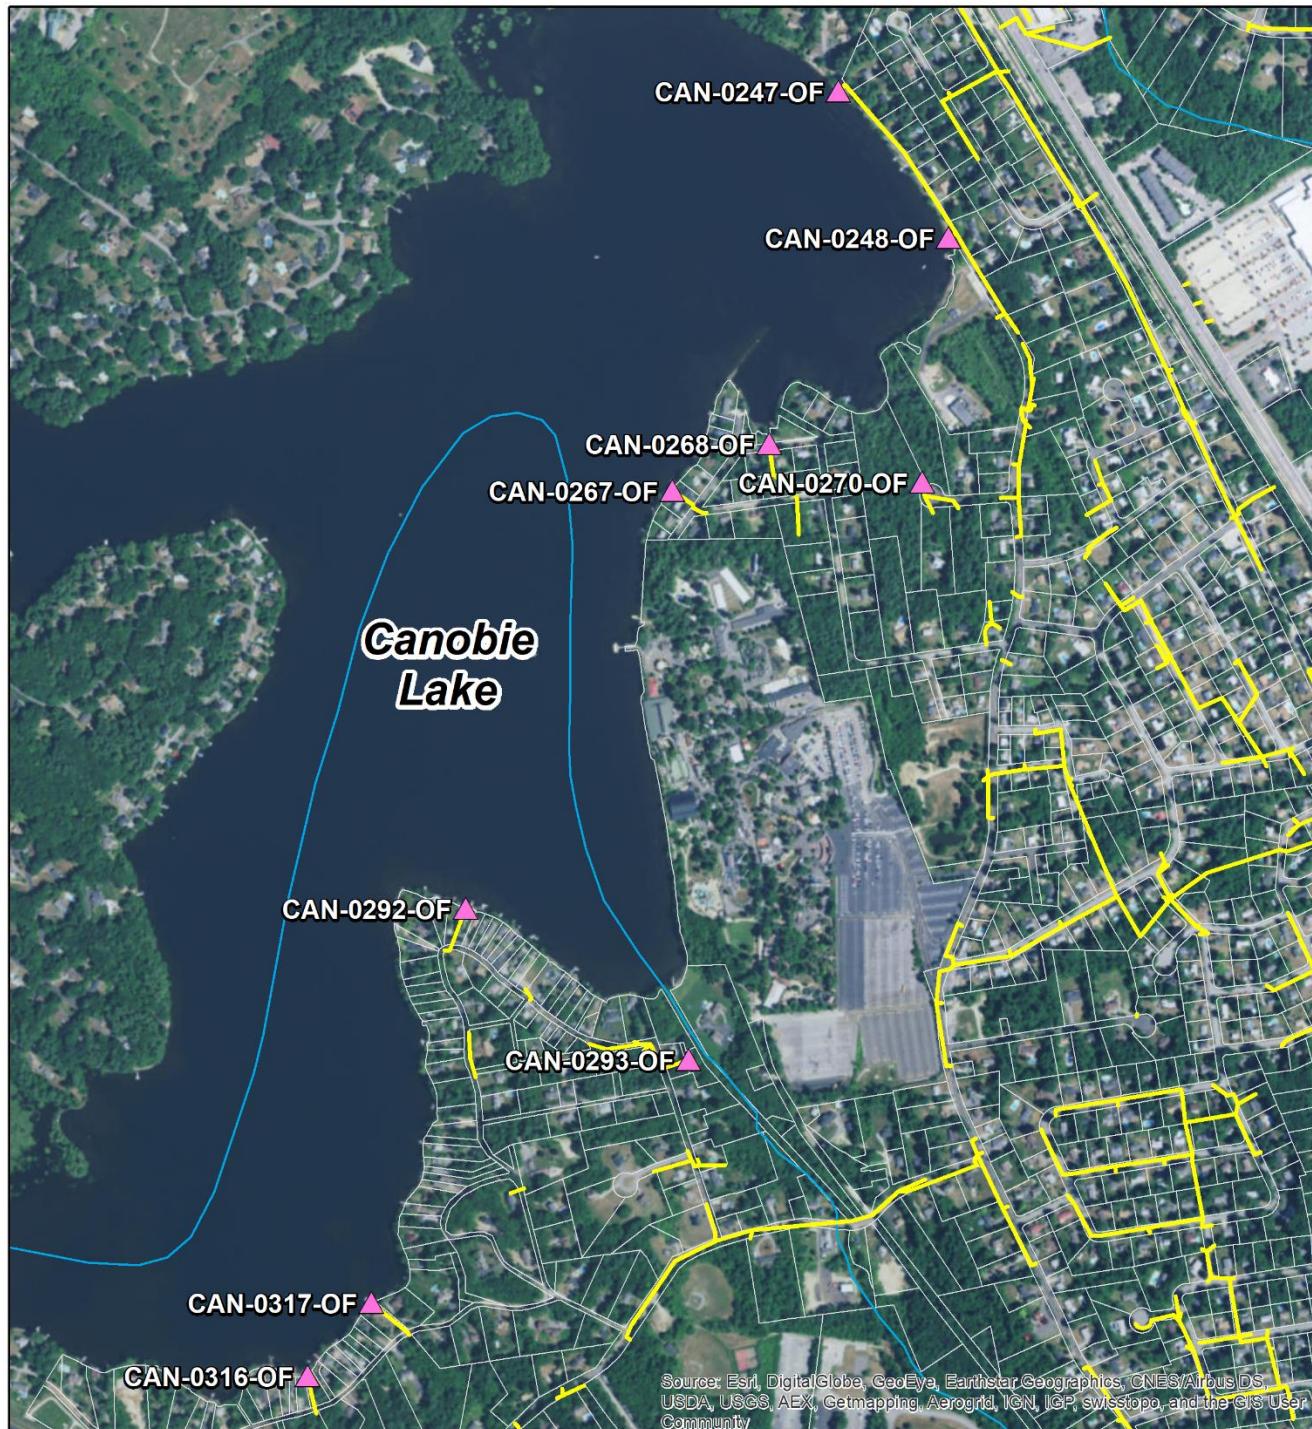
FIGURE 2. Stormwater outfall sampling locations for 2017 MS4 screening at Canobie Lake.

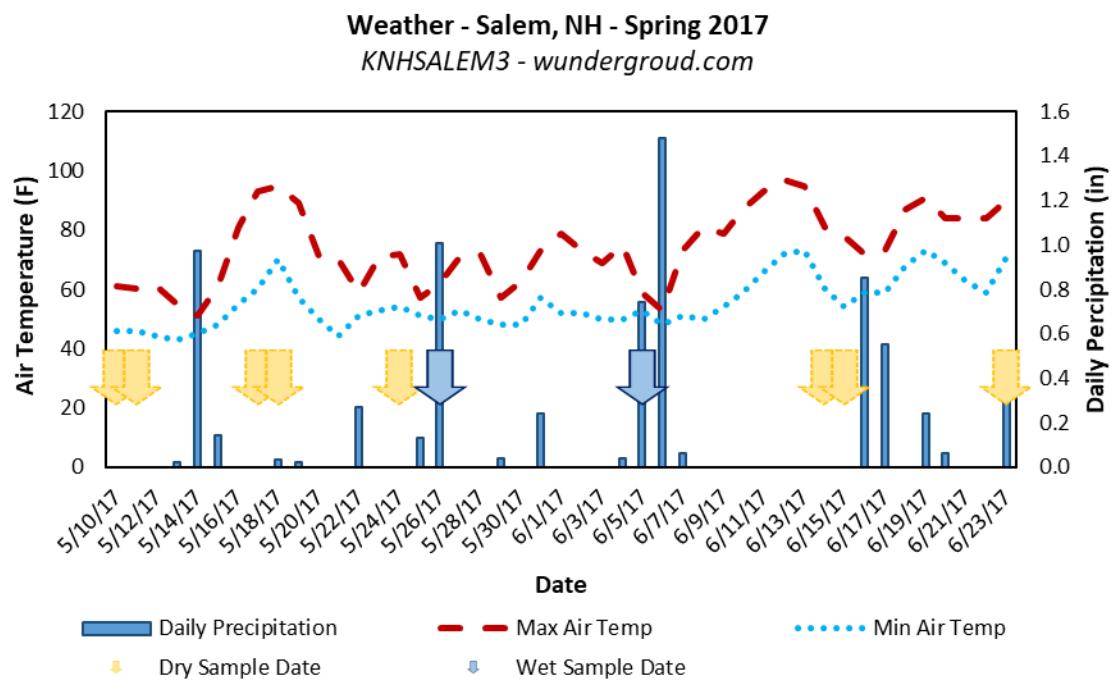
**FIGURE 3.** Spring dry and wet weather sample dates with daily minimum and maximum temperatures and daily cumulative precipitation from weather station KNHSALEM3 (Weather Underground), located east of Millville Pond.

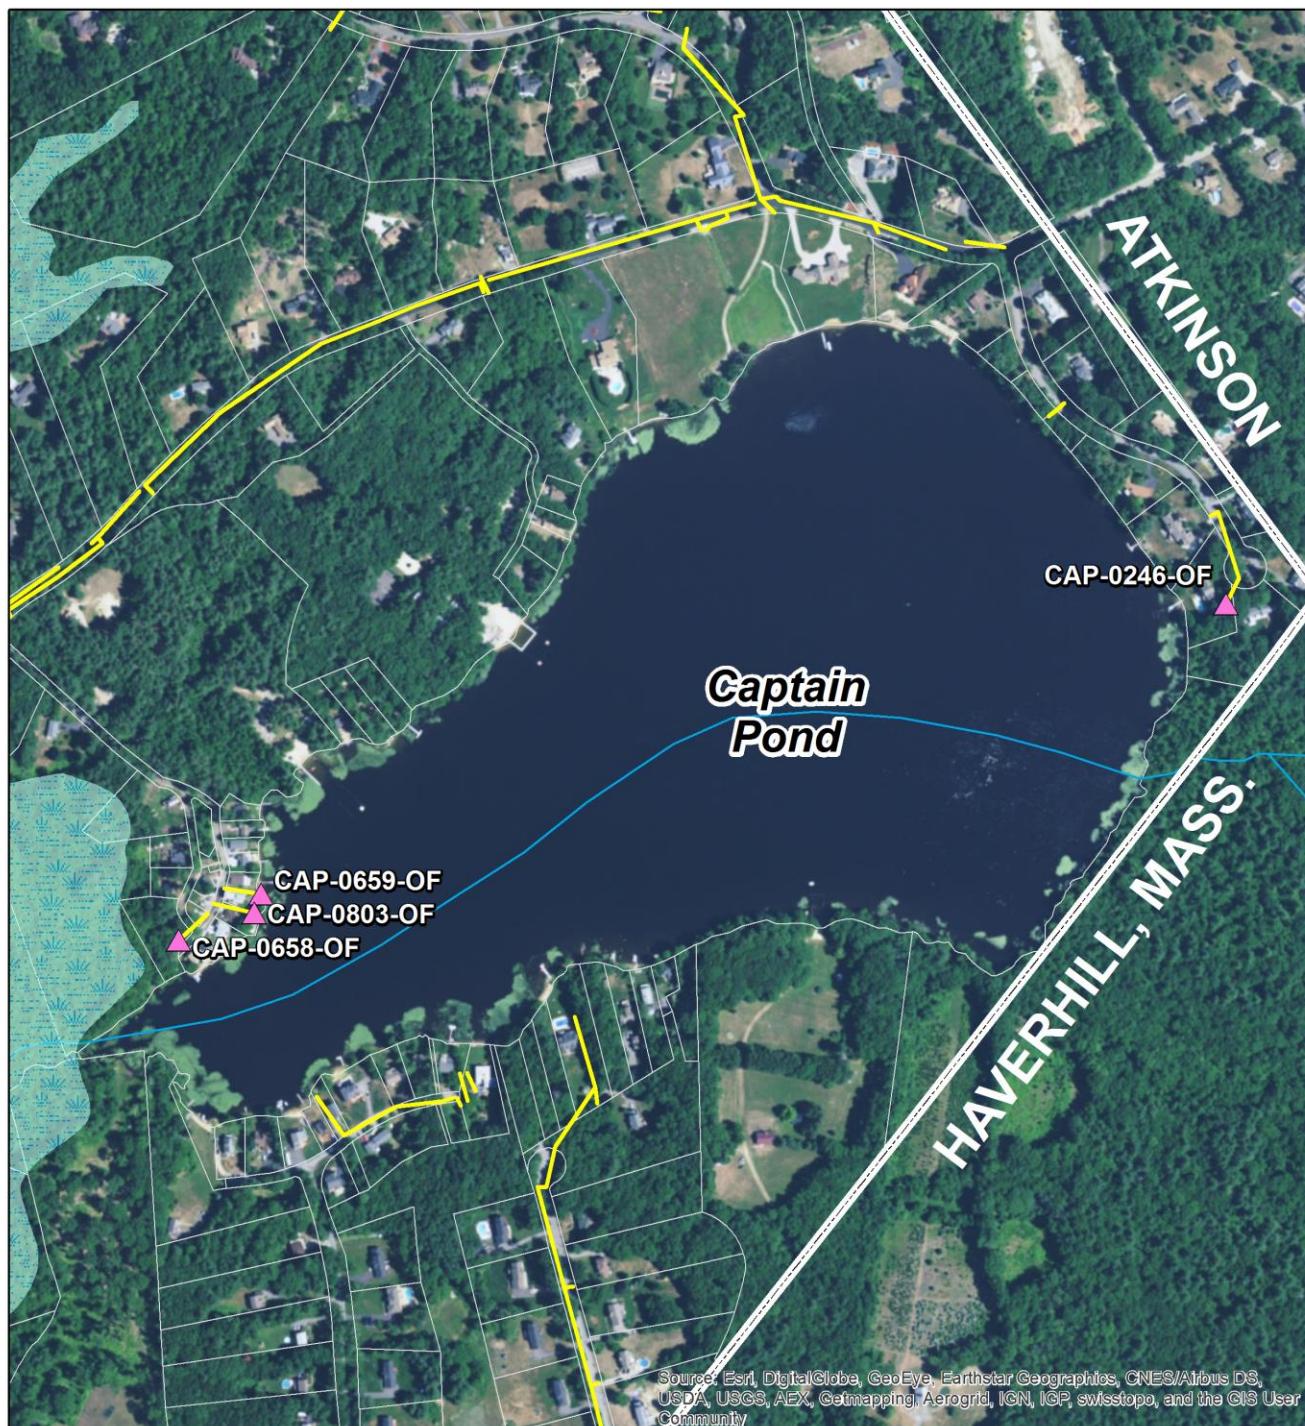
FIGURE 1. Stormwater outfall sampling locations for Task 1 2017 at Captain Pond.

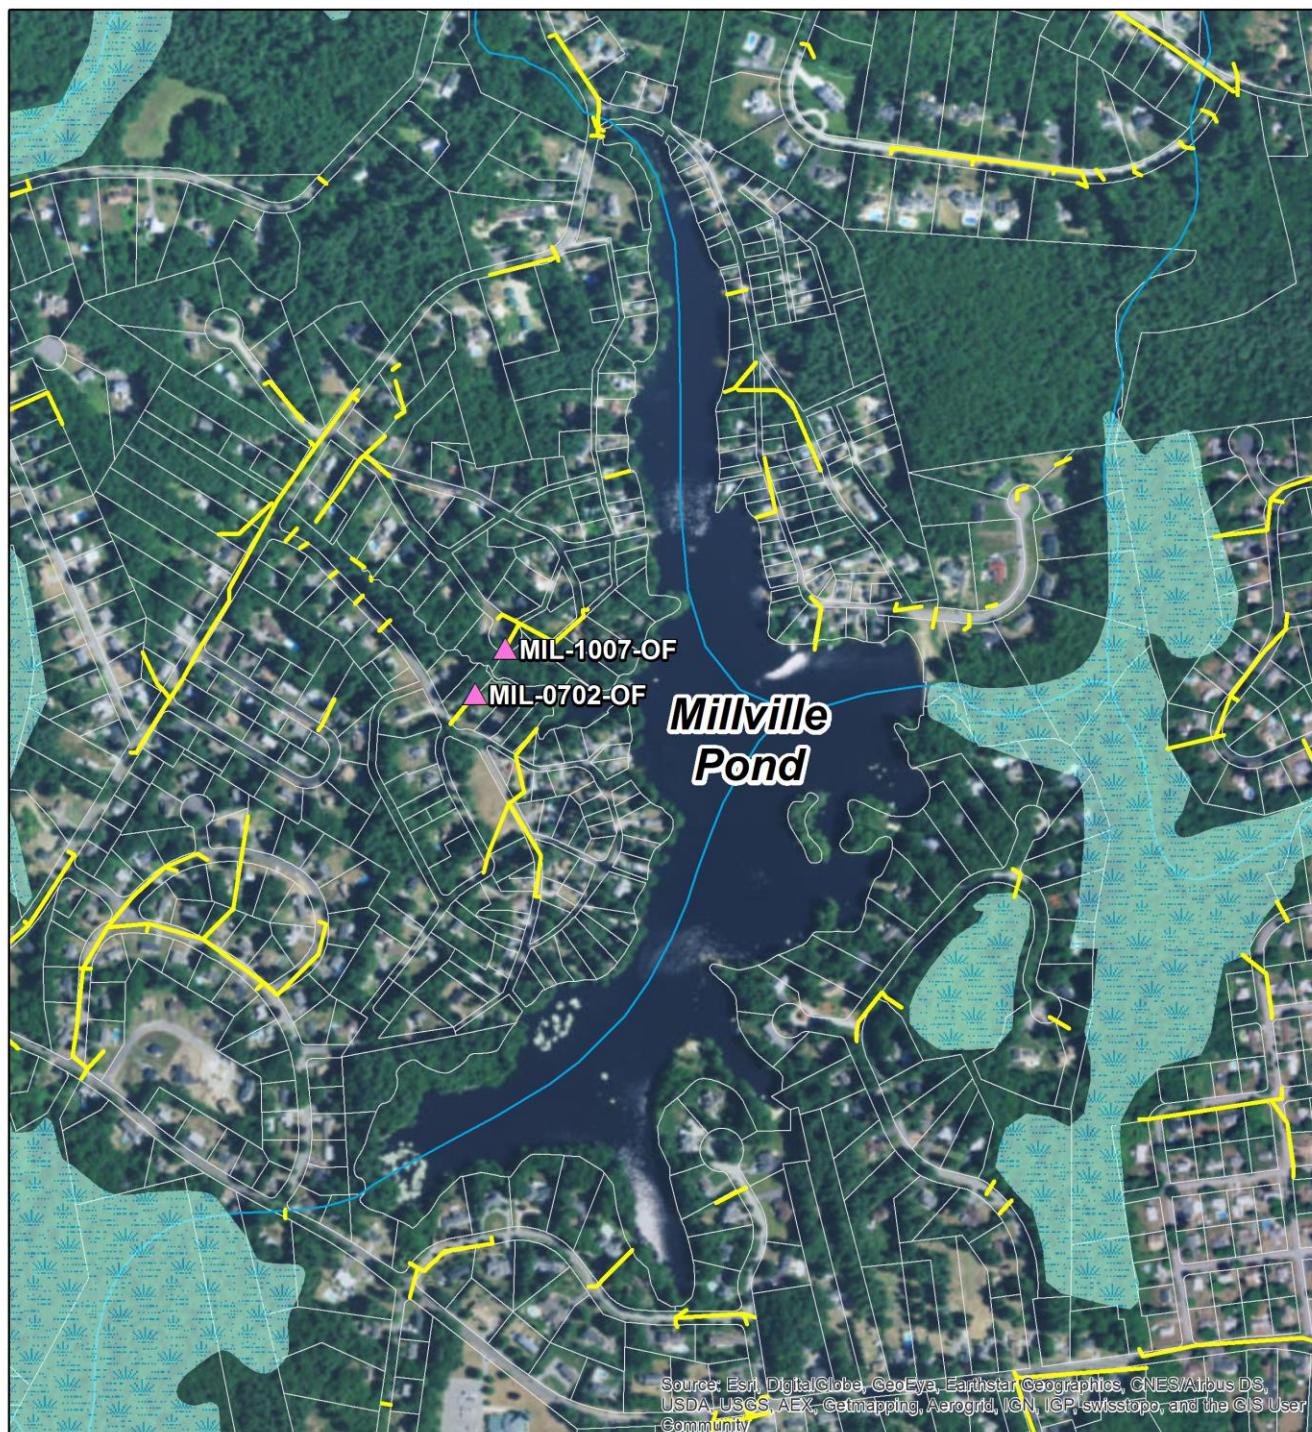
FIGURE 2. Stormwater outfall sampling locations for Task 1 2017 at Millville Pond.

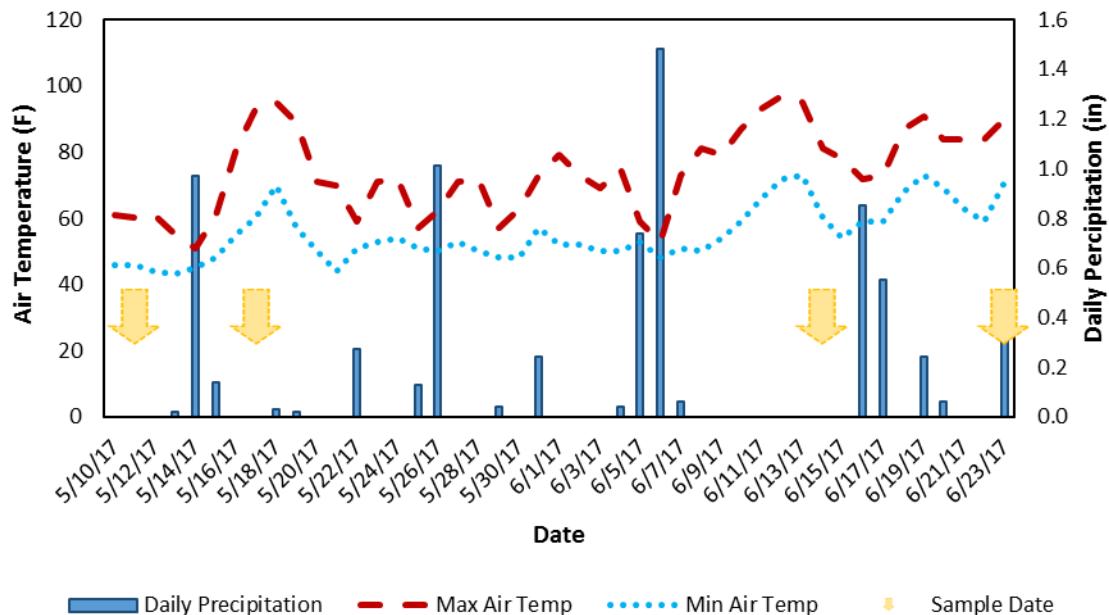
**FIGURE 3.** Spring dry weather sample dates with daily minimum and maximum temperatures and daily cumulative precipitation from weather station KNHSALEM3 (Weather Underground), located east of Millville Pond.

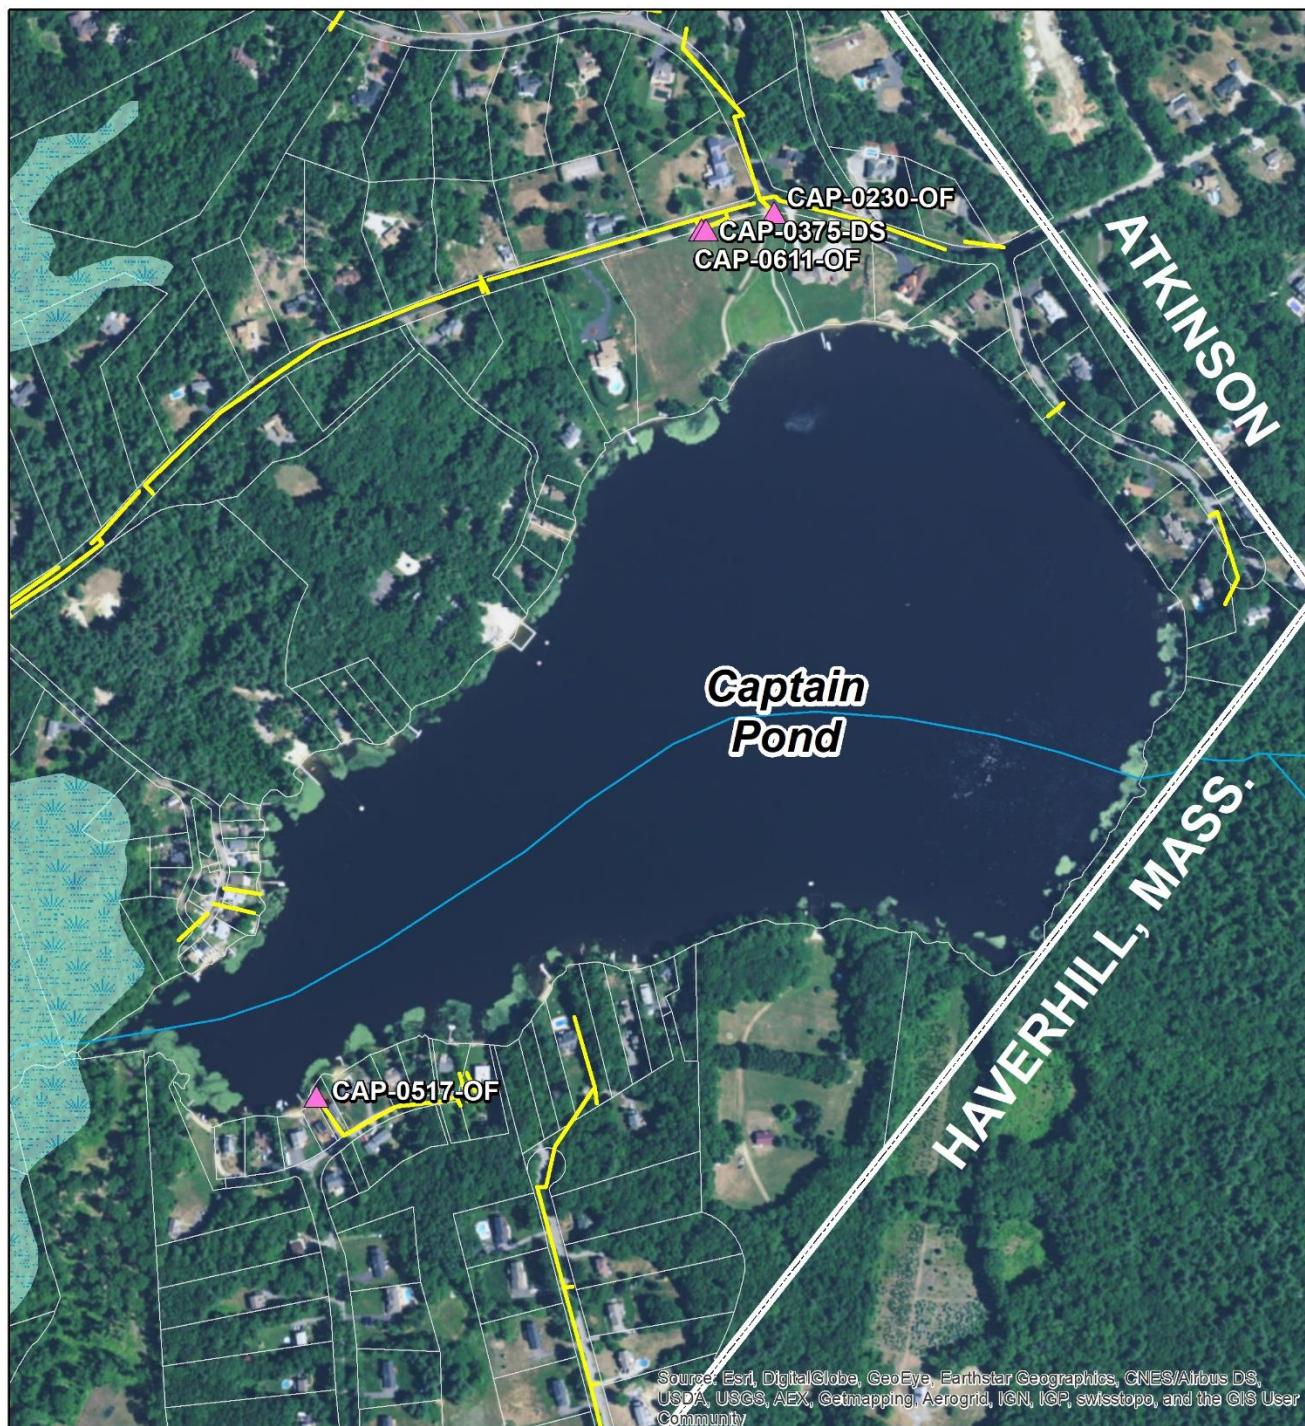
FIGURE 1. Stormwater outfall sampling locations for Task 2 2017 at Captain Pond.

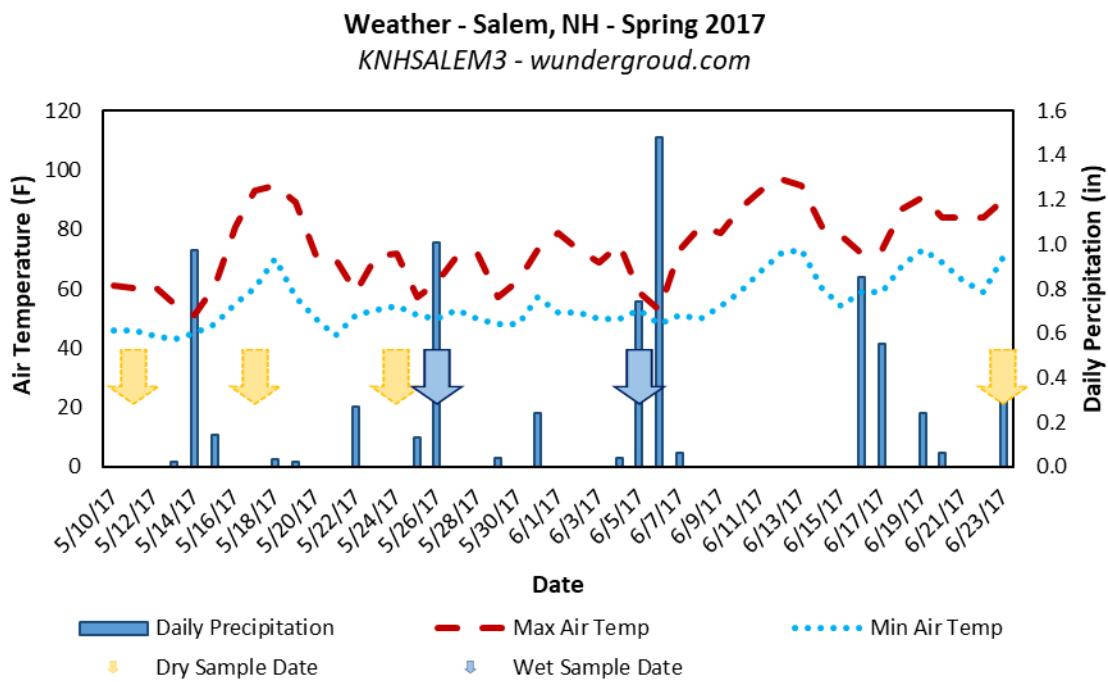
**FIGURE 3.** Spring dry and wet weather sample dates with daily minimum and maximum temperatures and daily cumulative precipitation from weather station KNHSALEM3 (Weather Underground), located east of Millville Pond.

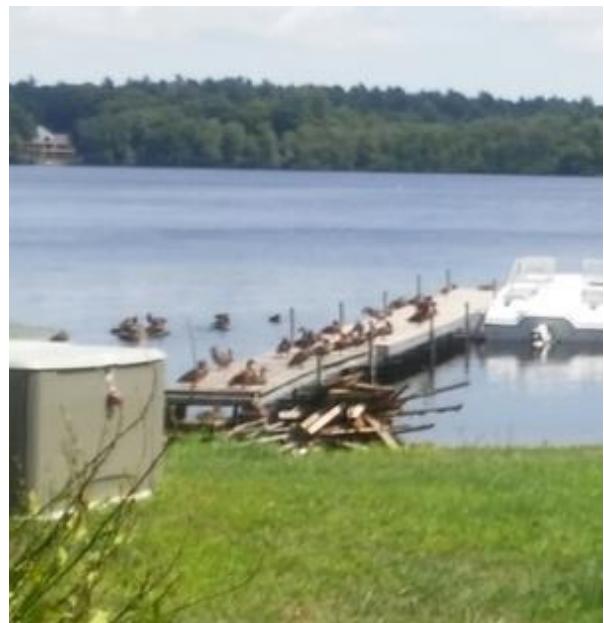
Hundreds of ducks noted on dock near CAP-0659-OF.

Pet and bird waste were noted as likely contamination sources to CAP-0659-OF. No evidence of household detergents (greywater) or road salt runoff were found during the site visit.

| <b>Site</b> | <b>Map-Lot</b> | <b>Catchment Investigation Observations</b> |
|---|---|---|
| CAP-0659-OF | 51-5872, | Leachfield immediately uphill is brand new. Pet waste noted throughout drainage area. |

The drainage area to **CAP-0659-OF** was investigated because of elevated fecal indicator bacteria, salinity, specific conductivity, and total chlorine measured during the initial outfall screening, suggesting a possible greywater source. The outfall may be receiving pollutants from pet and wildlife waste.

- Discourage birds from roosting on lawns, docks, and decks immediately on or adjacent to Captain Pond.
- Post signs in the neighborhood that encourages proper pet waste disposal.
- Distribute educational materials about the water quality benefits of minimizing fertilizer use, maintaining septic systems, and picking up after pets.

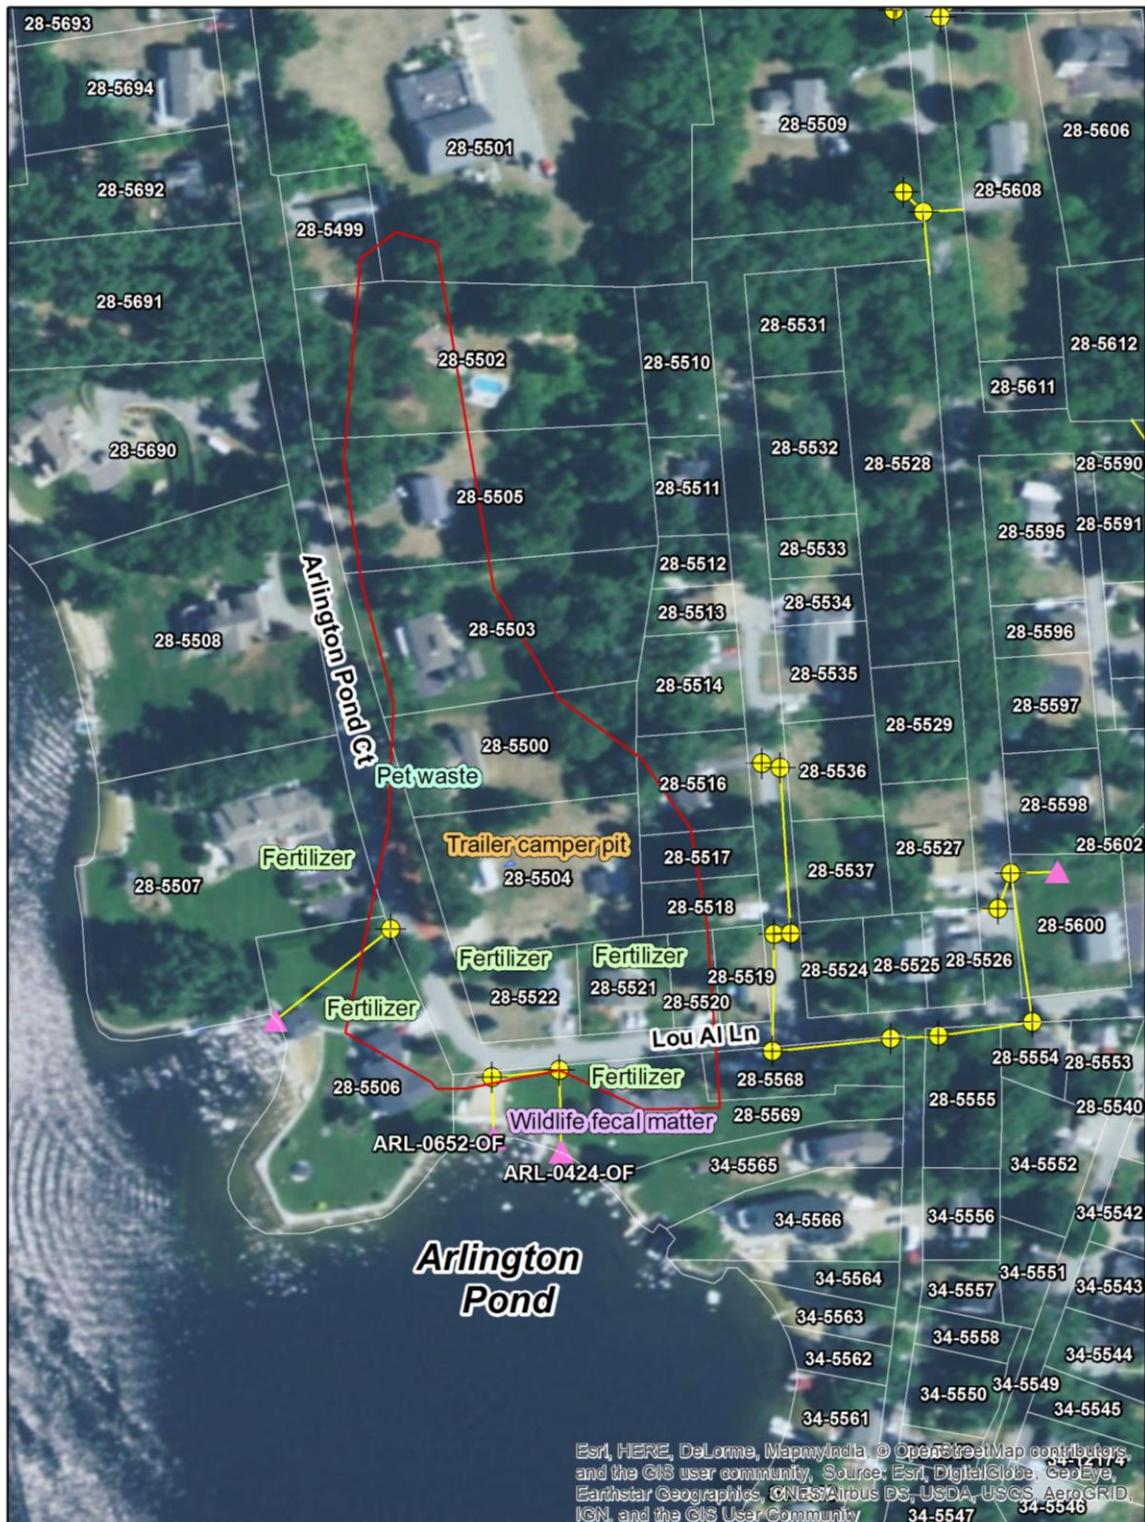
Arlington Pond Potential Pollutant Sources - Drainage to ARL-0652-OF

**FIGURE 1.** Stormwater outfall drainage to ARL-0652-OF at Arlington Mill Reservoir. Potential pollutant sources noted.

The drainage area to **ARL-0652-OF** was investigated because of a strong sewage odor noted during the initial outfall screening. The outfall may be receiving pollutants from a variety of sources, including pet, human, and wildlife waste and fertilizer. The beach at the outfall is heavily-used by humans and wildlife (notably birds).

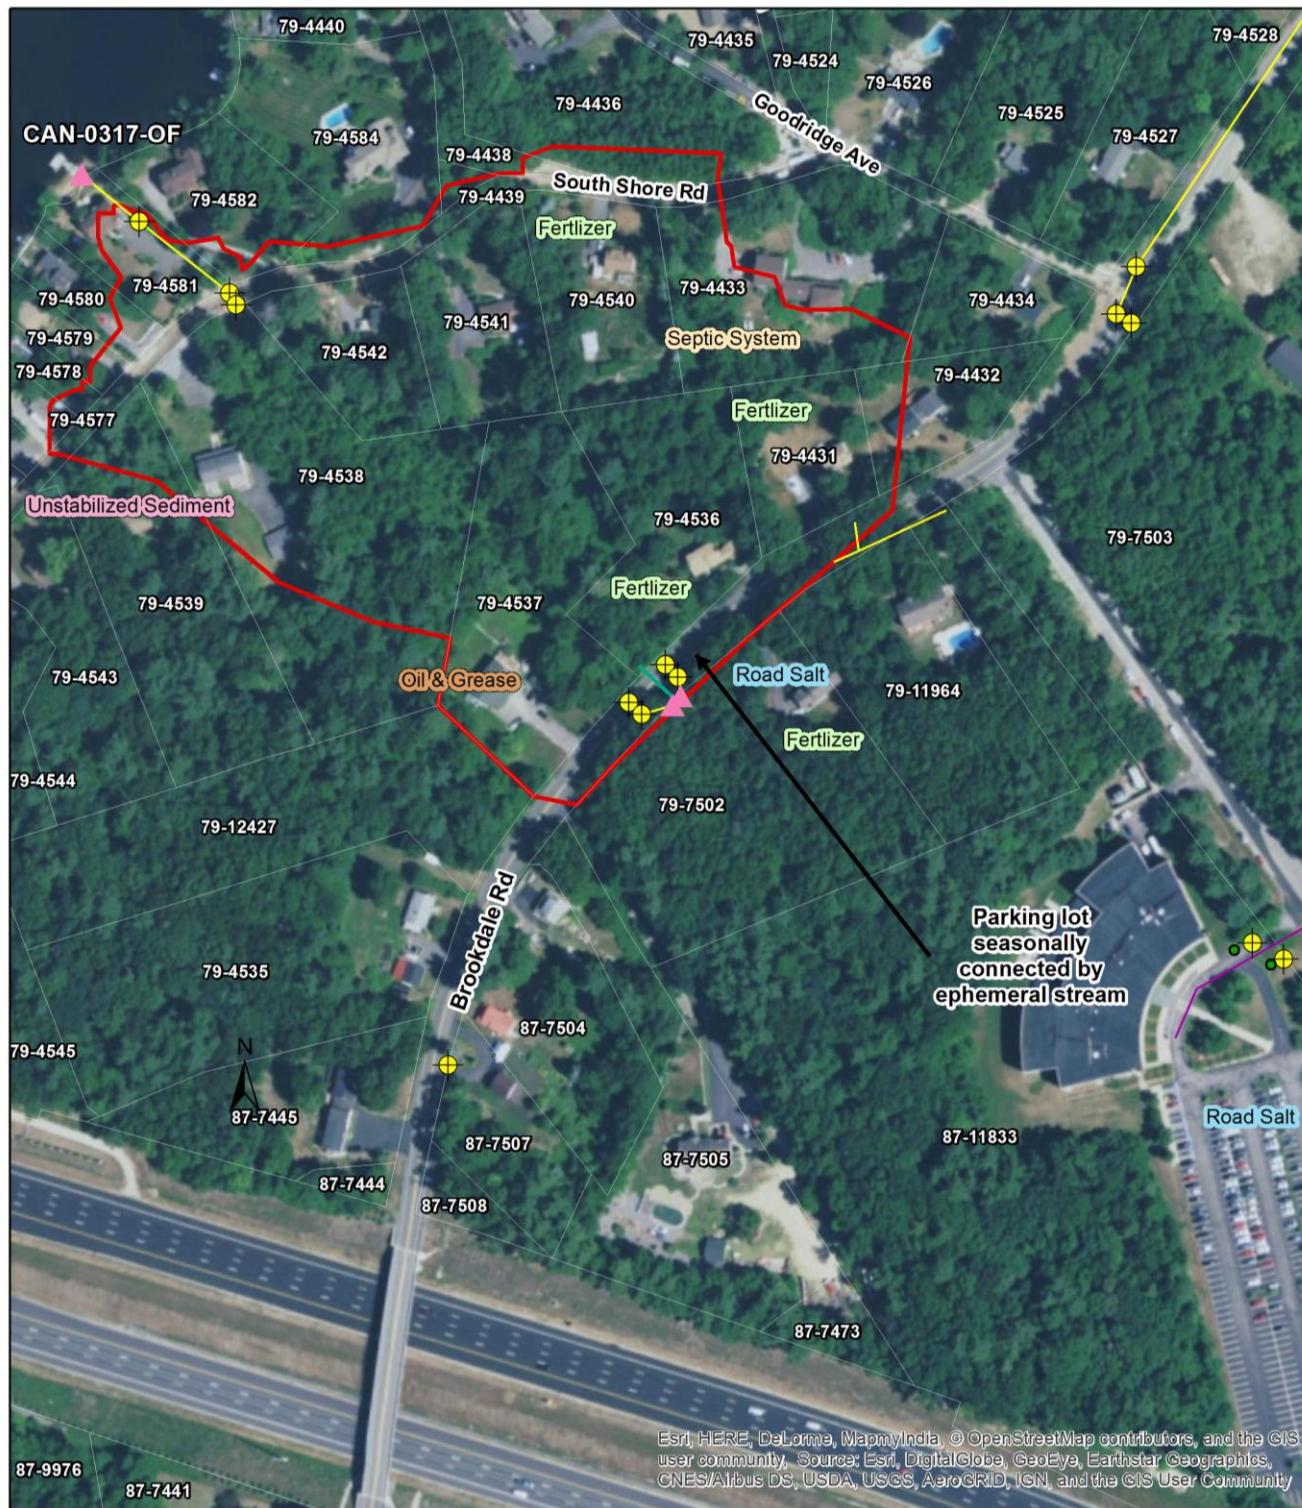
### Canobie Lake Potential Pollutants - Drainage to CAN-0317-OF

**FIGURE 2.** Stormwater outfall drainage to CAN-0317-OF at Canobie Lake. Potential pollutant sources noted.

The drainage area to **CAN-0317-OF** was investigated because of a strong sewage odor noted during the initial outfall screening, when the water collected was brown and cloudy with low oxygen and elevated levels of fecal indicator bacteria, total chlorine, and total ammonia. The outfall may be receiving pollutants from a variety of sources, including pet and human waste, fertilizer, un-stabilized soil (with associated nutrients), road salt, and oil and grease. One property owner operates a backyard mechanic shop where oil and grease may not be properly contained. Another property owner operates a landscaping and snow plowing business and stages equipment, road salt, and fertilizer in the steep driveway that may act as a conduit for runoff to the wetland area before reaching the outfall. An industrial building with a large parking lot to the southeast of the drainage area may be seasonally connected to the drainage area by an ephemeral stream; thus, road salt may be flushing to these critical wetland areas. Concerns with the proper functioning of a septic system accepting waste from a seven-family building were remedied in June 2017 by hooking up the building to sewer.

- Investigate properties with commercial staging to ensure proper controls are in place for containing pollutants from entering surface water or groundwater.
- Work with private and public entities to reduce salt usage on roads and parking lots.
- Re-sample the outfall in 2018 to ensure that water quality parameters and olfactory observations no longer indicate human sewage (assuming the seven-family building septic system was in failure).
- Distribute educational materials about the water quality benefits of minimizing fertilizer use, maintaining septic systems, and picking up after pets.

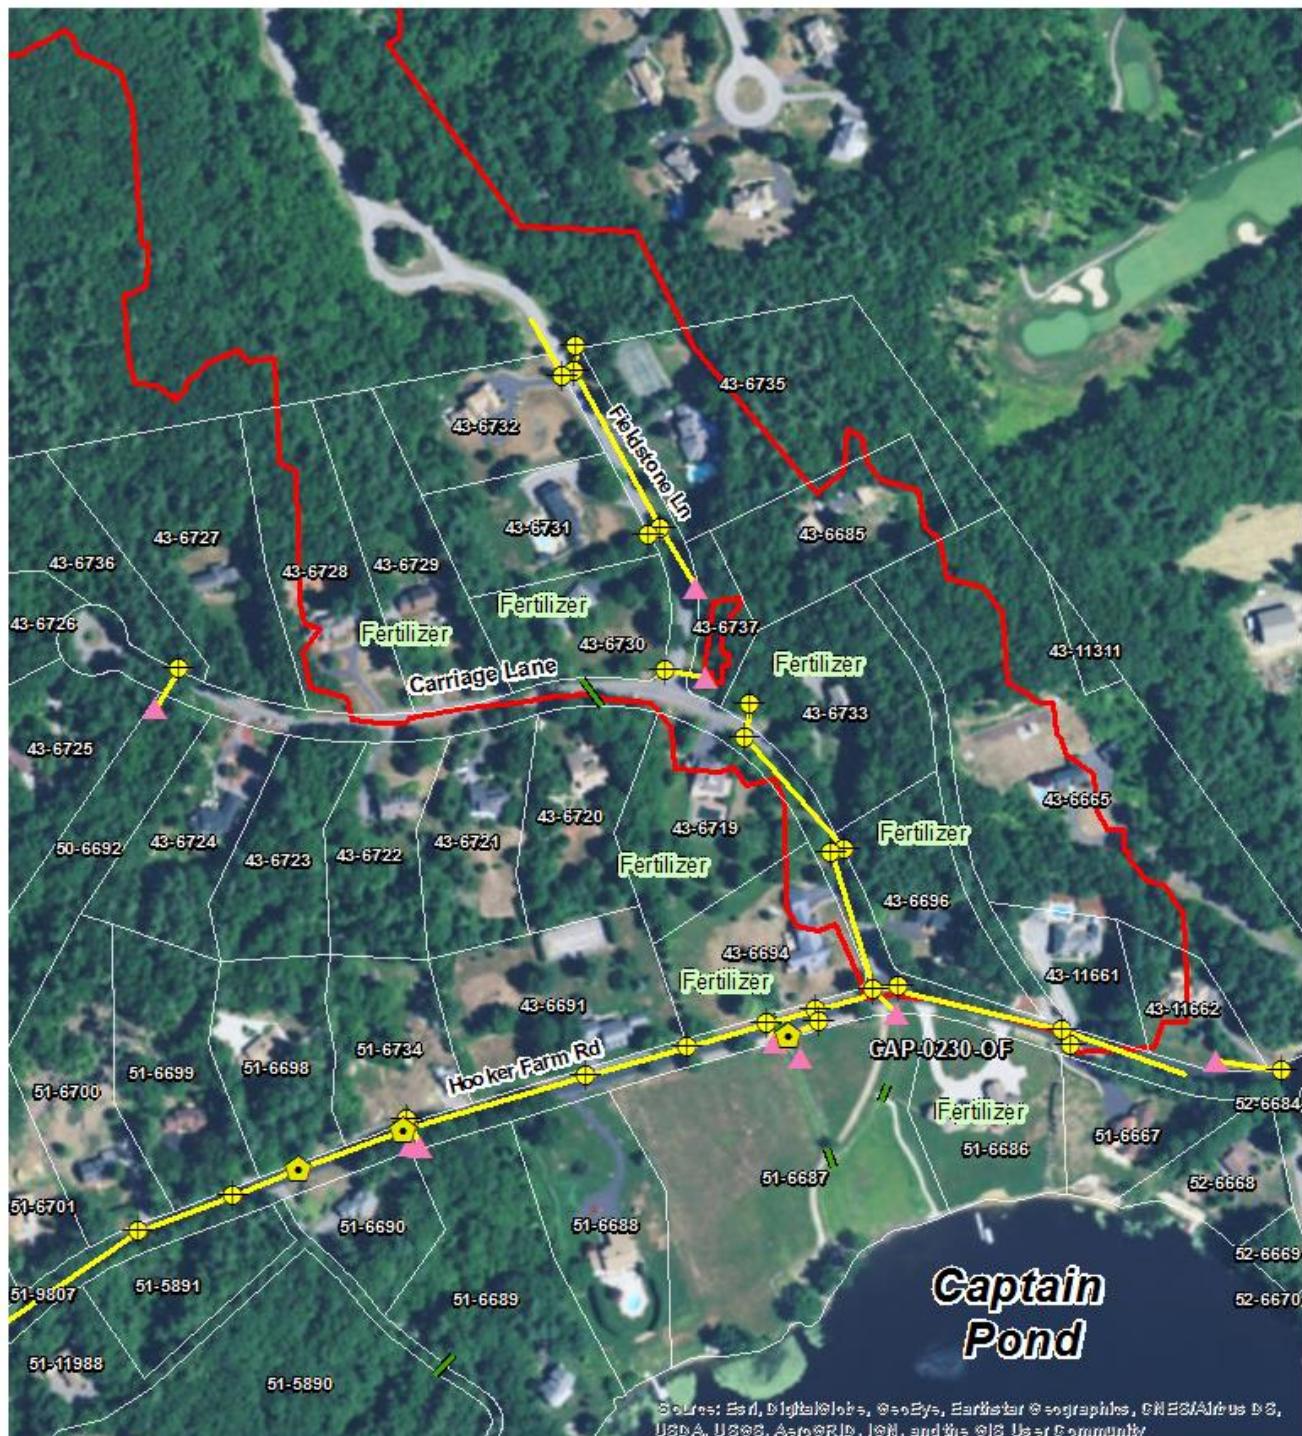
Newer, larger homes in the drainage area to CAP-0230-OF may be taxing their septic systems with excessive use of garbage disposals and water for washing. Pet waste and fertilizers are also likely sources to the outfall.

**FIGURE 3.** Stormwater outfall drainage to CAP-0230-OF at Captain Pond. Potential pollutant sources noted.

The drainage area to **CAP-0230-OF** was investigated because of elevated fecal indicator bacteria and total chlorine, as well as the presence of soapy suds and algae growth, indicating a possible greywater source and nutrient enrichment. Densely-packed residential neighborhoods with large, new homes in the drainage area may be contributing excess greywater flow from leachfields and use of garbage disposals may be threatening the proper functioning of leachfields. Well-manicured and large lawns are likely fertilized and contributing to nutrient enrichment noted downstream.

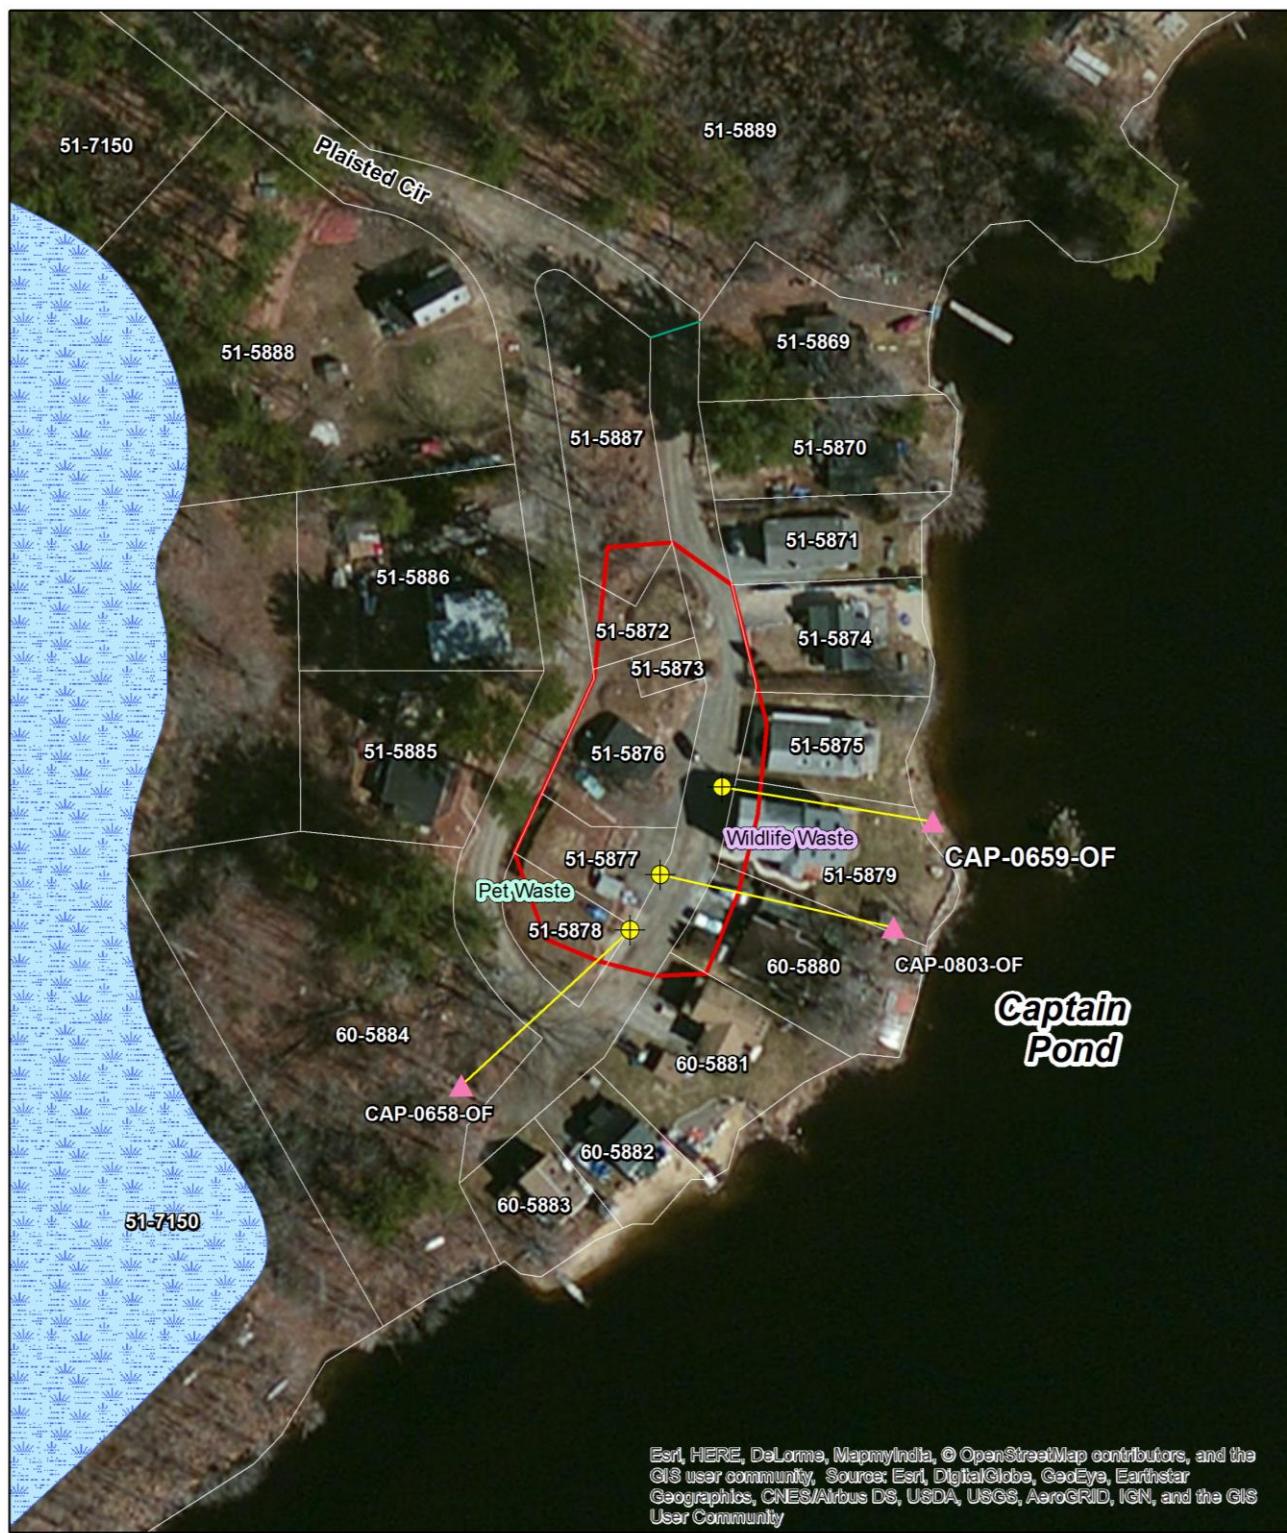
### Captain Pond Potential Pollutant Sources - Drainage to CAP-0659-OF

**FIGURE 4.** Stormwater outfall drainage to CAP-0659-OF at Captain Pond. Potential pollutant sources noted.
