**2020 ANNUAL WETLAND  
MONITORING REPORT  
(REPORT 1)**

**TUSCAN VILLAGE  
POLICY BROOK FLOODPLAIN  
IMPROVEMENT PROJECT**

Salem, New Hampshire

September 15, 2020

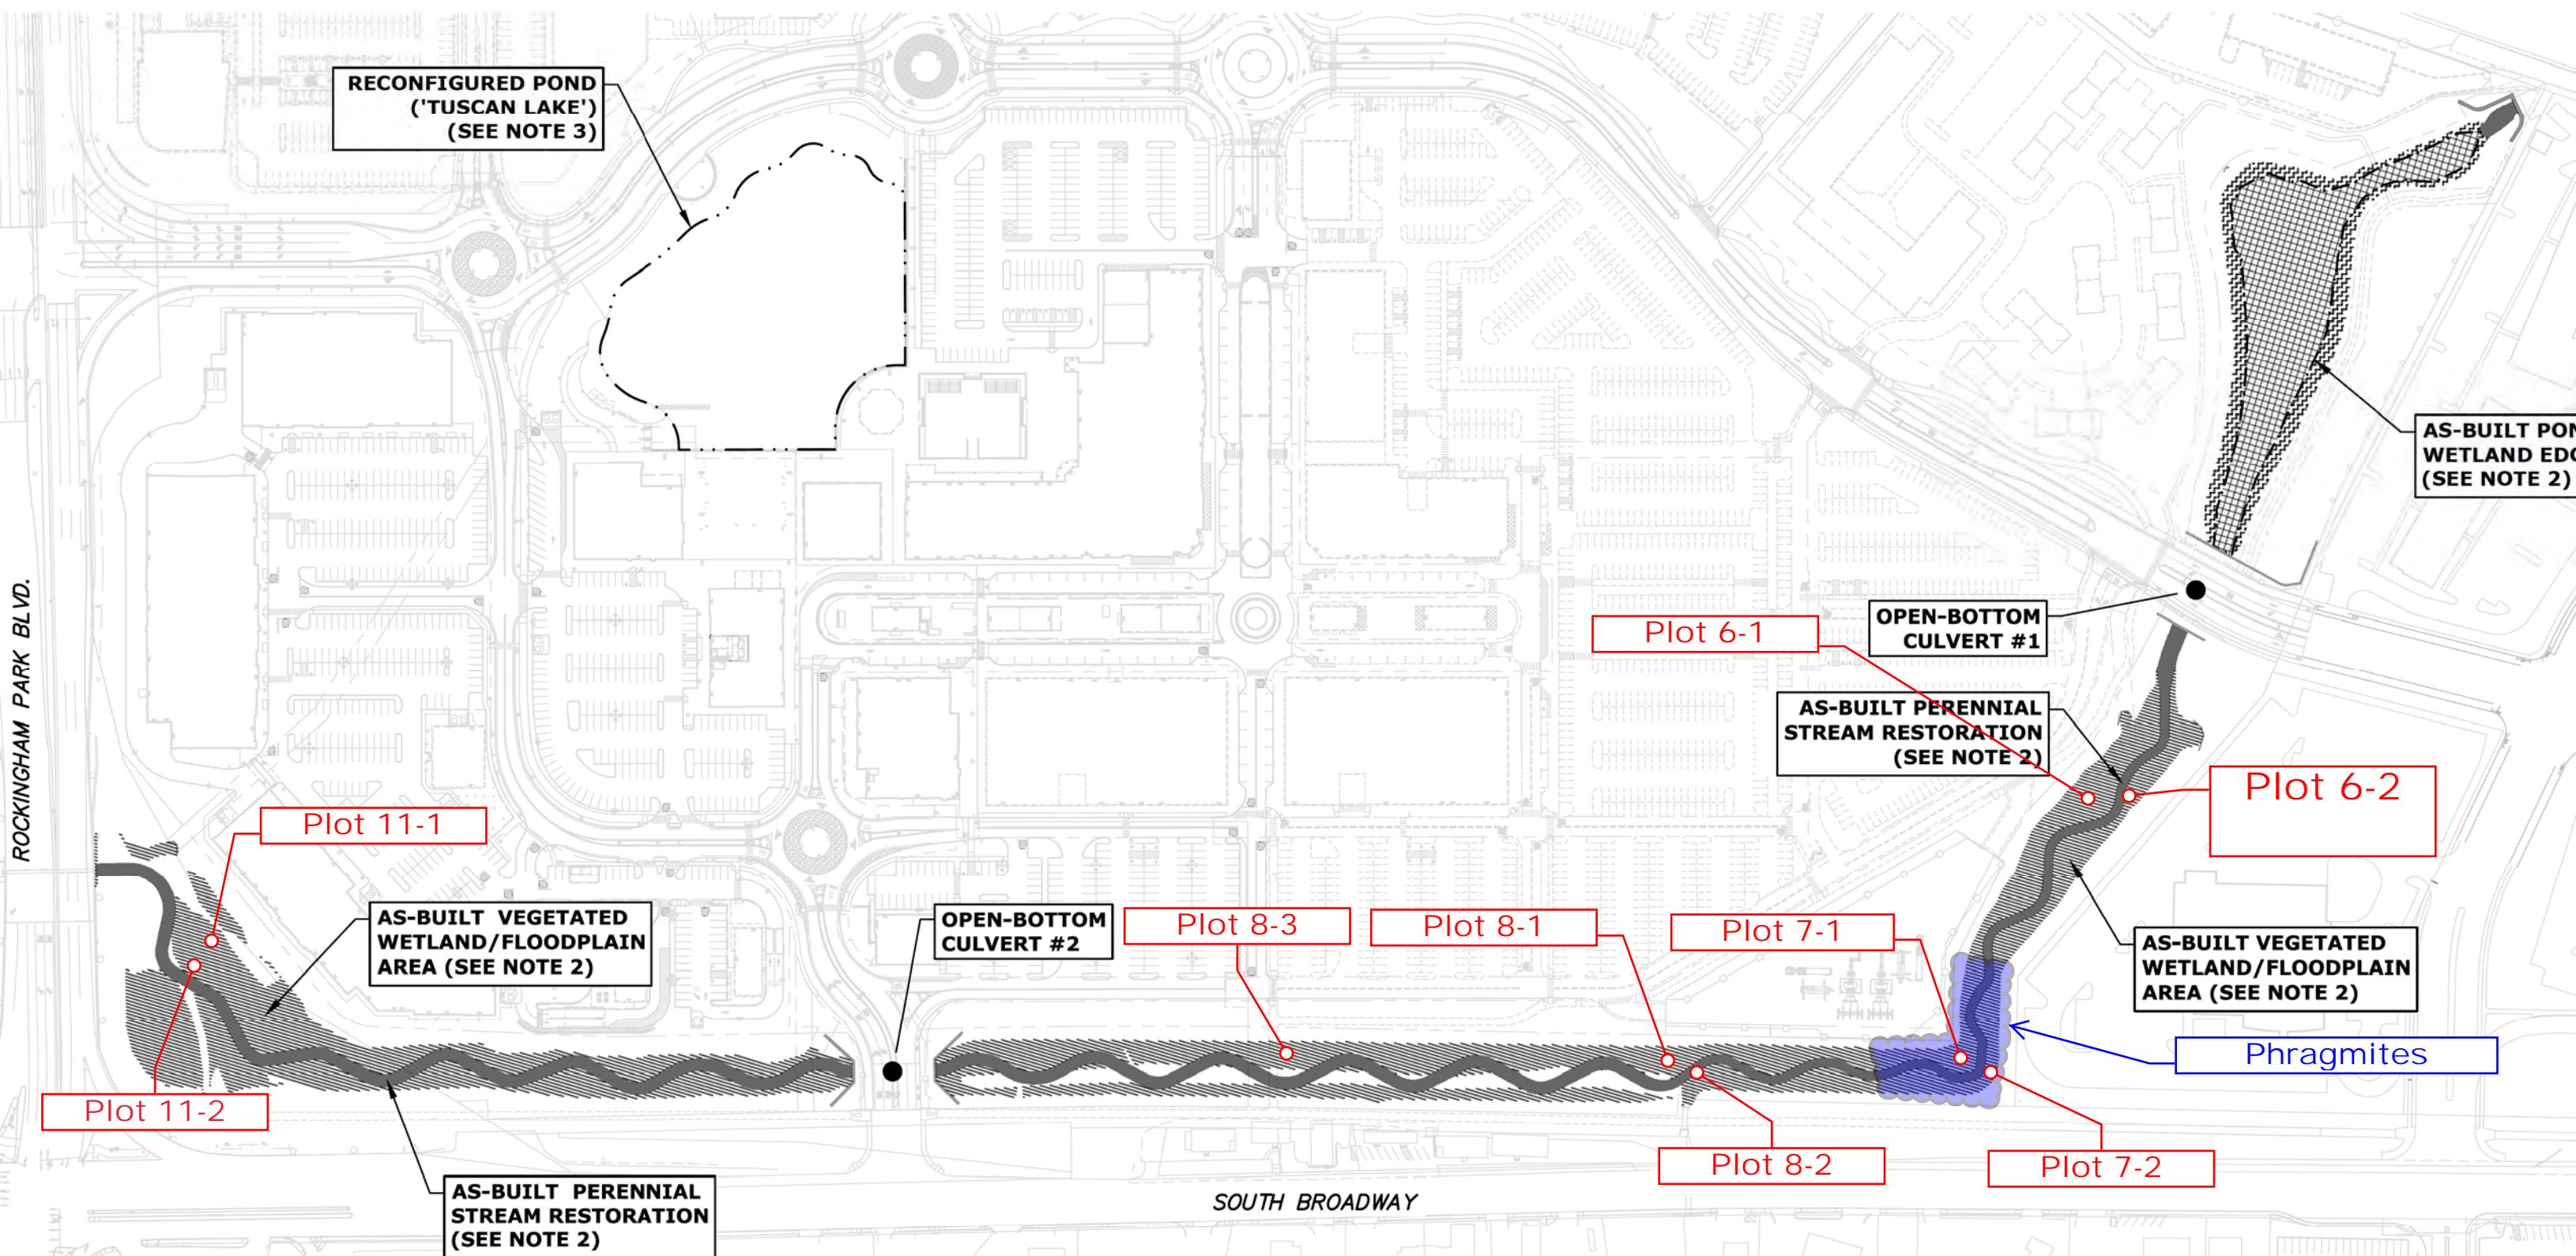
Tuscan Village Floodplain Improvement Project--2020 Wetland Monitoring Plan

area near the crossing. The location of these data plots and other relevant items are depicted on the monitoring plan, included before the appendices.

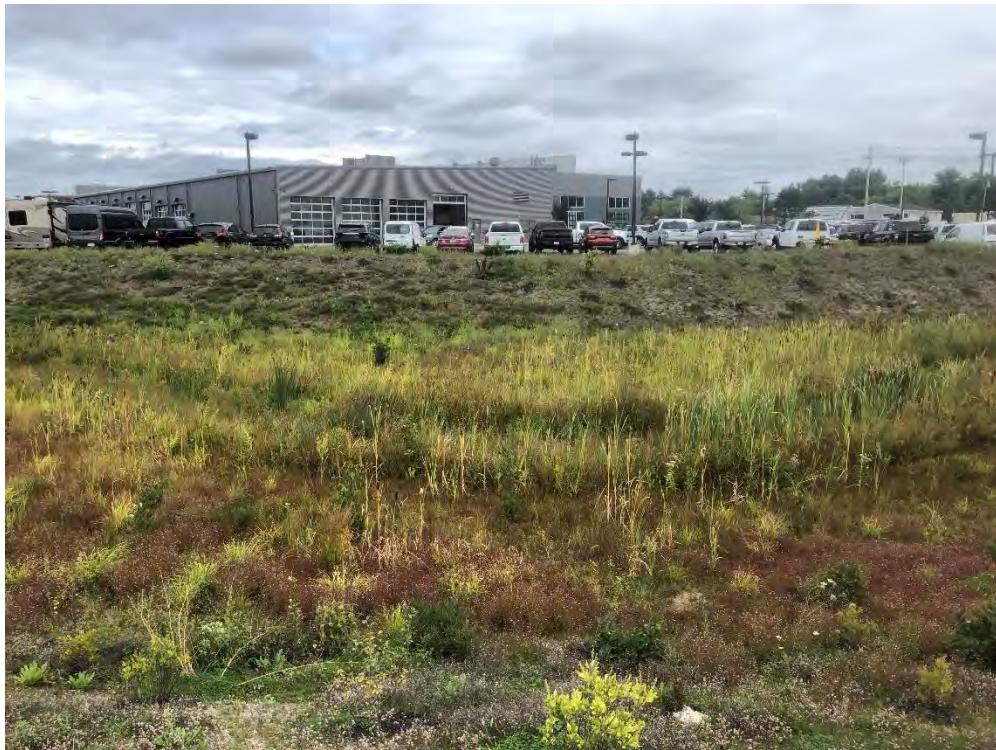
**Photo 1: Transect 6**

<b>Soil observation at Transect 6:</b>	
<b>Depth</b>	<b>Horizon/Description</b>
0" – 4"	<b>A</b> 2.5 Y 3/1— Oxidized rhizospheres Mucky coarse sand (moist) Wetland soil placed during construction
4" – 8"	<b>Bh</b> 10YR 3/4—7.5YR3/2 Loamy sand, evidence of organic matter transport and accumulation
8" – 16" +	<b>C</b> 2.5Y 6/3 Loamy sand construction subgrade
<b>Soil observation at Transect 7:</b>	
<b>Depth</b>	<b>Horizon/Description</b>
0" – 12"	<b>A</b> 2.5 Y 3/1—10YR 3/3 2% Redox faint Mucky coarse sand (moist) Wetland soil placed during construction
12" – 18" +	<b>C</b> 2.5Y 6/4—7.5 YR 4/6 redox 5% Loamy sand construction subgrade
<b>Soil observation at Transect 8:</b>	
<b>Depth</b>	<b>Horizon/Description</b>
0" – 12"	<b>A</b> 2.5 Y 3/2—2.5Y 4/4 2% redox faint Mucky coarse sand (moist) Wetland soil placed during construction
12" – 16" +	<b>C</b> 5Y 4/2 Dense sand and gravel construction subgrade
<b>Soil observation at Transect 11:</b>

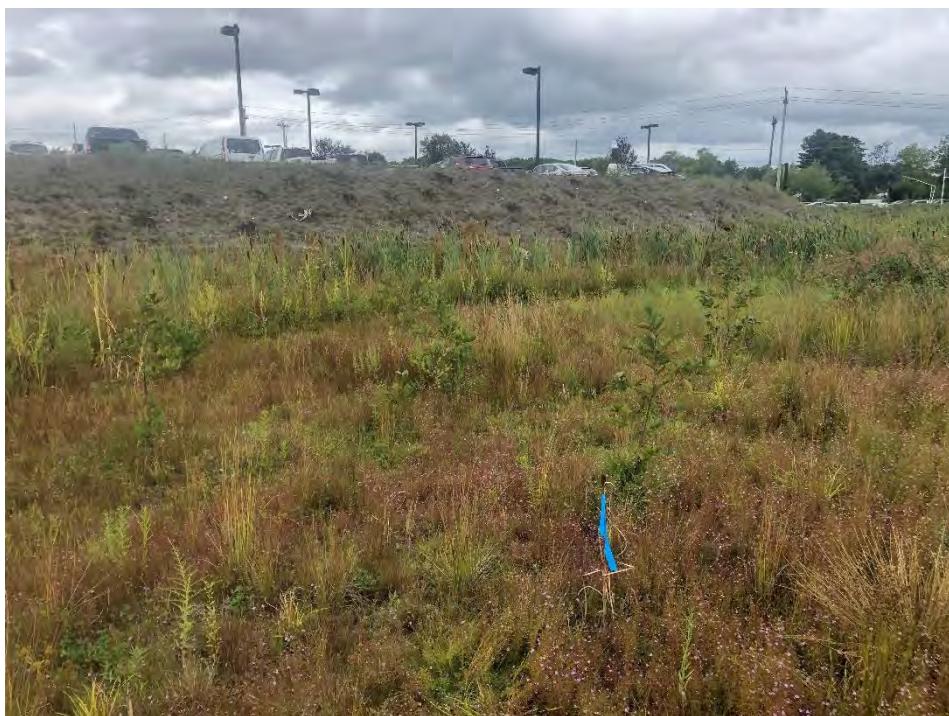
**Photo 2: Data Plot 6-1**

PLOT ID	COMPOSITION OF PLANTS		INDICATOR STATUS	% AREAL COVER	COMMENTS
	COMMON NAME	SCIENTIFIC NAME			
6-1	<b>SHRUBS</b>				
	Speckled Alder	<i>Alnus rugosa</i>	FACW	5	
	Winterberry	<i>Ilex verticillata</i>	FACW	2	
	<b>HERBS</b>				
	Soft Rush	<i>Juncus effusus</i>	FACW	20	
	Slender False Foxglove	<i>Agalinis tenuifolia</i>	FACW	25	
	Canada Rush	<i>Juncus canadensis</i>	OBL	2	
	Nut Sedge	<i>Cyperus esculentus</i>	FACW	2	
	Red Clover	<i>Trifolium repens</i>	FACU	5	
	Path Rush	<i>Juncus tenuis</i>	FAC	10	
	TOTAL % COVER (excluding invasive sp).....			71 %

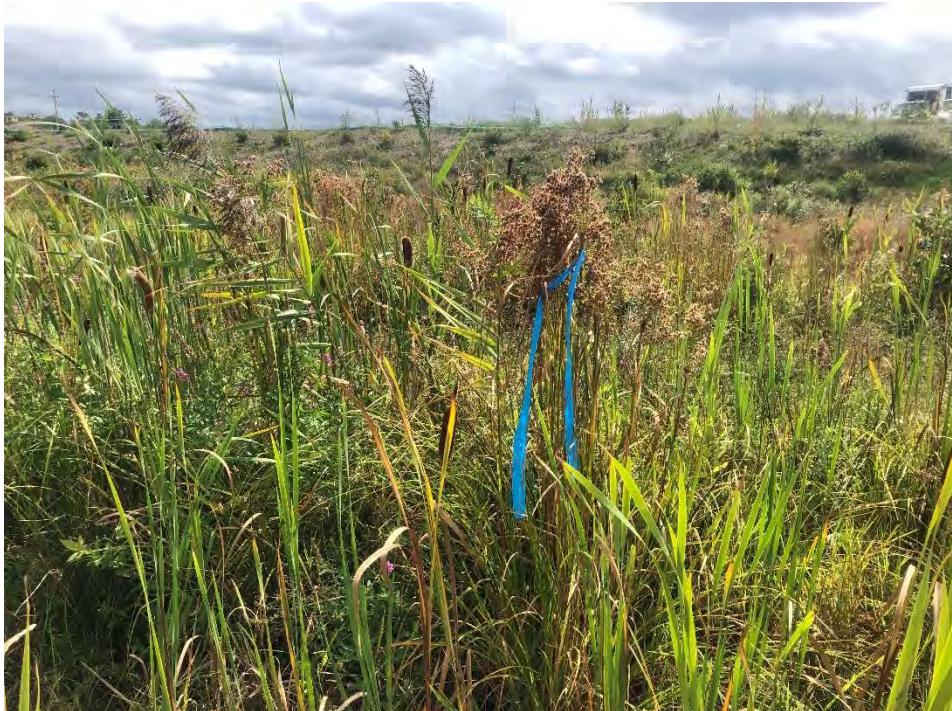
**Photo 3: Data Plot 6-2**

PLOT ID	COMPOSITION OF PLANTS		INDICATOR STATUS	% AREAL COVER	COMMENTS
	COMMON NAME	SCIENTIFIC NAME			
6-2	<b>SHRUBS</b>				
	Willow	Salix sp.	FACW	20	Dormant cutting installation
	<b>HERBS</b>				
	Woolgrass	<i>Scirpus cyperinus</i>	FACW	20	
	Cattail	<i>Typha latifolia</i>	OBL	25	
	Soft Rush	<i>Juncus effusus</i>	FACW	10	
	Rice Cutgrass	<i>Leersia oryzoides</i>	OBL	5	
	Yellow Sedge	<i>Carex flava</i>	OBL	2	
	Nodding Beggarticks	<i>Bidens cernua</i>	OBL	5	
	Phragmites	<i>Phragmites australis</i>	FACW	(5)	
	Purple loosestrife	<i>Lythrum salicaria</i>	OBL	(10)	
TOTAL % COVER (excluding invasive sp).....				82 %

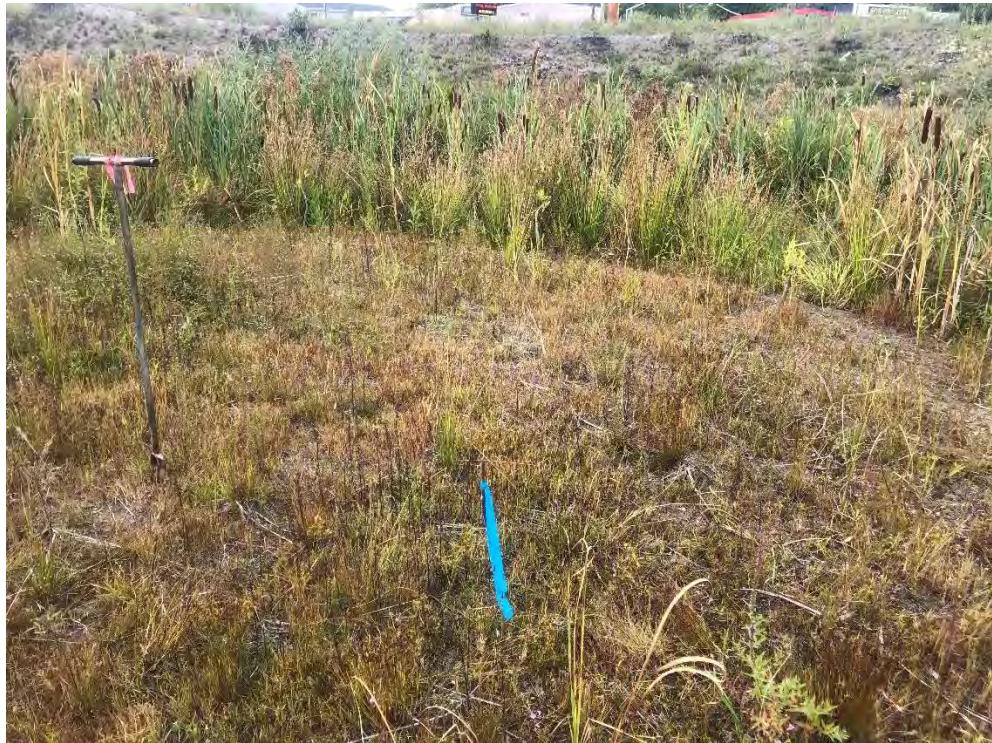
**Photo 5: Plot 7-1**

PLOT ID	COMPOSITION OF PLANTS		INDICATOR STATUS	% AREAL COVER	COMMENTS
	COMMON NAME	SCIENTIFIC NAME			
7-1	<b>SHRUBS</b>				
7-1	Willow	Salix sp.	FACW	2	Dormant cutting installation
	Winterberry	<i>Ilex verticillata</i>	FACW	2	2 planted individuals
	<b>HERBS</b>				
	Path Rush	<i>Juncus tenuis</i>	FAC	20	
	Nut Sedge	<i>Cyperus esculentus</i>	FACW	20	
	Cattail	<i>Typha latifolia</i>	OBL	5	
	Purple Stem Beggars Tick	<i>Bidens connata</i>	OBL	5	
	Slender False Foxglove	<i>Agalinis tenuifolia</i>	FACW	5	
	Purple loosestrife	<i>Lythrum salicaria</i>	OBL	(2)	
TOTAL % COVER (excluding invasive sp).....				59 %

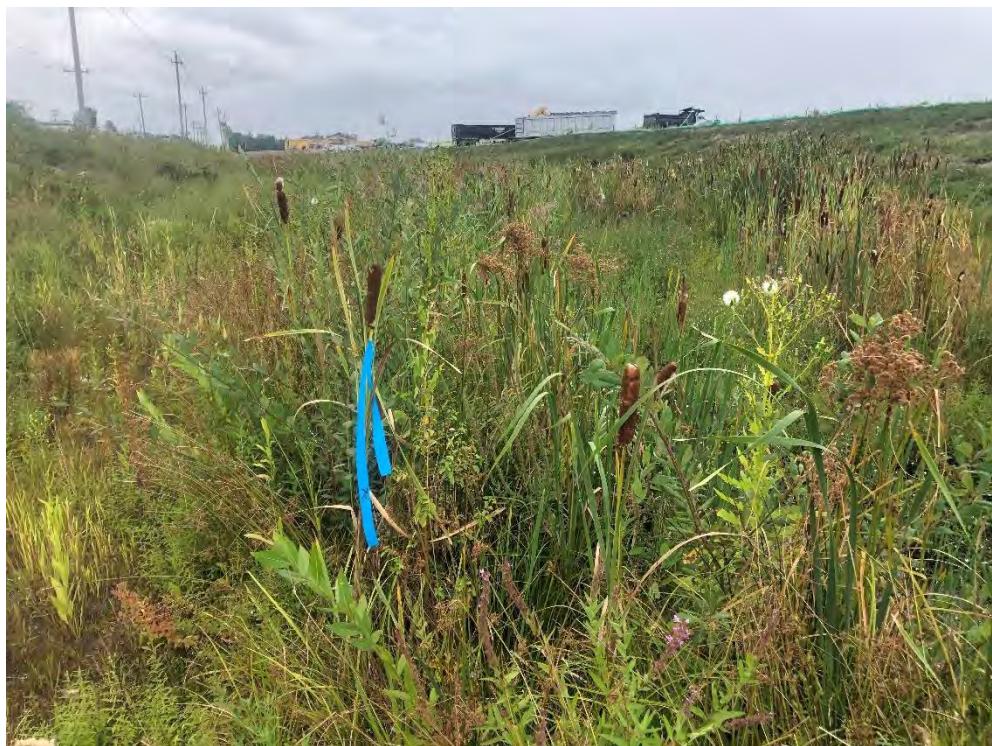
**Photo 6: Plot 7-2**

PLOT ID	COMPOSITION OF PLANTS		INDICATOR STATUS	% AREAL COVER	COMMENTS
	COMMON NAME	SCIENTIFIC NAME			
7-2	<b>SHRUBS</b>				
	Willow	Salix sp.	FACW	30	Dormant cutting installation
	<b>HERBS</b>				
	Cattail	<i>Typha latifolia</i>	OBL	30	
	Woolgrass	<i>Scirpus cyperinus</i>	FACW	20	
	Soft Rush	<i>Juncus effusus</i>	FACW	10	
	Common Groundsel	<i>Senecio vulgaris</i>	FAVU	5	
	Nut Sedge	<i>Cyperus esculentus</i>	FACW	2	
	Purple loosestrife	<i>Lythrum salicaria</i>	OBL	(5)	
	TOTAL % COVER (excluding invasive sp).....			97 %

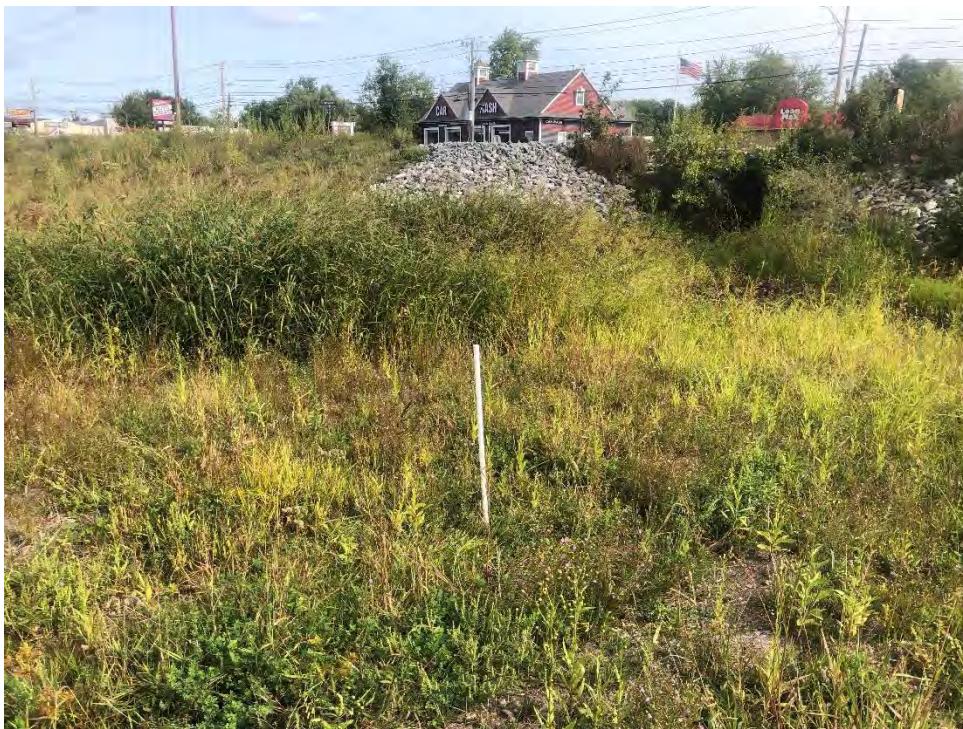
**Photo 8: Data Plot 8-1**

PLOT ID	COMPOSITION OF PLANTS		INDICATOR STATUS	% AREAL COVER	COMMENTS
	COMMON NAME	SCIENTIFIC NAME			
8-1	<b>SHRUBS</b>				
	No shrubs				
	<b>HERBS</b>				
	Red Clover	<i>Trifolium repens</i>	FACU	25	
	Birdsfoot Trefoil	<i>Lotus corniculatus</i>	FACU	20	
	Slender False Foxglove	<i>Agalinis tenuifolia</i>	FACW	15	
	Common Groundsel	<i>Senecio vulgaris</i>	FAVU	10	
	Barnyard Grass	<i>Echinochloa crusgalli</i>	FACU	10	
	Crabgrass	<i>Digitaria sanguinalis</i>	FACU	10	
	Common Vetch	<i>Vicia sativa</i>	FACU	5	
	TOTAL % COVER (excluding invasive sp).....				95 %

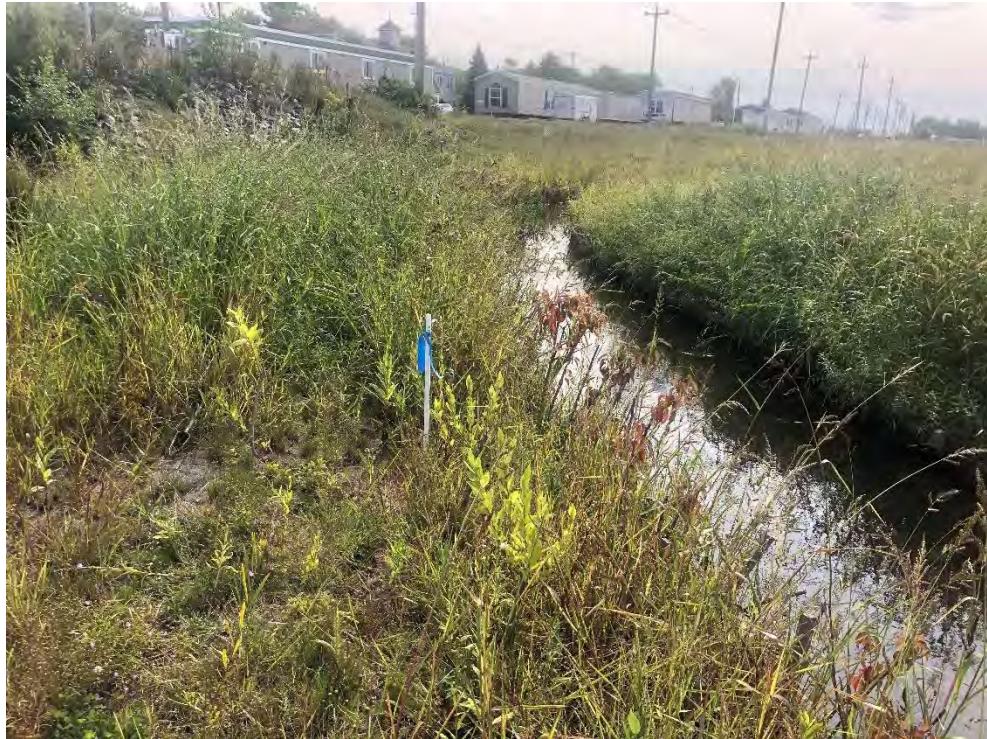
**Photo 9: Data plot 8-2**

PLOT ID	COMPOSITION OF PLANTS		INDICATOR STATUS	% AREAL COVER	COMMENTS
	COMMON NAME	SCIENTIFIC NAME			
8-2	<b>SHRUBS</b>				
8-2	Willow	Salix sp.	FACW	10	Dormant cutting installation
	Silky dogwood	<i>Cornus amomum</i>	FACW	15	Dormant cutting installation
	<b>HERBS</b>				
	Barnyard Grass	<i>Echinochloa crusgalli</i>	FACU	30	
	Common Groundsel	<i>Senecio vulgaris</i>	FAVU	15	
	Purple Stem Beggars Tick	<i>Bidens connata</i>	OBL	10	
	Nut Sedge	<i>Cyperus esculentus</i>	FACW	5	
	Northern Water Plantain	<i>Alisma plantago-aquatica</i>	OBL	2	
TOTAL % COVER (excluding invasive sp).....				87 %

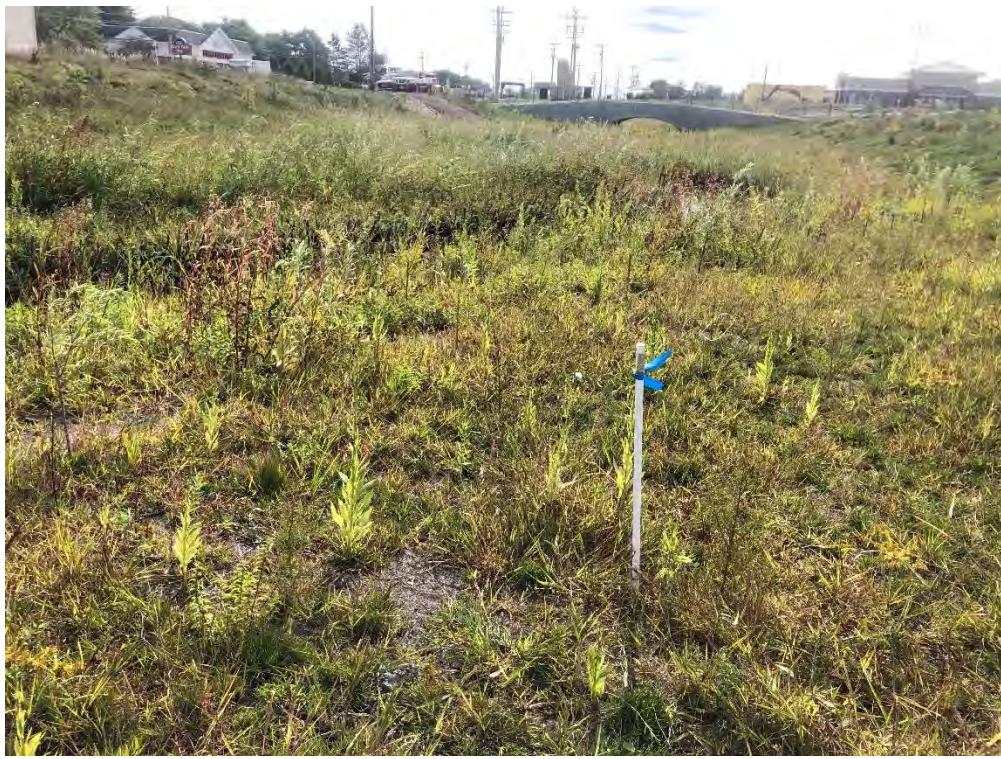
**Photo 10: Data Plot 8-3**

PLOT ID	COMPOSITION OF PLANTS		INDICATOR STATUS	% AREAL COVER	COMMENTS
	COMMON NAME	SCIENTIFIC NAME			
8-3	<b>SHRUBS</b>				
	Willow	Salix sp.	FACW	2	Dormant cutting installation
	<b>HERBS</b>				
	Barnyard Grass	<i>Echinochloa crusgalli</i>	FACU	30	
	Crabgrass	<i>Digitaria sanguinalis</i>	FACU	15	
	Common Groundsel	<i>Senecio vulgaris</i>	FACU	5	
	Slender False Foxglove	<i>Agalinis tenuifolia</i>	FACW	5	
	Pennsylvania Smartweed	<i>Persicaria pensylvanica</i>	FACW	5	
	Nut Sedge	<i>Cyperus esculentus</i>	FACW	2	
	TOTAL % COVER (excluding invasive sp).....			64 %

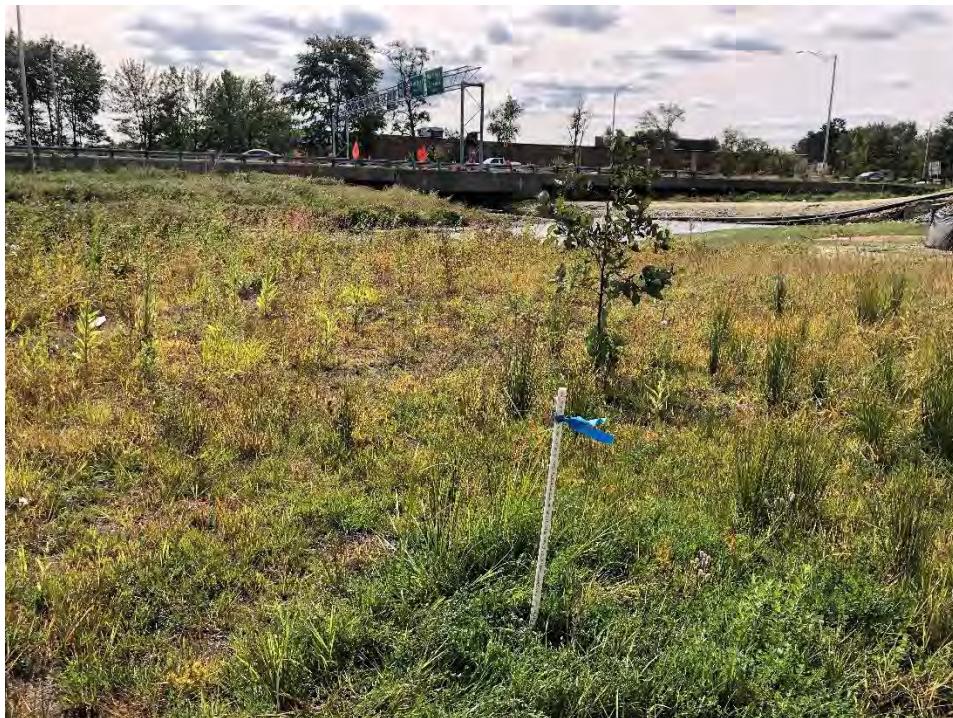
**Photo 11: Data Plot 11-1**

PLOT ID	COMPOSITION OF PLANTS		INDICATOR STATUS	% AREAL COVER	COMMENTS
	COMMON NAME	SCIENTIFIC NAME			
11-1	<b>SHRUBS</b>				
11-1	Speckled Alder	<i>Alnus rugosa</i>	FACW	5	2 planted individuals
	Winterberry	<i>Ilex verticillata</i>	FACW	2	2 planted individuals
	<b>HERBS</b>				
	Birdsfoot Trefoil	<i>Lotus corniculatus</i>	FACU	35	
	Nut Sedge	<i>Cyperus esculentus</i>	FACW	10	
	Soft Rush	<i>Juncus effusus</i>	FACW	5	
	Rabbits Foot Clover	<i>Trifolium arvense</i>	NI	5	
	TOTAL % COVER (excluding invasive sp).....				62 %

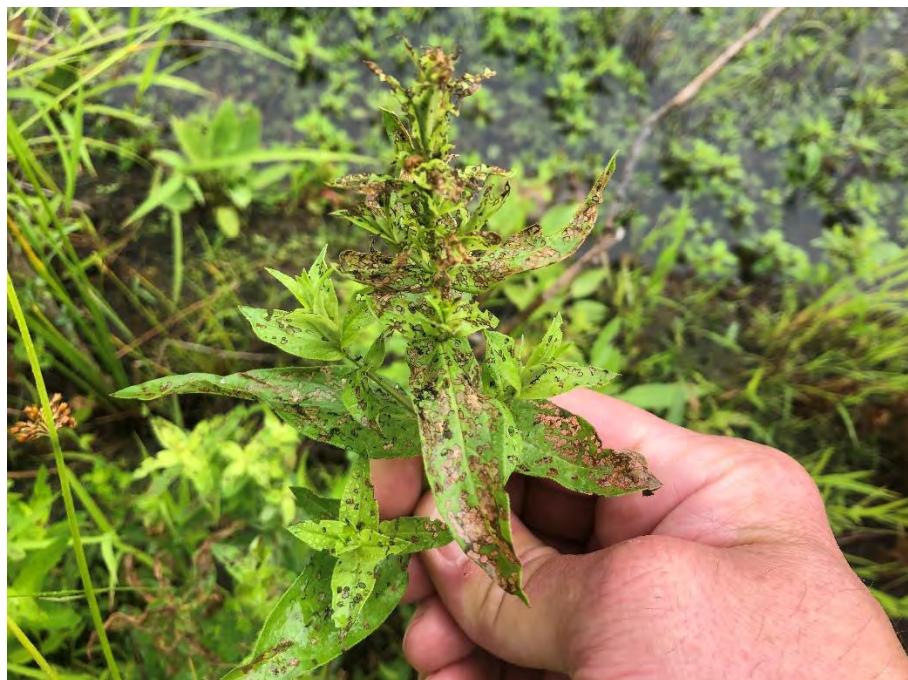
The development of planted woody species and seed mix is good and, in general, the floodplain meets or exceeds overall coverage requirements. Coverage by common pioneer species should decline as more desirable and diverse plant community develops including shrub species. These will be key focus points in the coming monitoring efforts. Invasive species are currently limited and the presence of Galerucella beetle is promising as it should help control Purple Loosestrife in the floodplain.

**Photo 13: Galerucella beetle acting on Purple Loosestrife, June 2020**

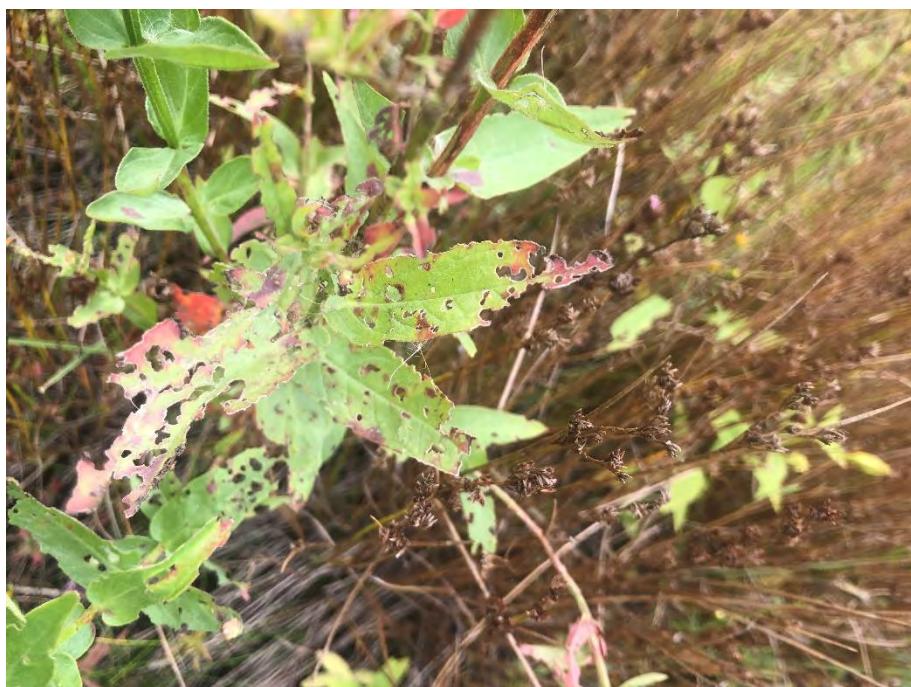
Two invasive species were observed in the floodplain, Purple Loosestrife and Phragmites. Together less than 3% cover was recorded in all the data plots with Purple Loosestrife being more widely distributed, mostly along the bank of the stream. Fortunately, Galerucella beetle, which has been widely introduced in the region for biological control of Purple Loosestrife was also confirmed to be active on the site. This should help keep this species under. The presence and relative activity of Galerucella beetle activity will be noted in future reports. More concerning is the emergence of Phragmites which is limited to the area immediately upstream and downstream of Transect 6 where the stream turns south (see monitoring plan). Eradication of Phragmites from the site is possible at this early stage, but it is very important that it be addressed now before the species proliferates into a much more difficult problem.

**Photo 14: Purple Loosestrife damage September 2020**

One important corrective action is recommended. A concerted effort needs to be made to eradicate this invasive species before it becomes entrenched. The recommended method is targeted application of Glyphosate based herbicide with a hand wiping technique to avoid collateral damage to desirable vegetation.

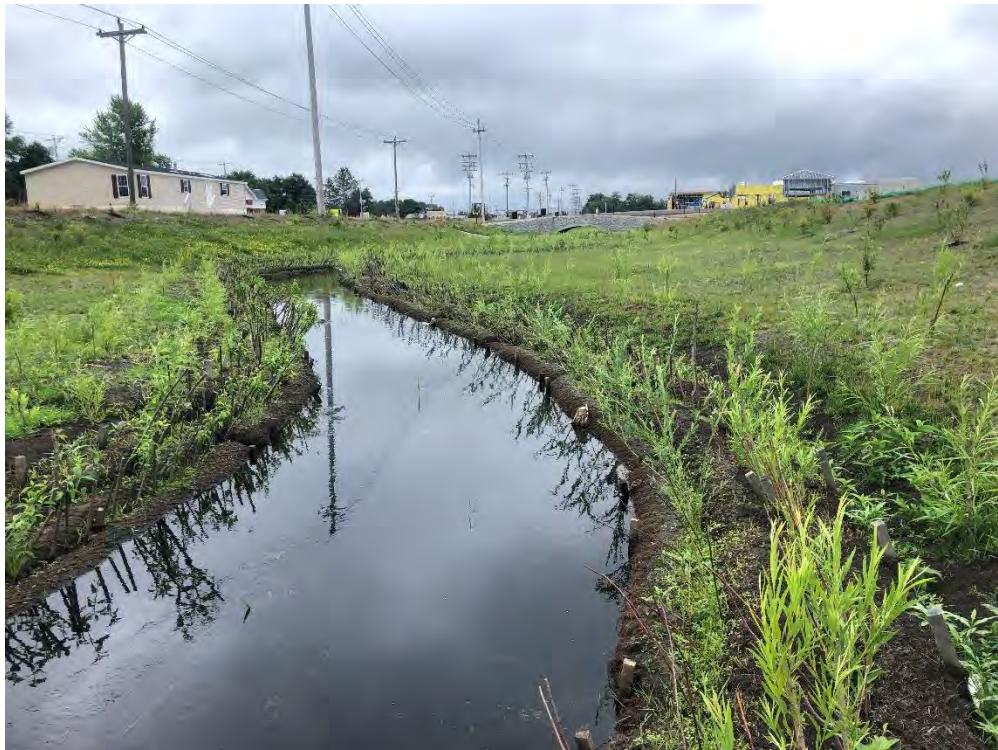
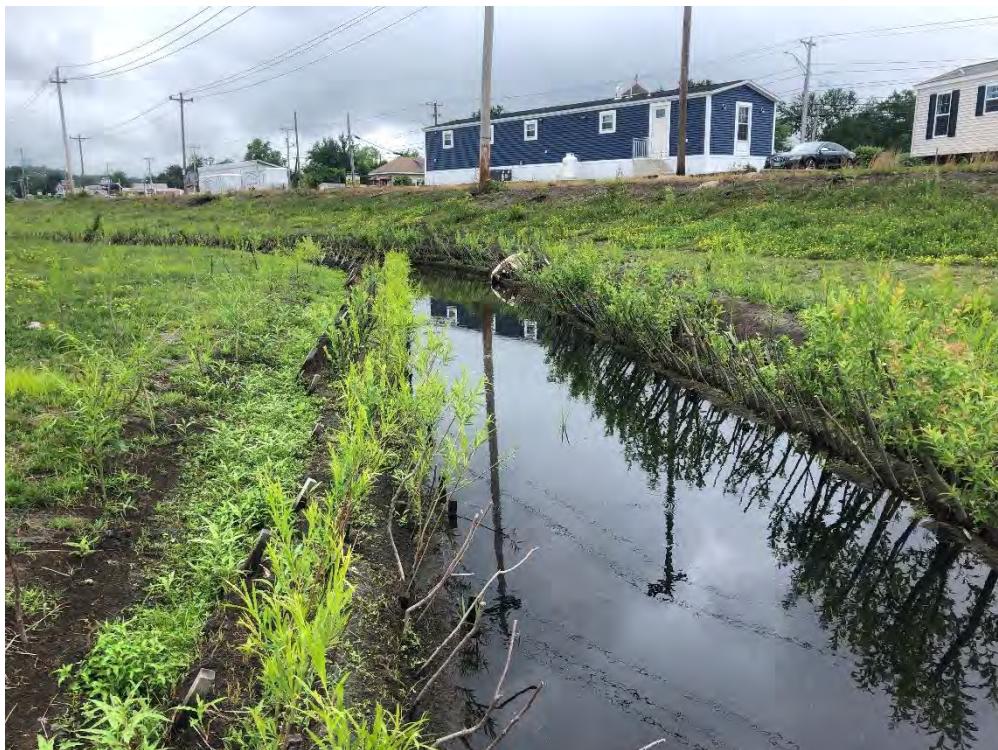
The remainder of plantings in wetland areas were delayed over concerns that high water levels, particularly in the lower portions of the floodplain, would result in the immediate mortality of potted plant material. A change in the planting schedule was requested and approved in October 2019. The revised planting schedule greatly reduced the number of containerized and bare root plantings and substituted additional seed mixes for diversity, including with shrub seed. The revised list is presented below. These plantings along with the dormant willow and dogwood cuttings were installed in the spring of 2020.

**Photo 15&16: June 2020, dormant cuttings installed in May are sprouting**

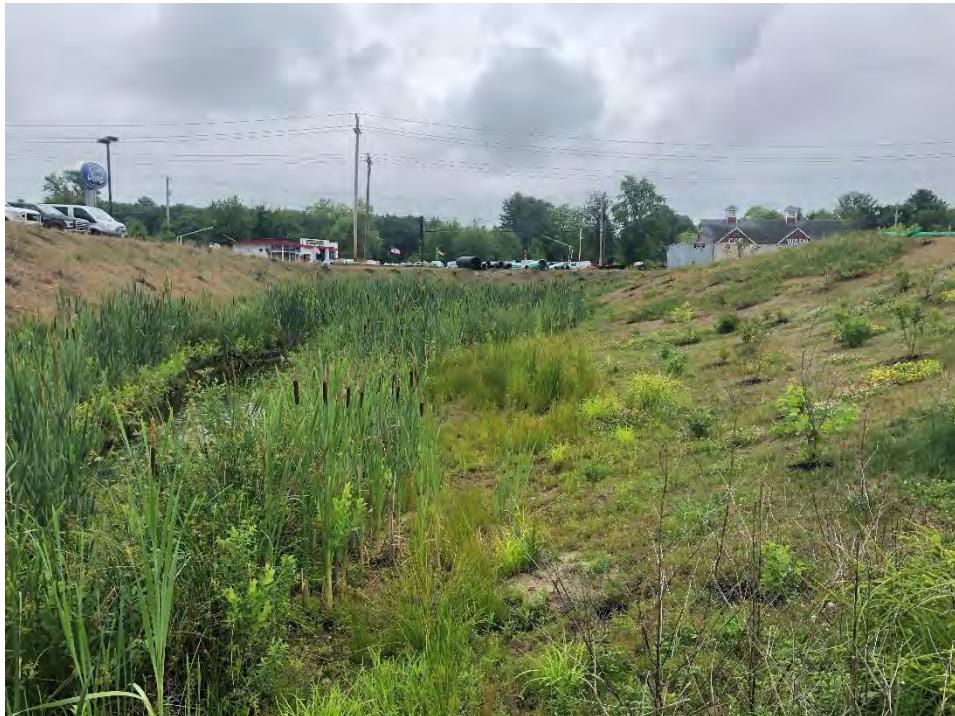
Importantly, the banks of stream channel are consistently well vegetated throughout the floodplain. Species from the seed mixes as well as common volunteer species are well represented, particularly in the areas seeded more than a year ago. Unsurprisingly, Cattail is present along the stream edge in most areas. The dormant willow and dogwood cutting installed this spring have sprouted nicely and can be expected to flourish. The primary intent of the dormant woody cuttings was to anchor coir log/soil interface and secure the bank of the stream. Over the rather long duration of construction, however, the coir lot installation has proved quite stable and the bank was well vegetated in many areas when the dormant cuttings were finally installed. Some of the dormant cuttings were therefore also installed beyond the bank up to several feet away to supplement the adjacent wetland areas. A healthy corridor of shrub vegetation is anticipated along the stream by the end of next season

**Photo 17: The stretch of channel adjacent to the Ford dealership is very well vegetated**

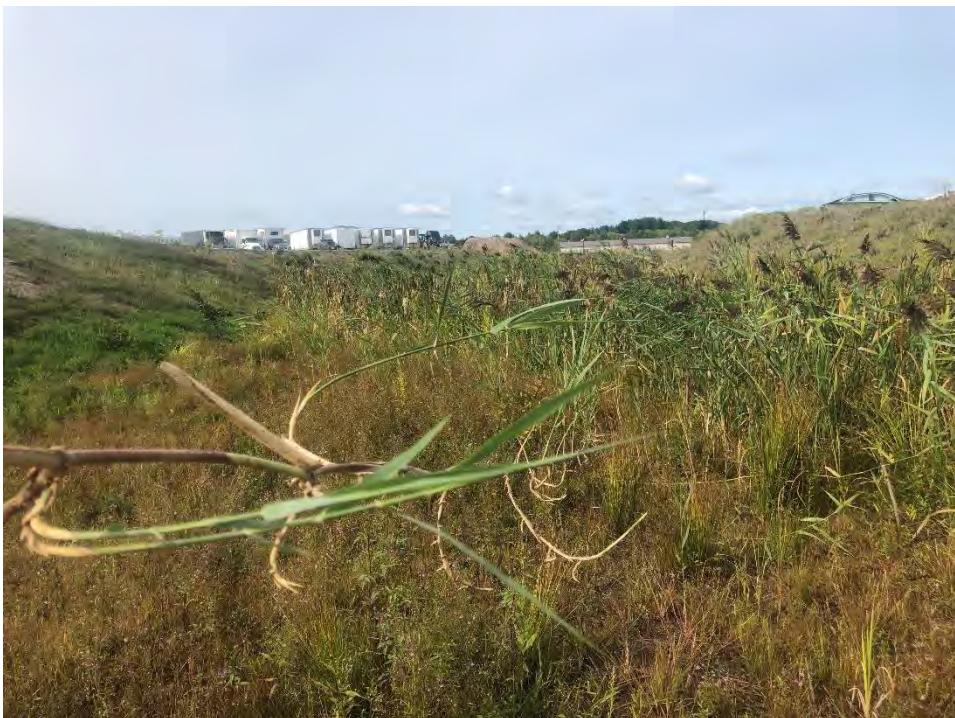
**Photo 18: Phragmites near Ford dealership needs to be addressed (see monitoring plan for location)**
