North Main Street Bridge Construction Progress

April 28, 2017

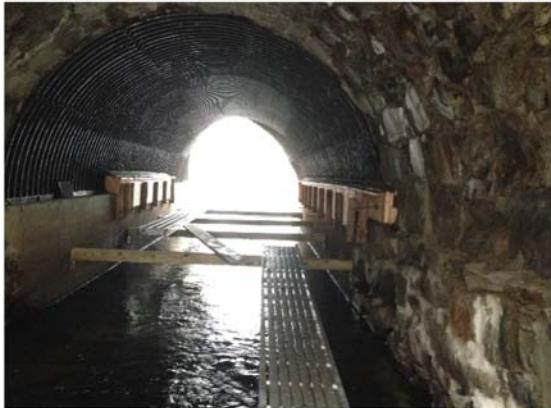
Abutment Wall Extension – Looking Downstream/East

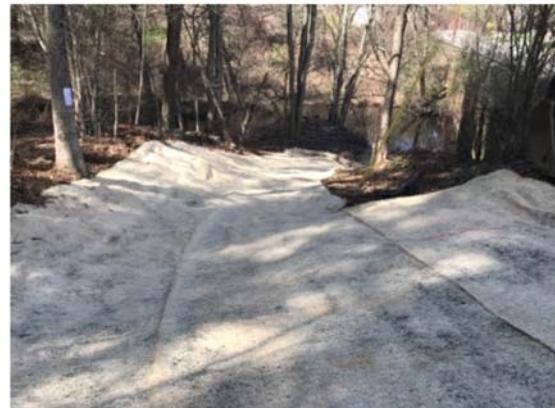
Stabilized Disturbed Slope – Looking North
