FINAL REPORT

EVALUATION AND ASSESSMENT
TOWN OF SALEM DISTRICT COURTHOUSE
35 GEREMONTY DRIVE
SALEM, NEW HAMPSHIRE

FEBRUARY 10, 2017

Facility Assessment Report

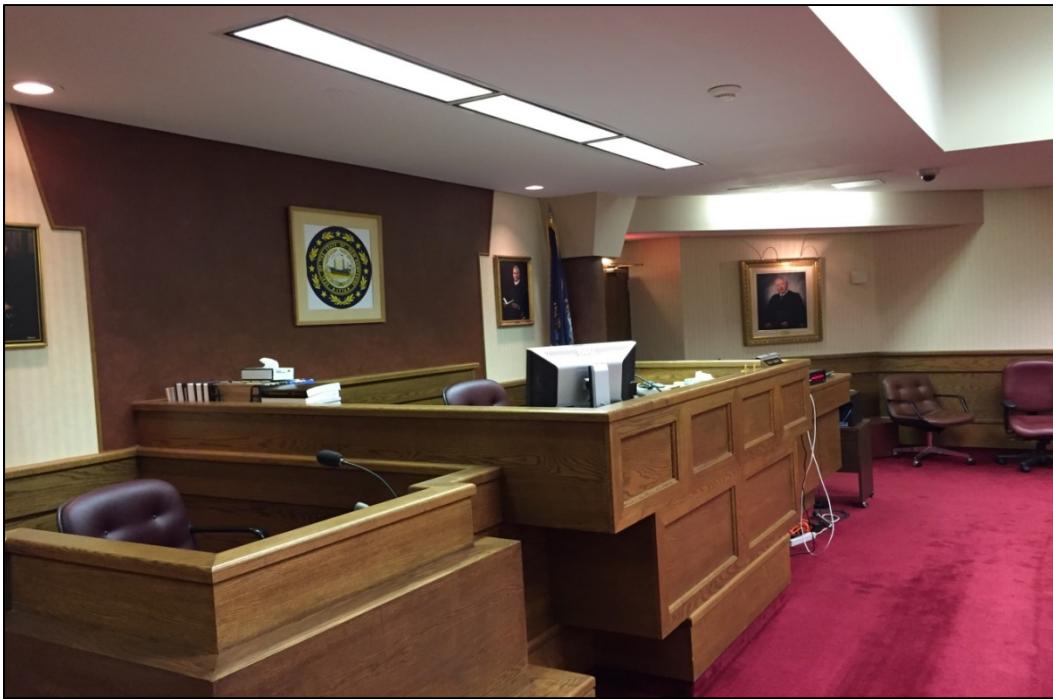
Courtroom No. 1.

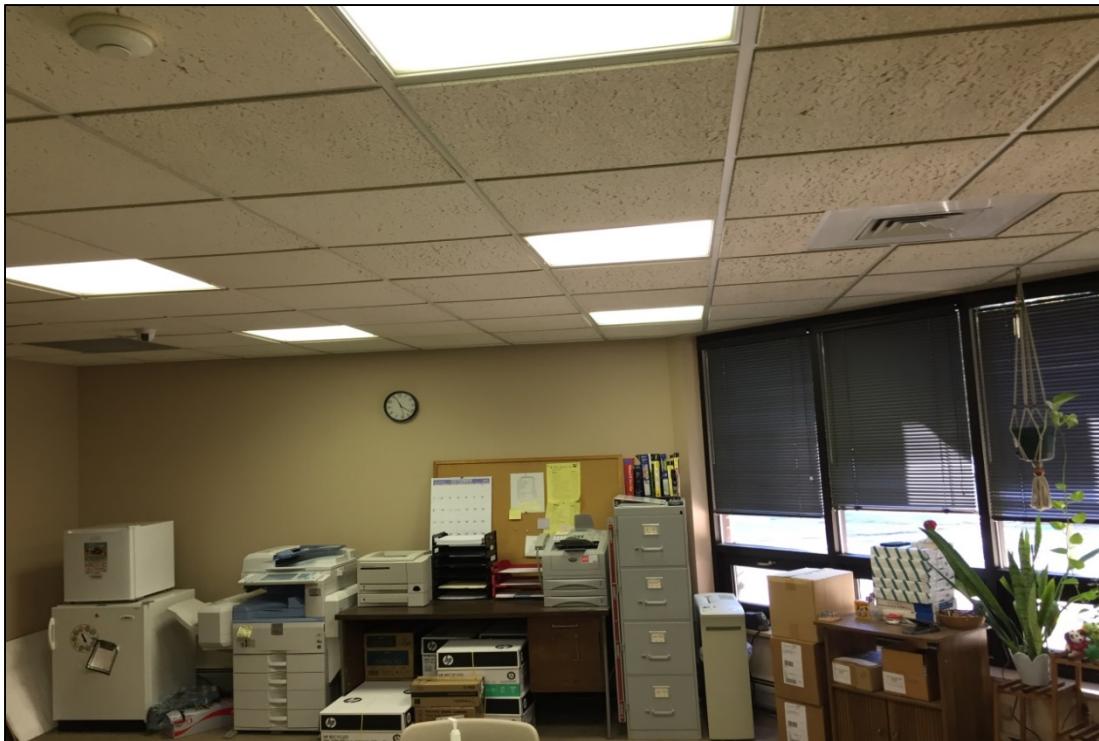
Grid-type acoustical ceiling in probation department.

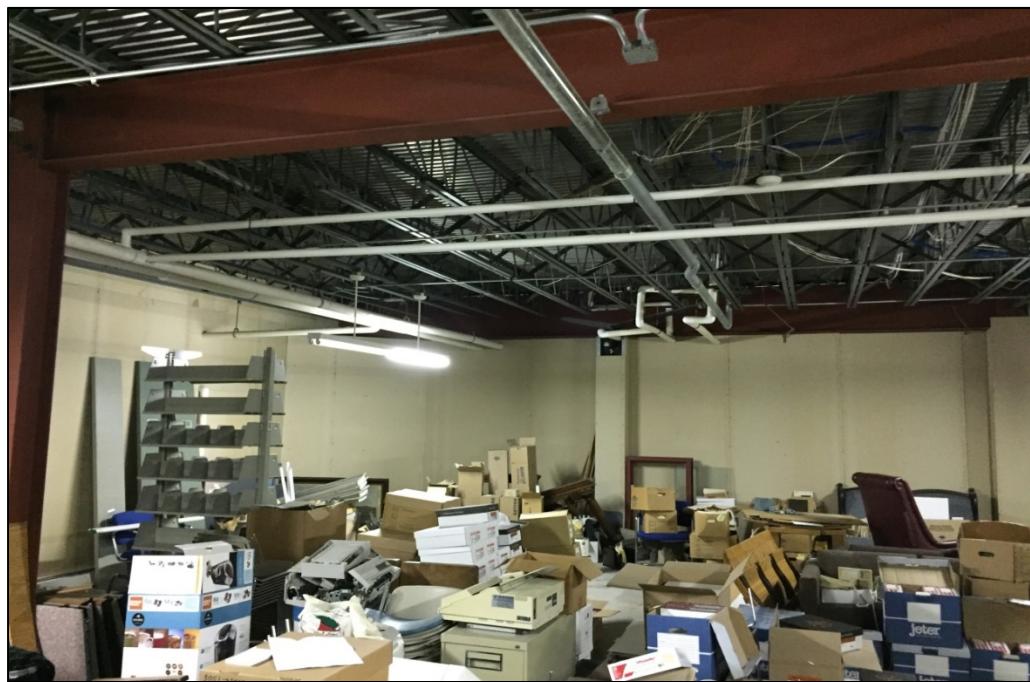
Future courtroom at lower level currently used for storage.

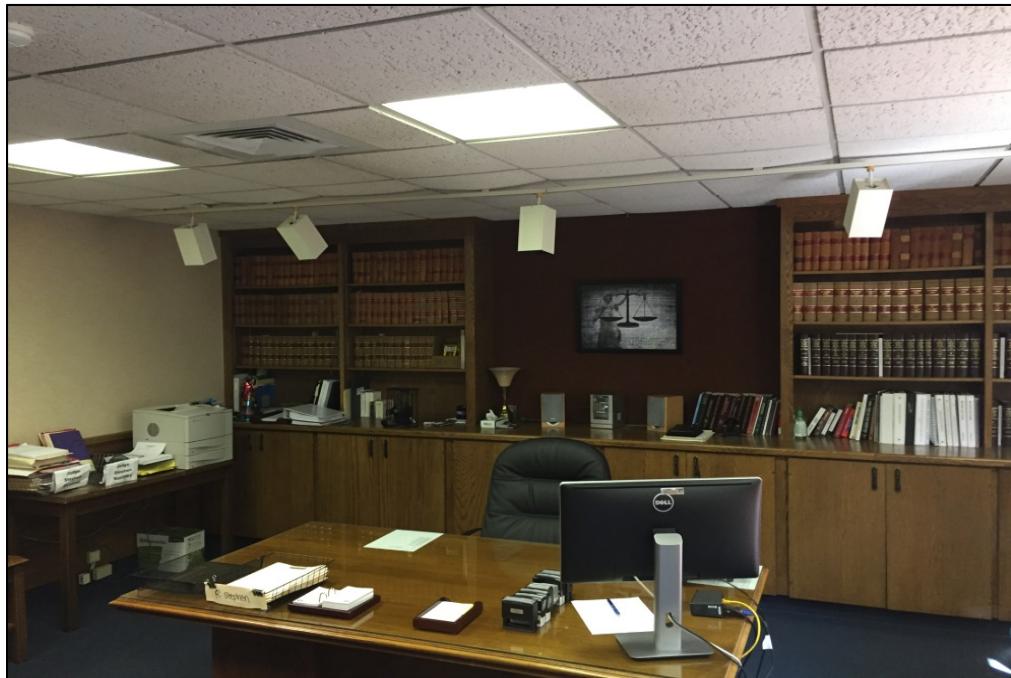
Judge's chamber.

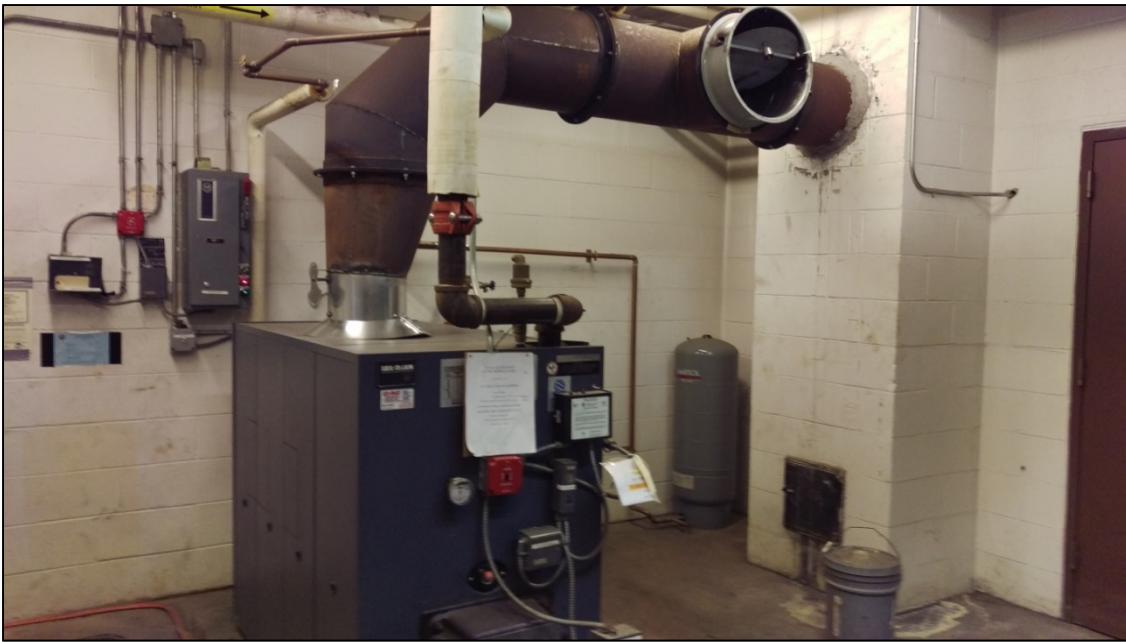
Oil-fired boiler.

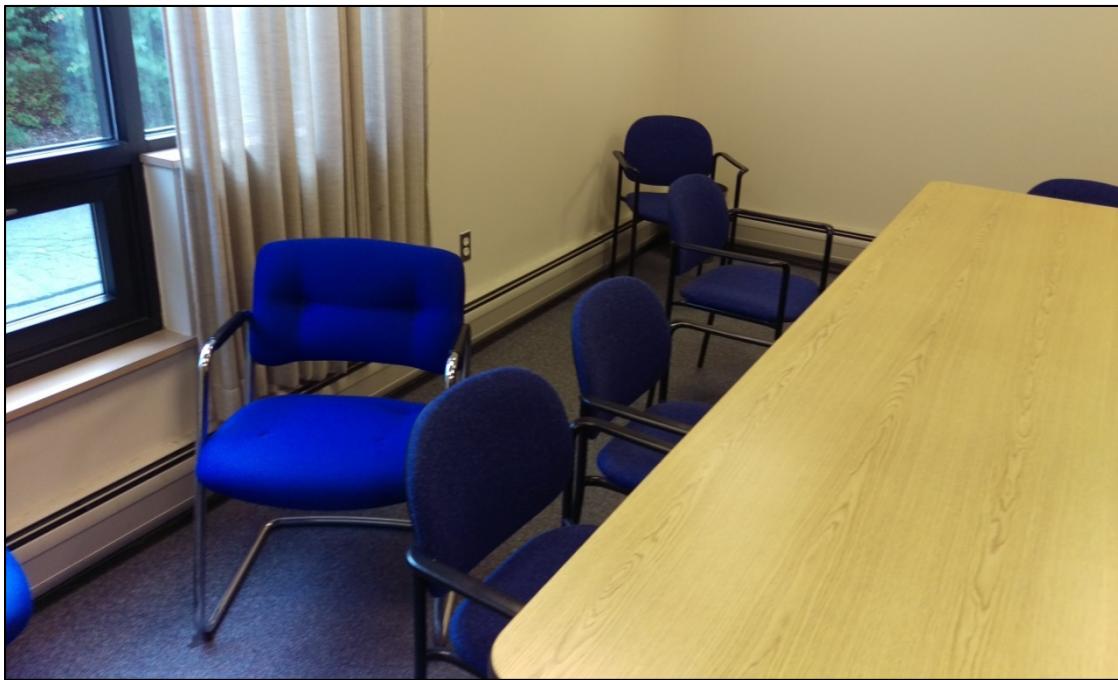
Typical fin tube radiators.

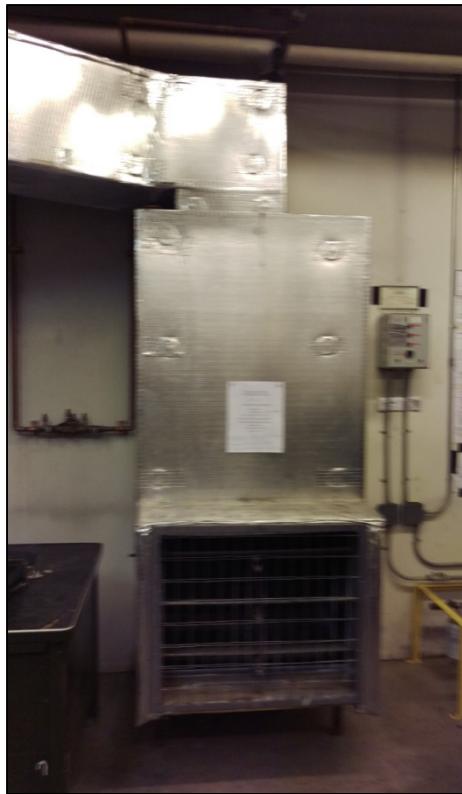
Combustion air duct.

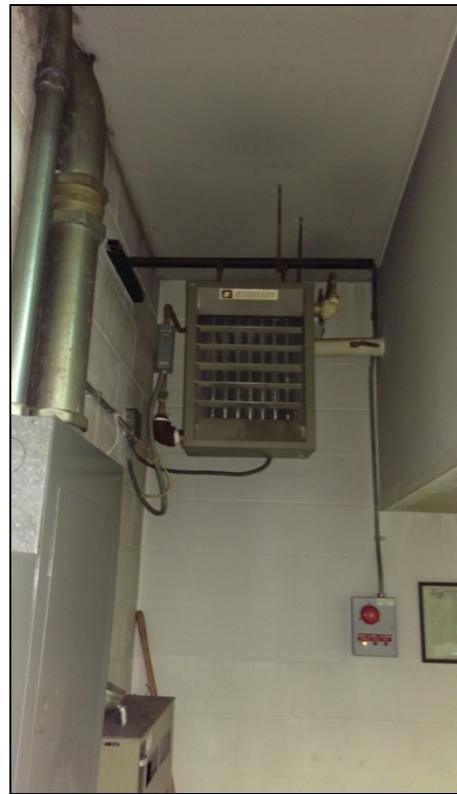
Unit heater.

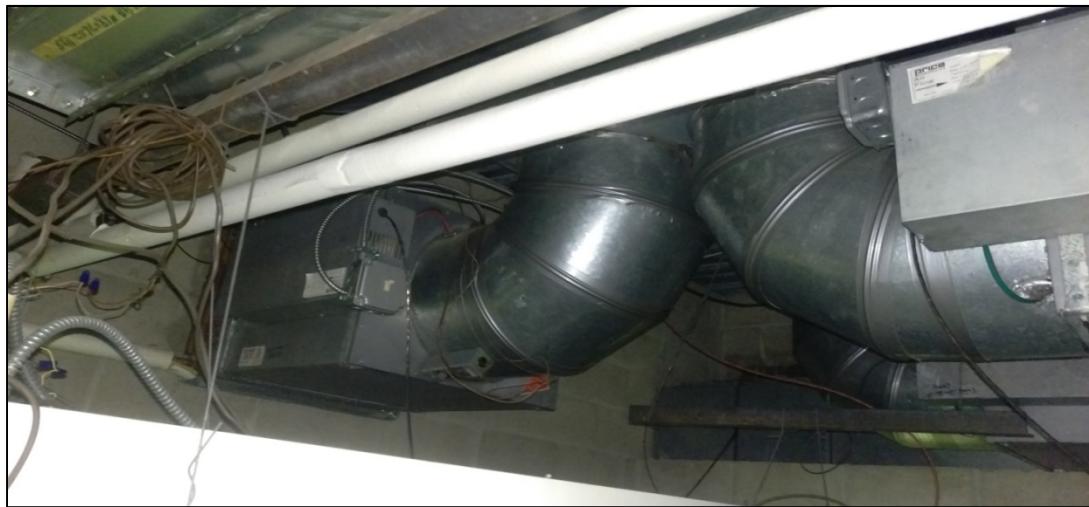
Variable air volume box.

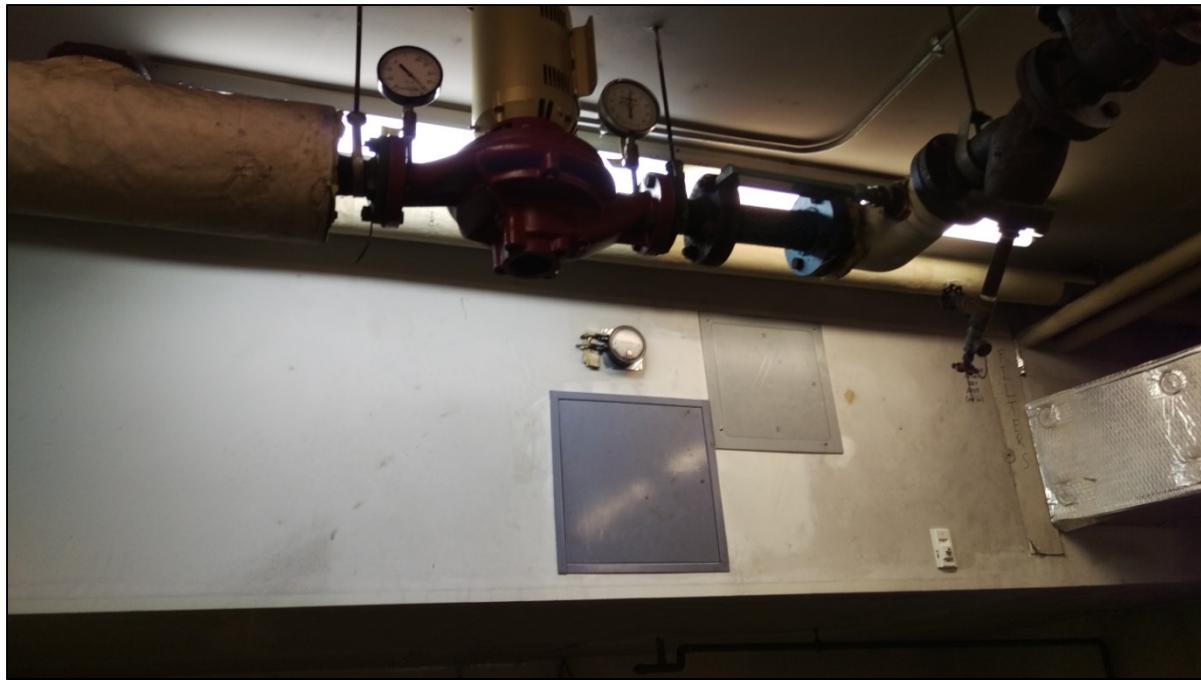
Hot water pump.

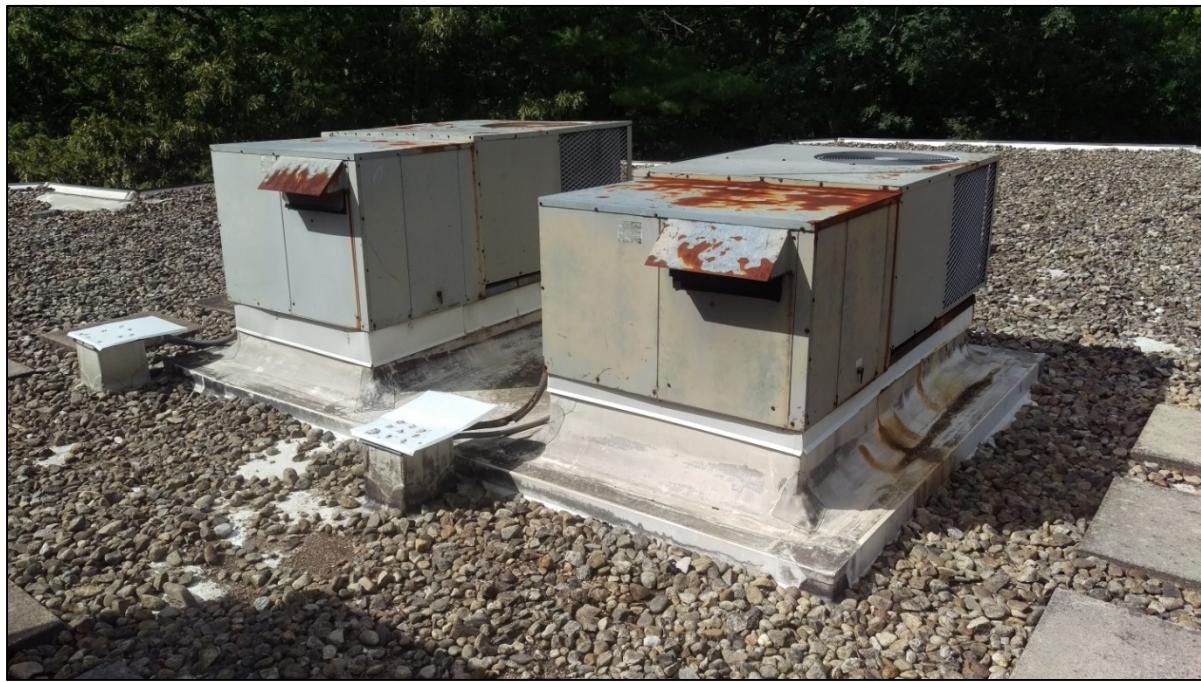
Roof mounted air handling units serving the lower level.

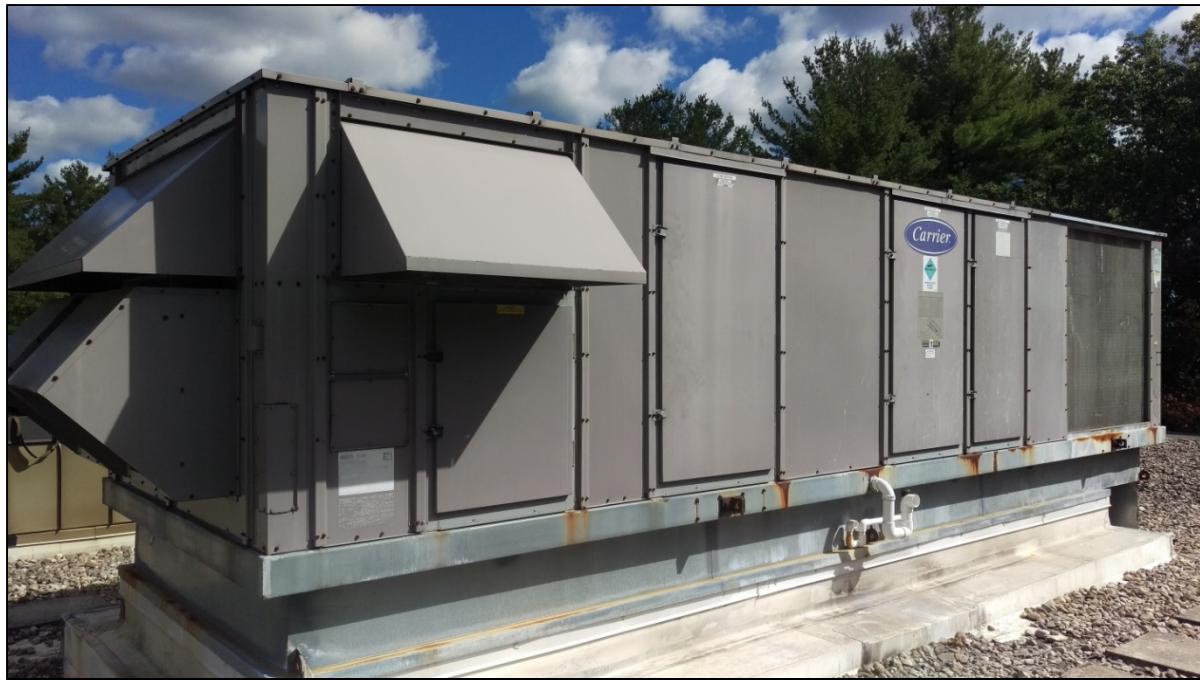
Large roof mounted air handling unit. Main unit for Level 1.

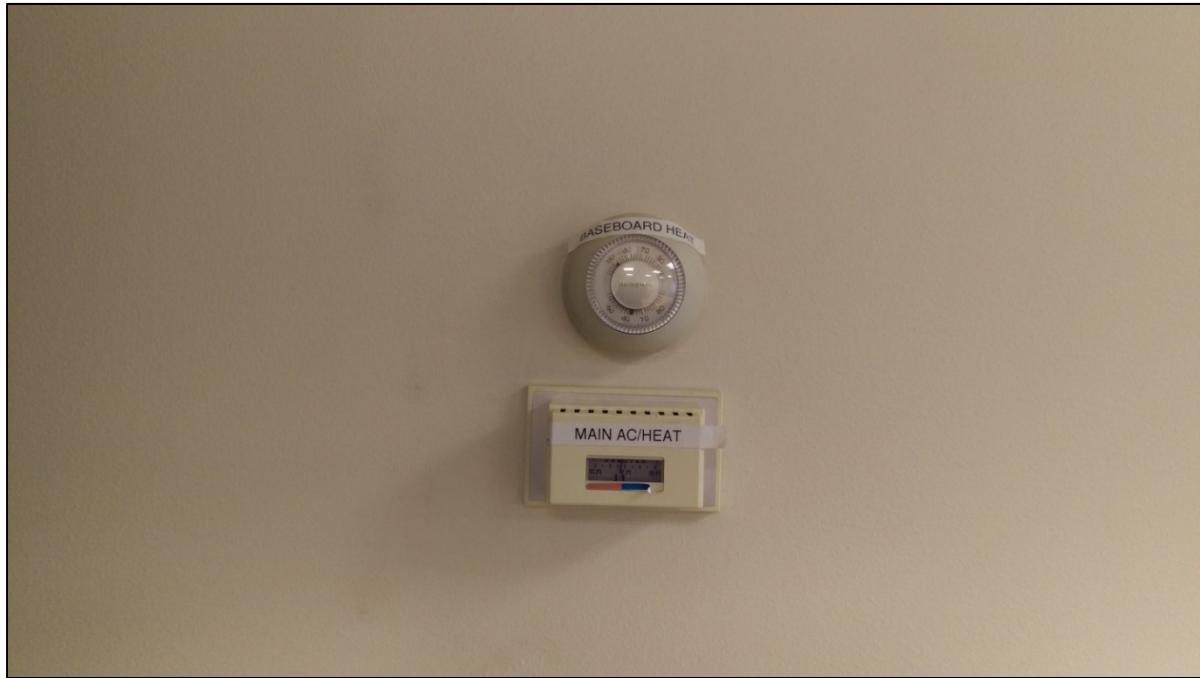
Typical temperature controls throughout building.

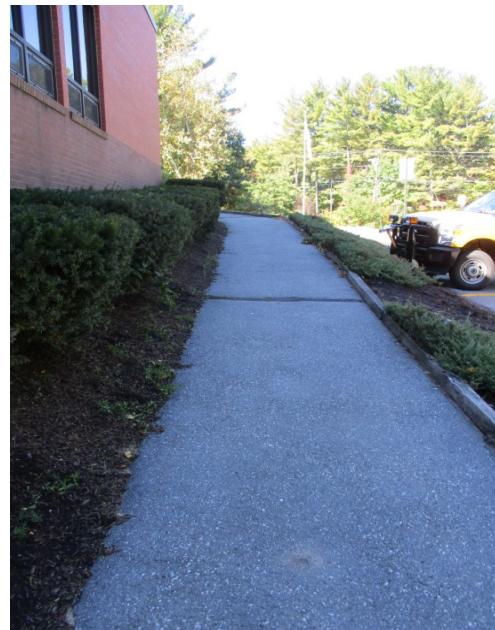
Asphalt ramp to main entrance.

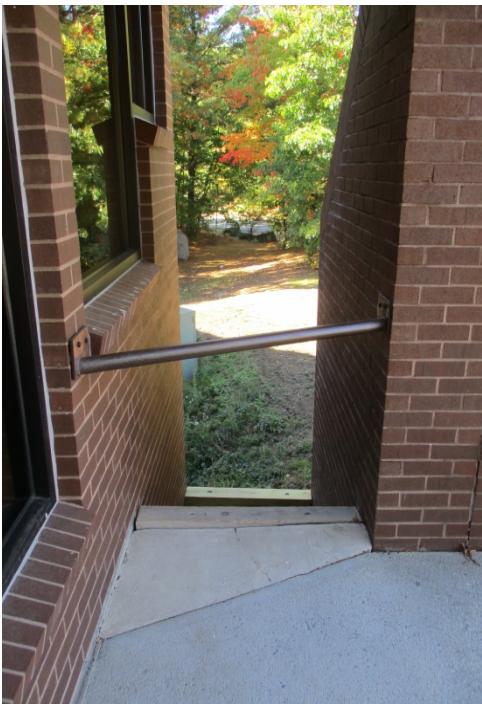
Guardrail to the right of the entrance.

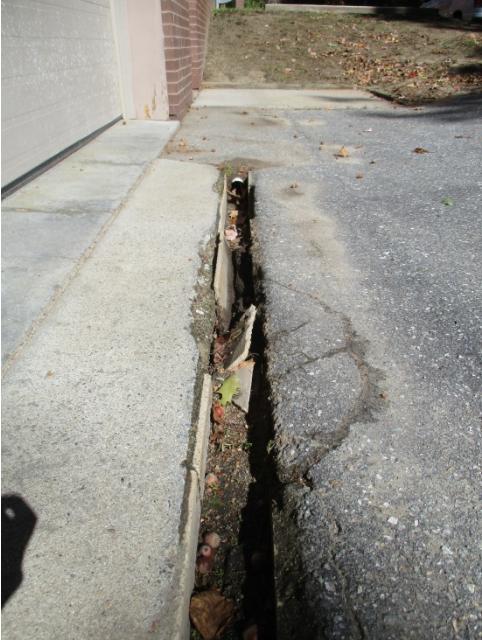
Trench drain on east side of Courthouse.

- Pump station upgrades
- Modify force main to prevent freezing
- New oil supply pump
- Repairs to catch basin and trench drains at overhead doors

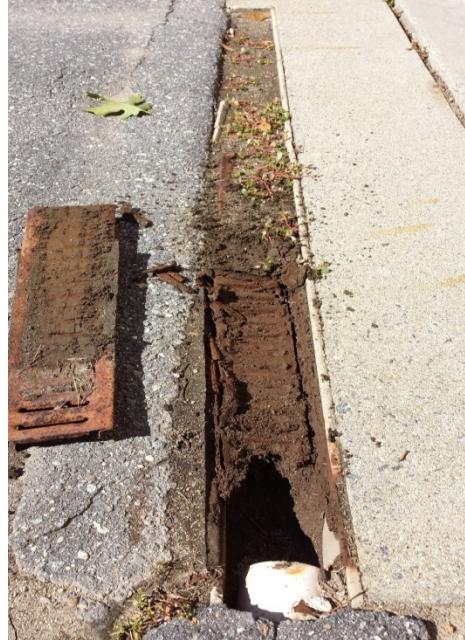
Trench drain on south side of Courthouse.

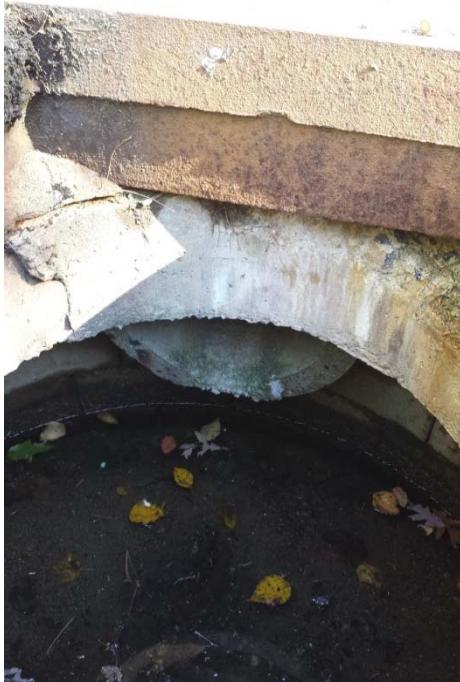
Catch basin with full sump.

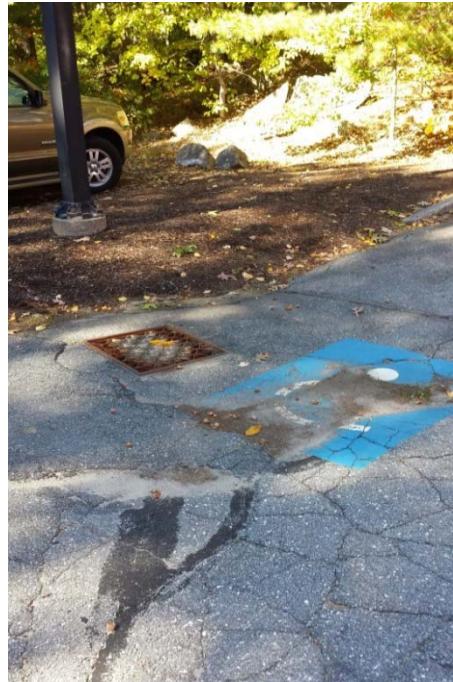
Catch basin at relative high point.

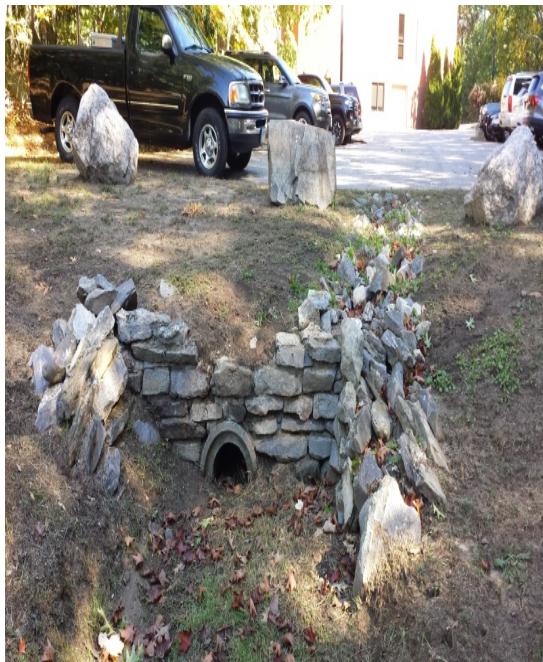
Obstructed drainage pipe outlet and
crumbling retaining wall.

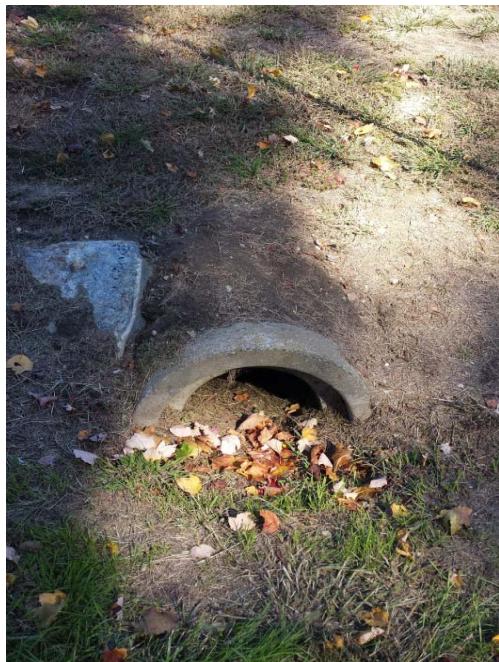
Culvert outlet at driveway entrance.

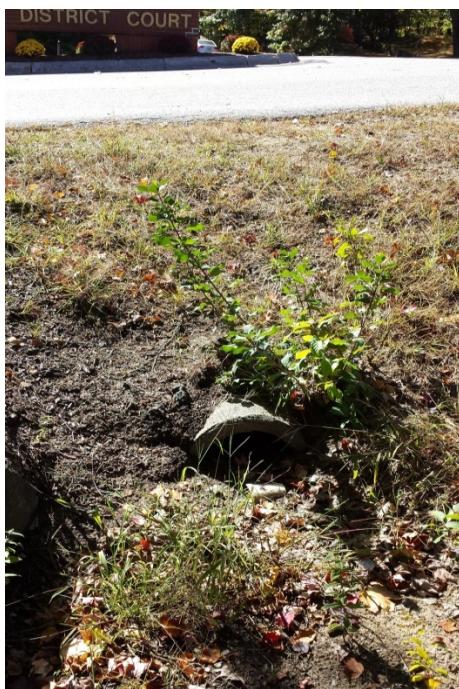
Culvert inlet at driveway entrance.
Note sediment in swale.

- Clean out culverts, trench drains, swales and catch basin sumps
- Replace overhead door trench drains
- Replace depressed pavement around catch basin
- Develop a stormwater inspection and maintenance plan

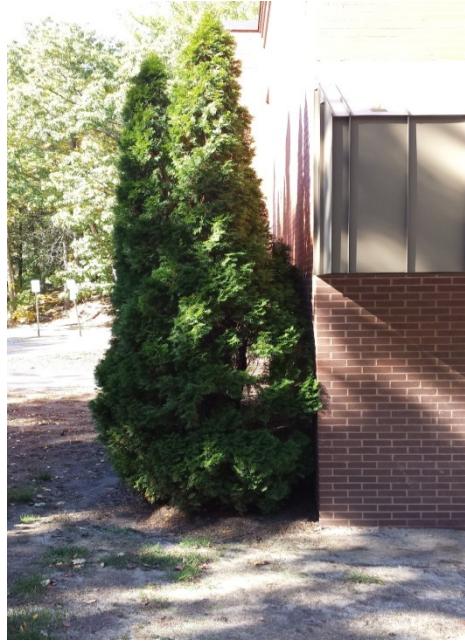
Arborvitae growing against building.

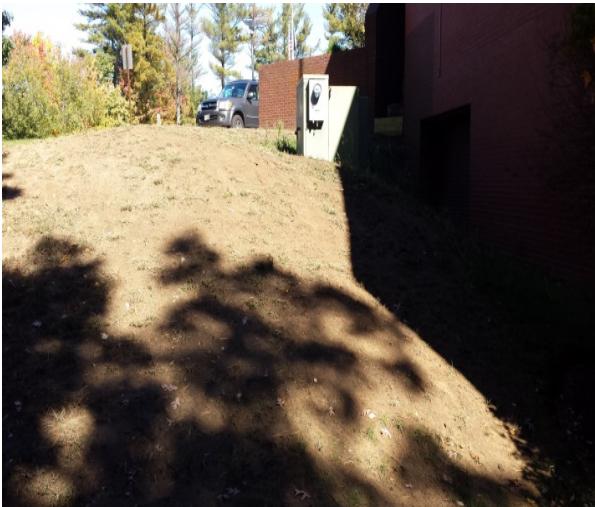
Sparse grass-cover (typical of many locations).

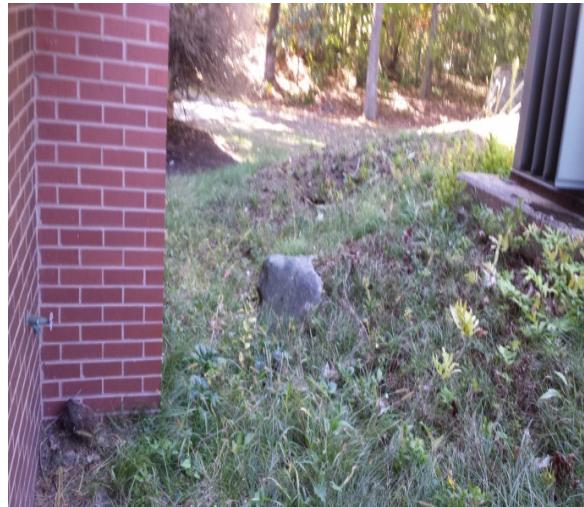
Steep slope behind transformer toward building.

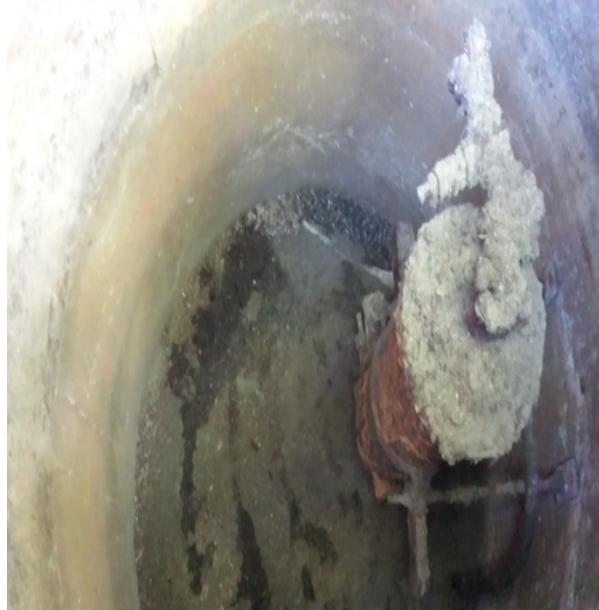
Interior of blow-off manhole.

- Insulate buried force main pipe
- Clean and test blow-off valve in manhole – replace if needed
- Clean-out manhole
- Comprehensive inspection of pump station
- Replace pump station cover

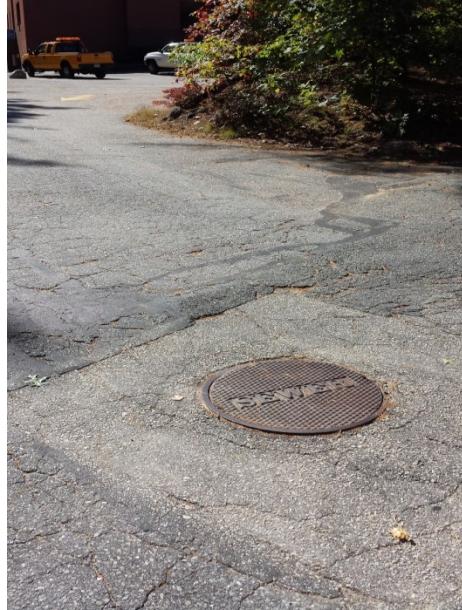
Clean-out manhole.

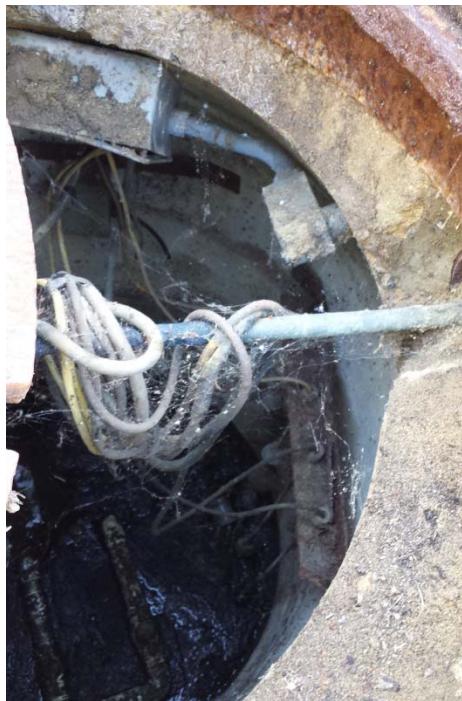
Pump station junction box and float rack.

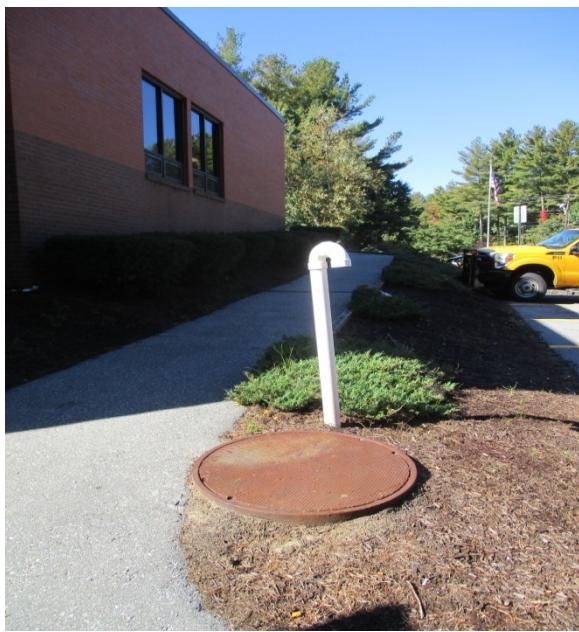
Pump station and vent pipe.

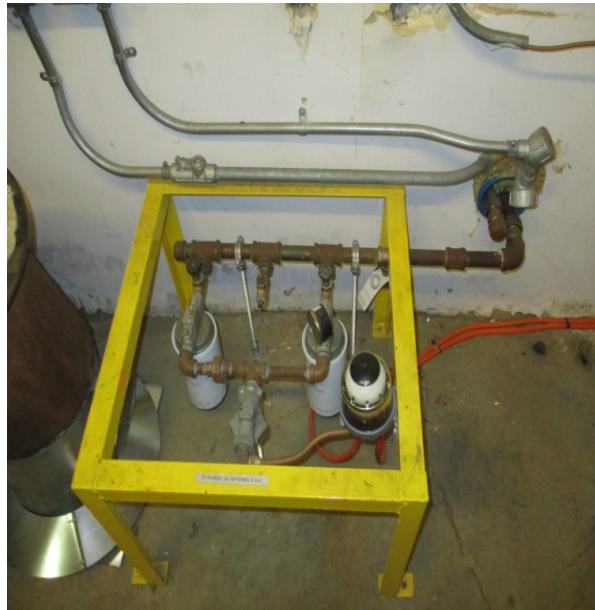
Oil supply piping. Note capped line.

- Replace oil supply – pump
- Perform a comprehensive inspection of the oil supply – system
- Cap exposed electrical conduit at main entrance – sign
